| <b>SMULDERS</b> | <b>EWP G1</b><br>External work platform – FAT documentation | 25220<br>Hollandse Kust Zuid |

## Mechanical Release Note EWP Rev 2 #19

## Punchlist mechanical

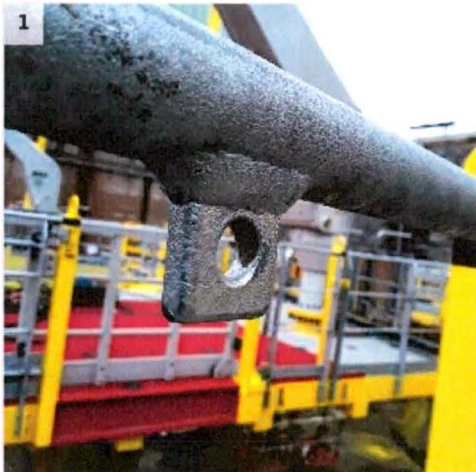
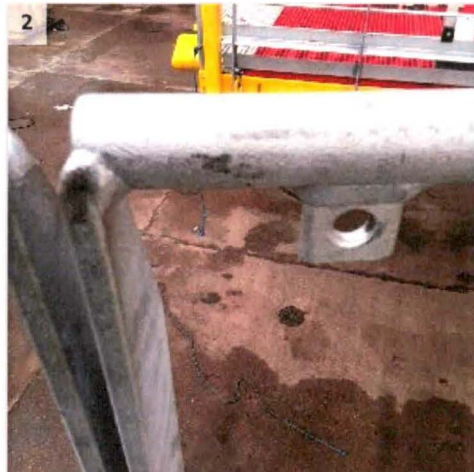
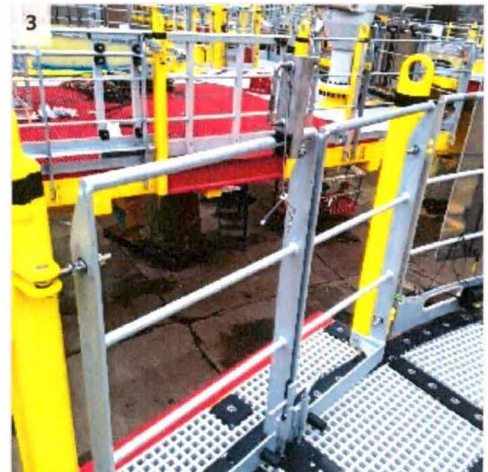
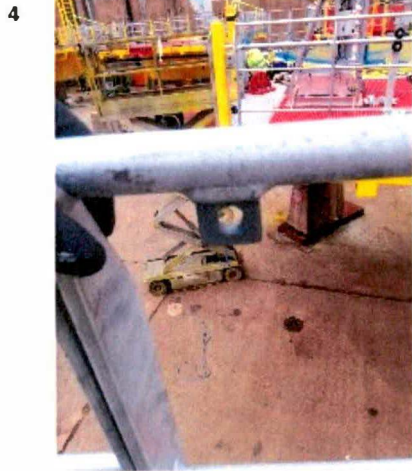
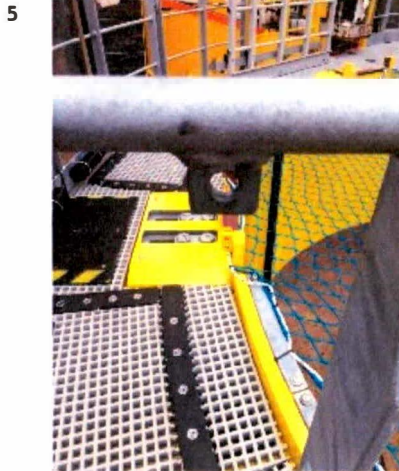
## ● #1403 - Coating missing

| Ben Herygers | Coating missing @TouchUp @ilchan_chanko #client | 26 Jun 08:26 |

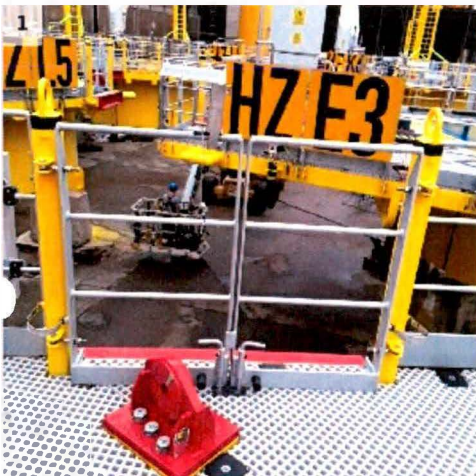
● **#1404 - Video missing for the double gate**

| Ben Herygers | Video missing for the double gate @Mechanical @dawid_kaminski @kevin_kemps #client | |
| Ben Herygers | For opening from the gate | |

| Marcin Witkowski | Check task #1509 | |

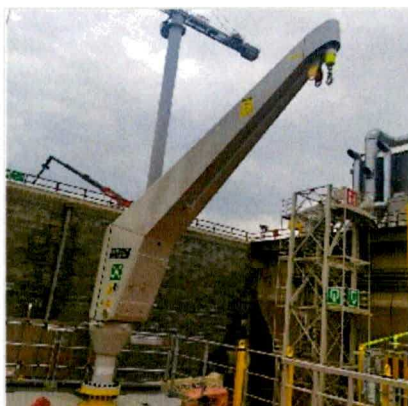
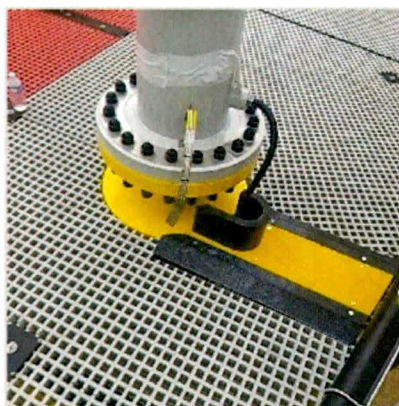
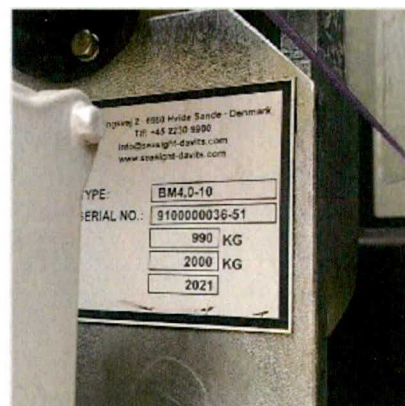
## 2.19 Davit crane =XMM13\_MZ001

RDS-PP label Correct OK with remarks

Remarks: RDS-PP label Davit Crane =XMM13

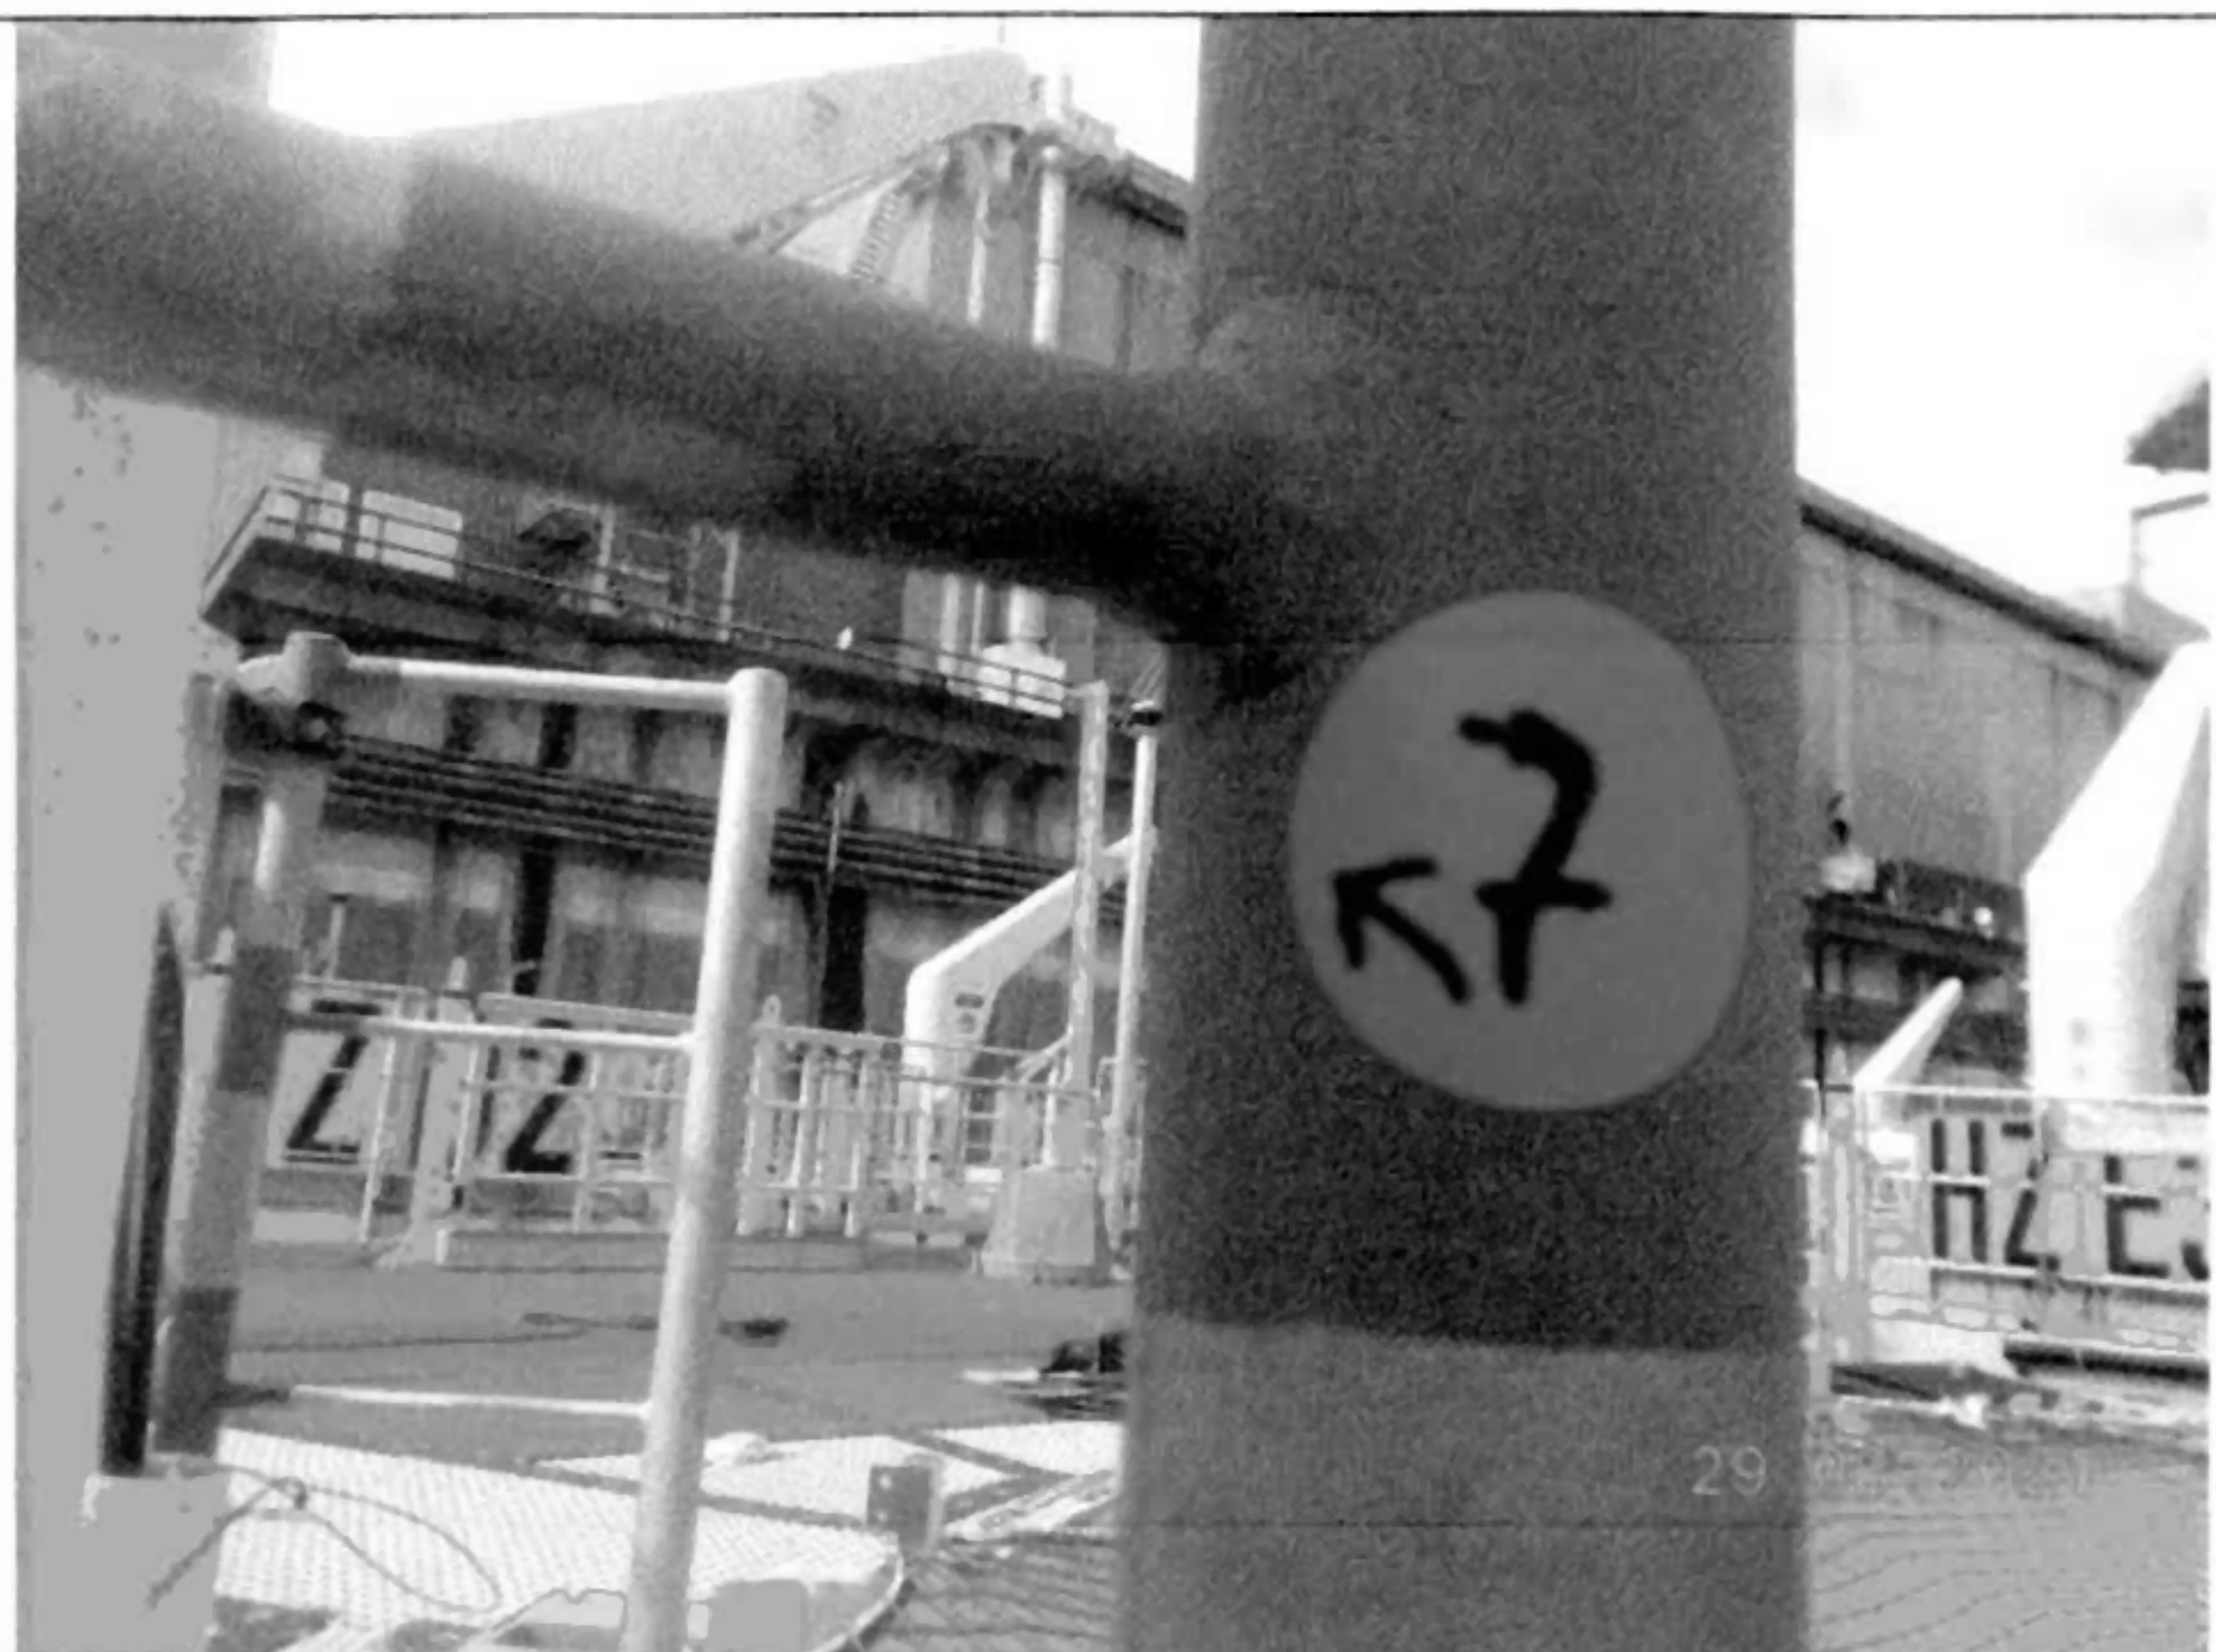
| H3M | | Rev. 2 | Date: 29.06.2021 |
|---|--|---|---|
| No. 7 – HDG railings, touch up rework required. | | No. 8 – Fly rust and tape residue, cleaning required. | |

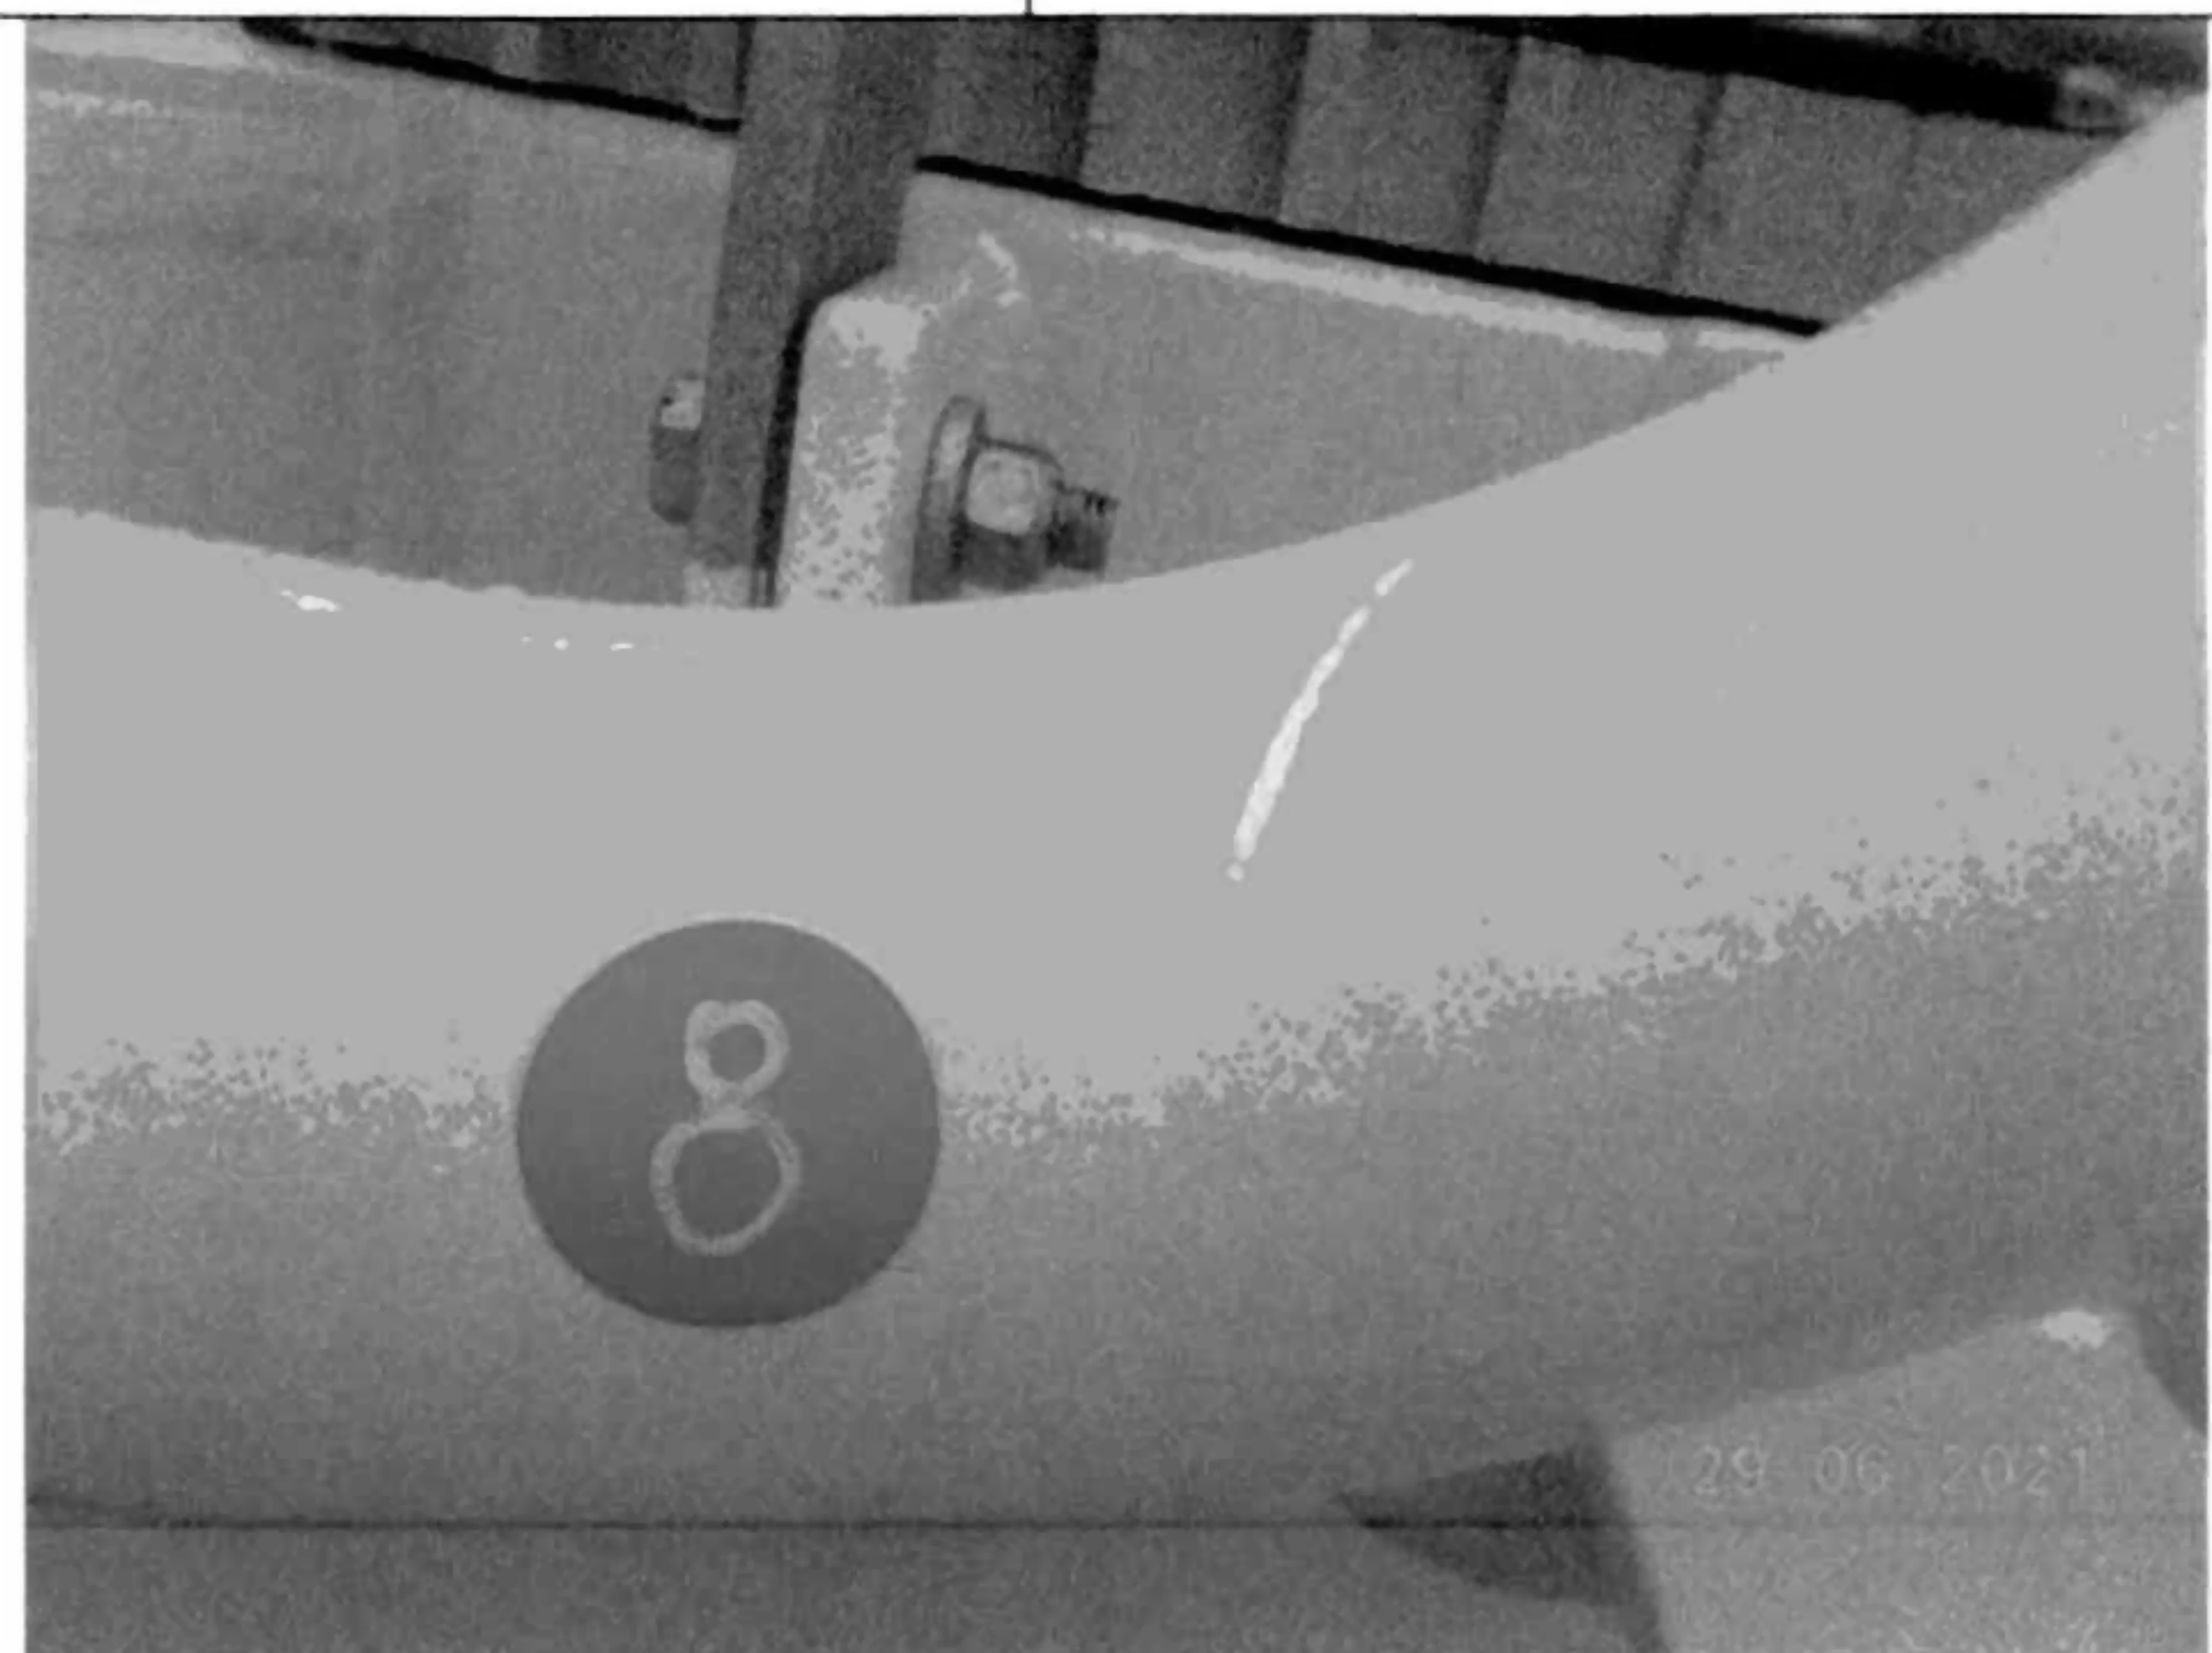
| N° | Description | Completion<br>Signature + Date | |
|---|---|---|---|
| 8 | Fly rust and tape residues, cleaning required. | | |

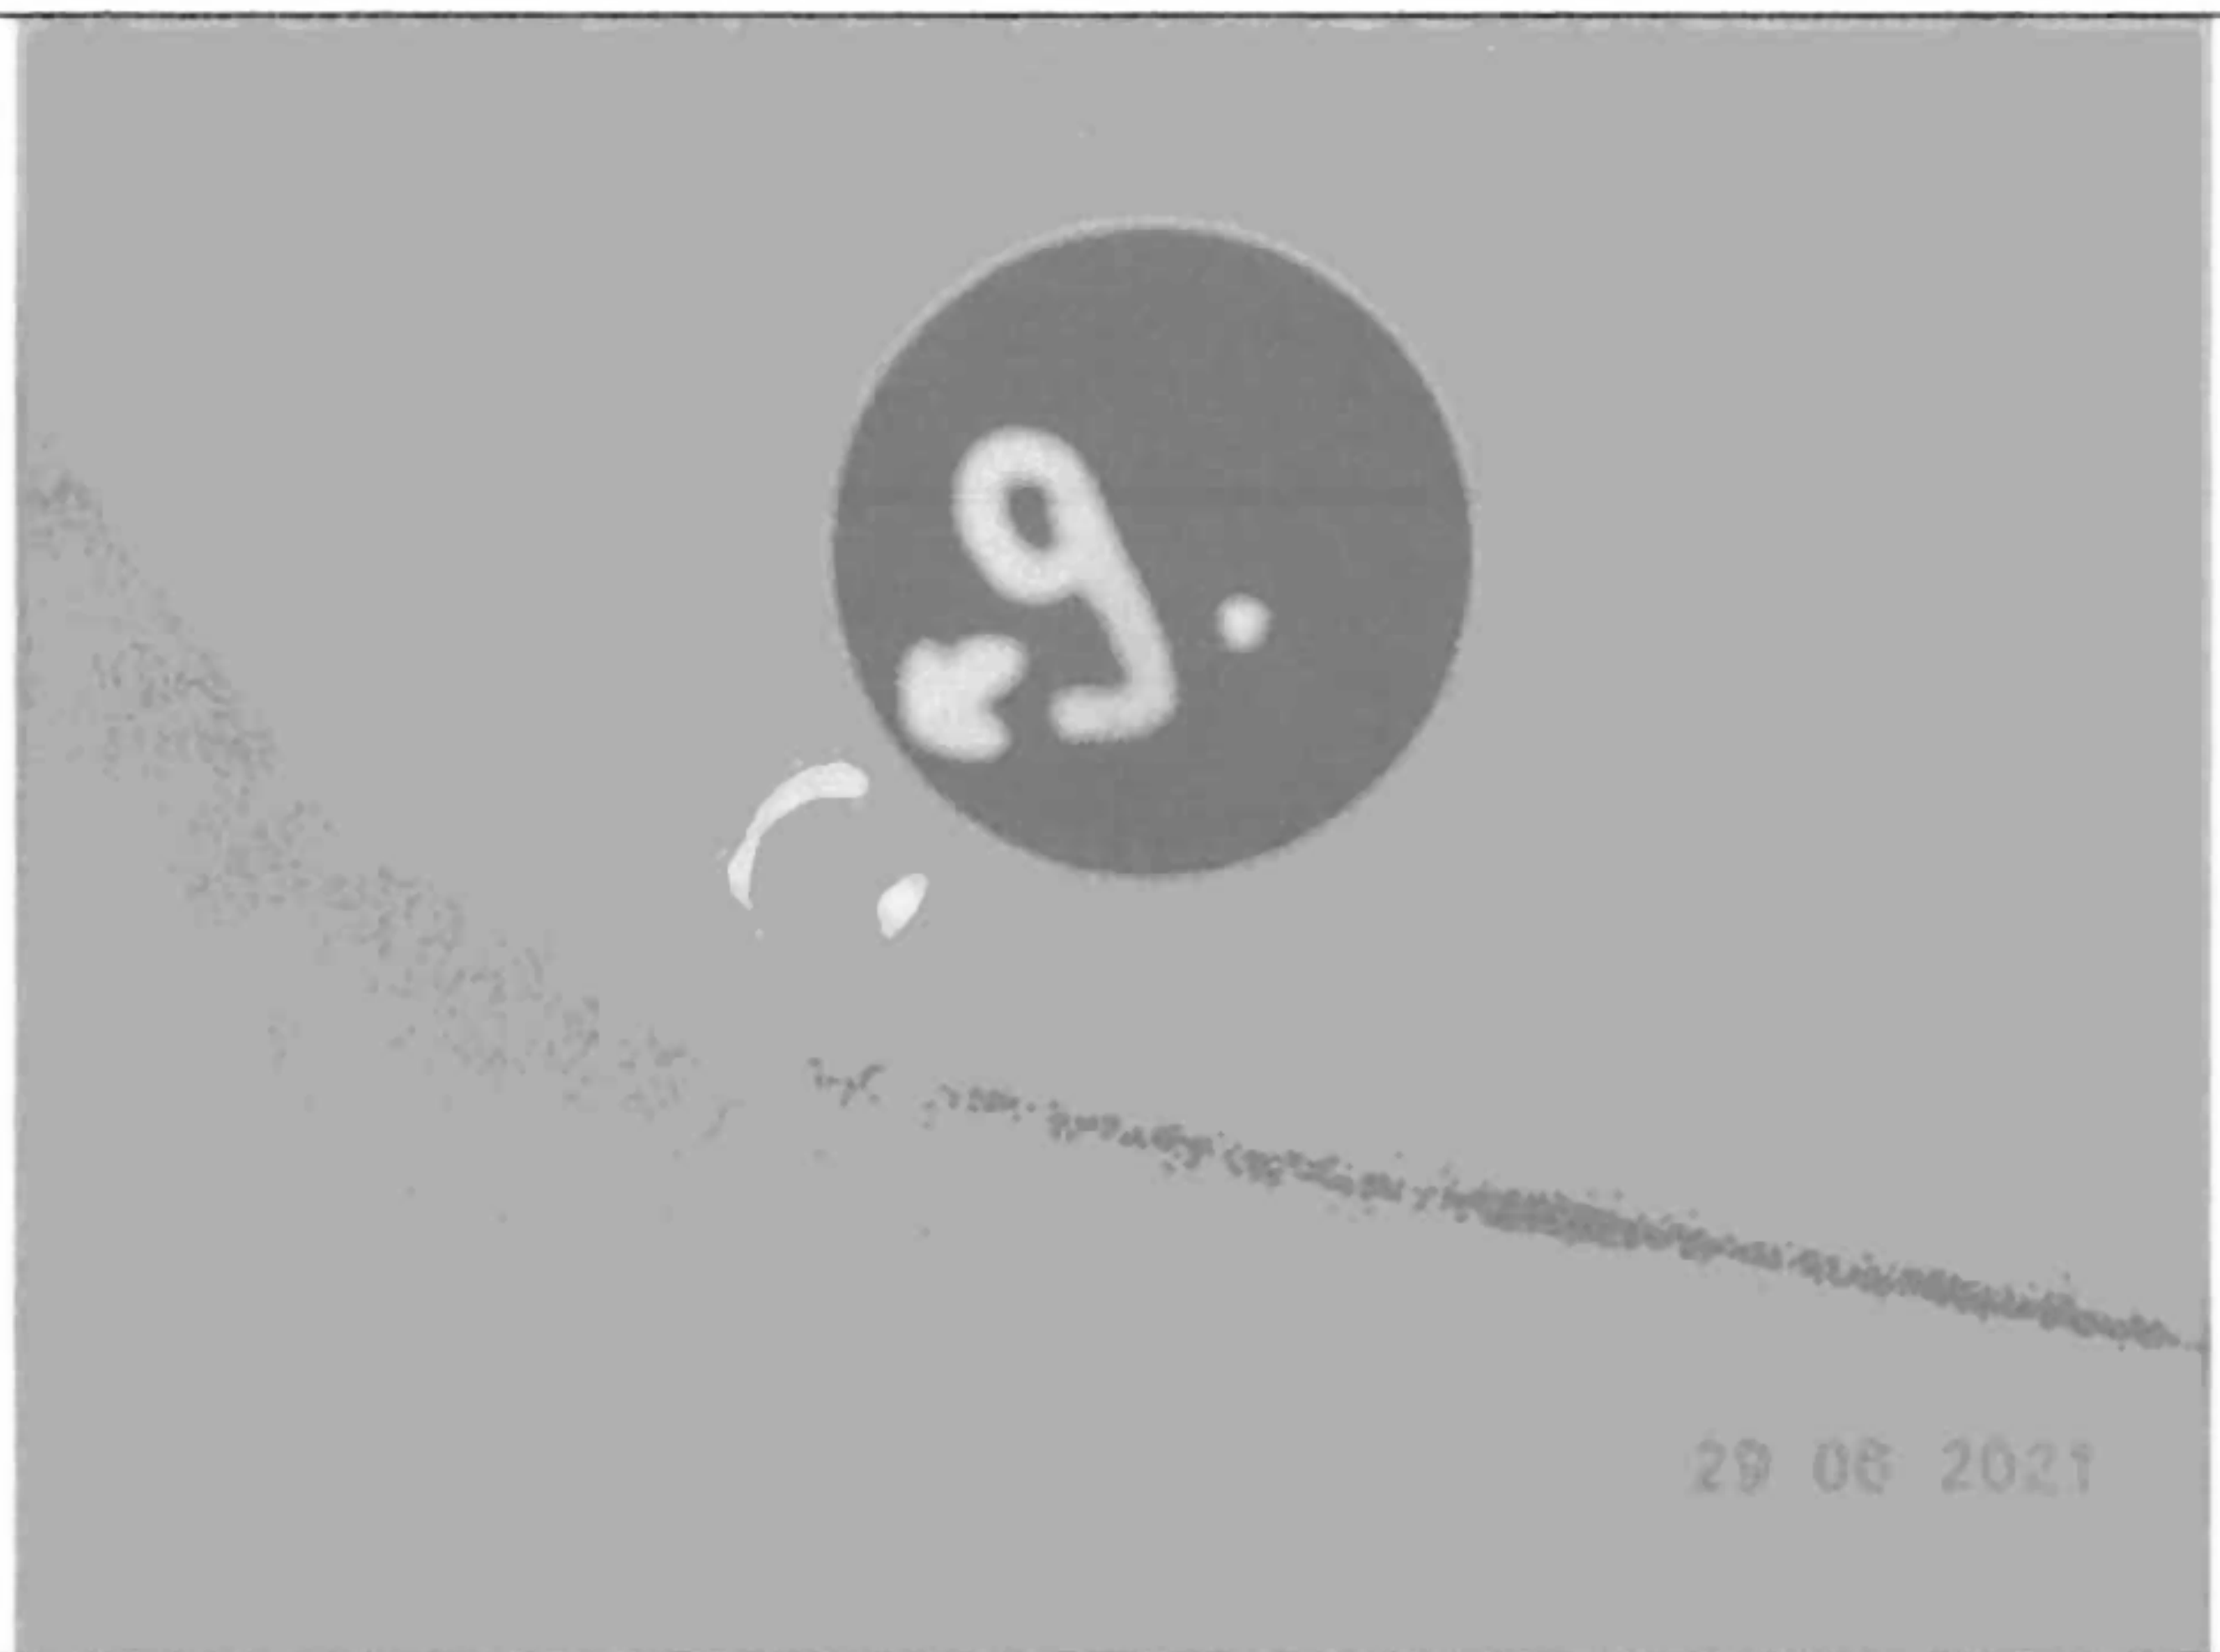
| N° | Description | Completion<br>Signature + Date | |
|---|---|---|---|
| 9 | Mechanical damages to coating. | | |

| H3M | | Rev. 2 | Date: 29.06.2021 |
|---|--|---|---|
| No. 9 – Mechanical damage to coating. | | No. 10 – Full coat system must be applied 20 mm up face of plate. See drawing 8522. | |

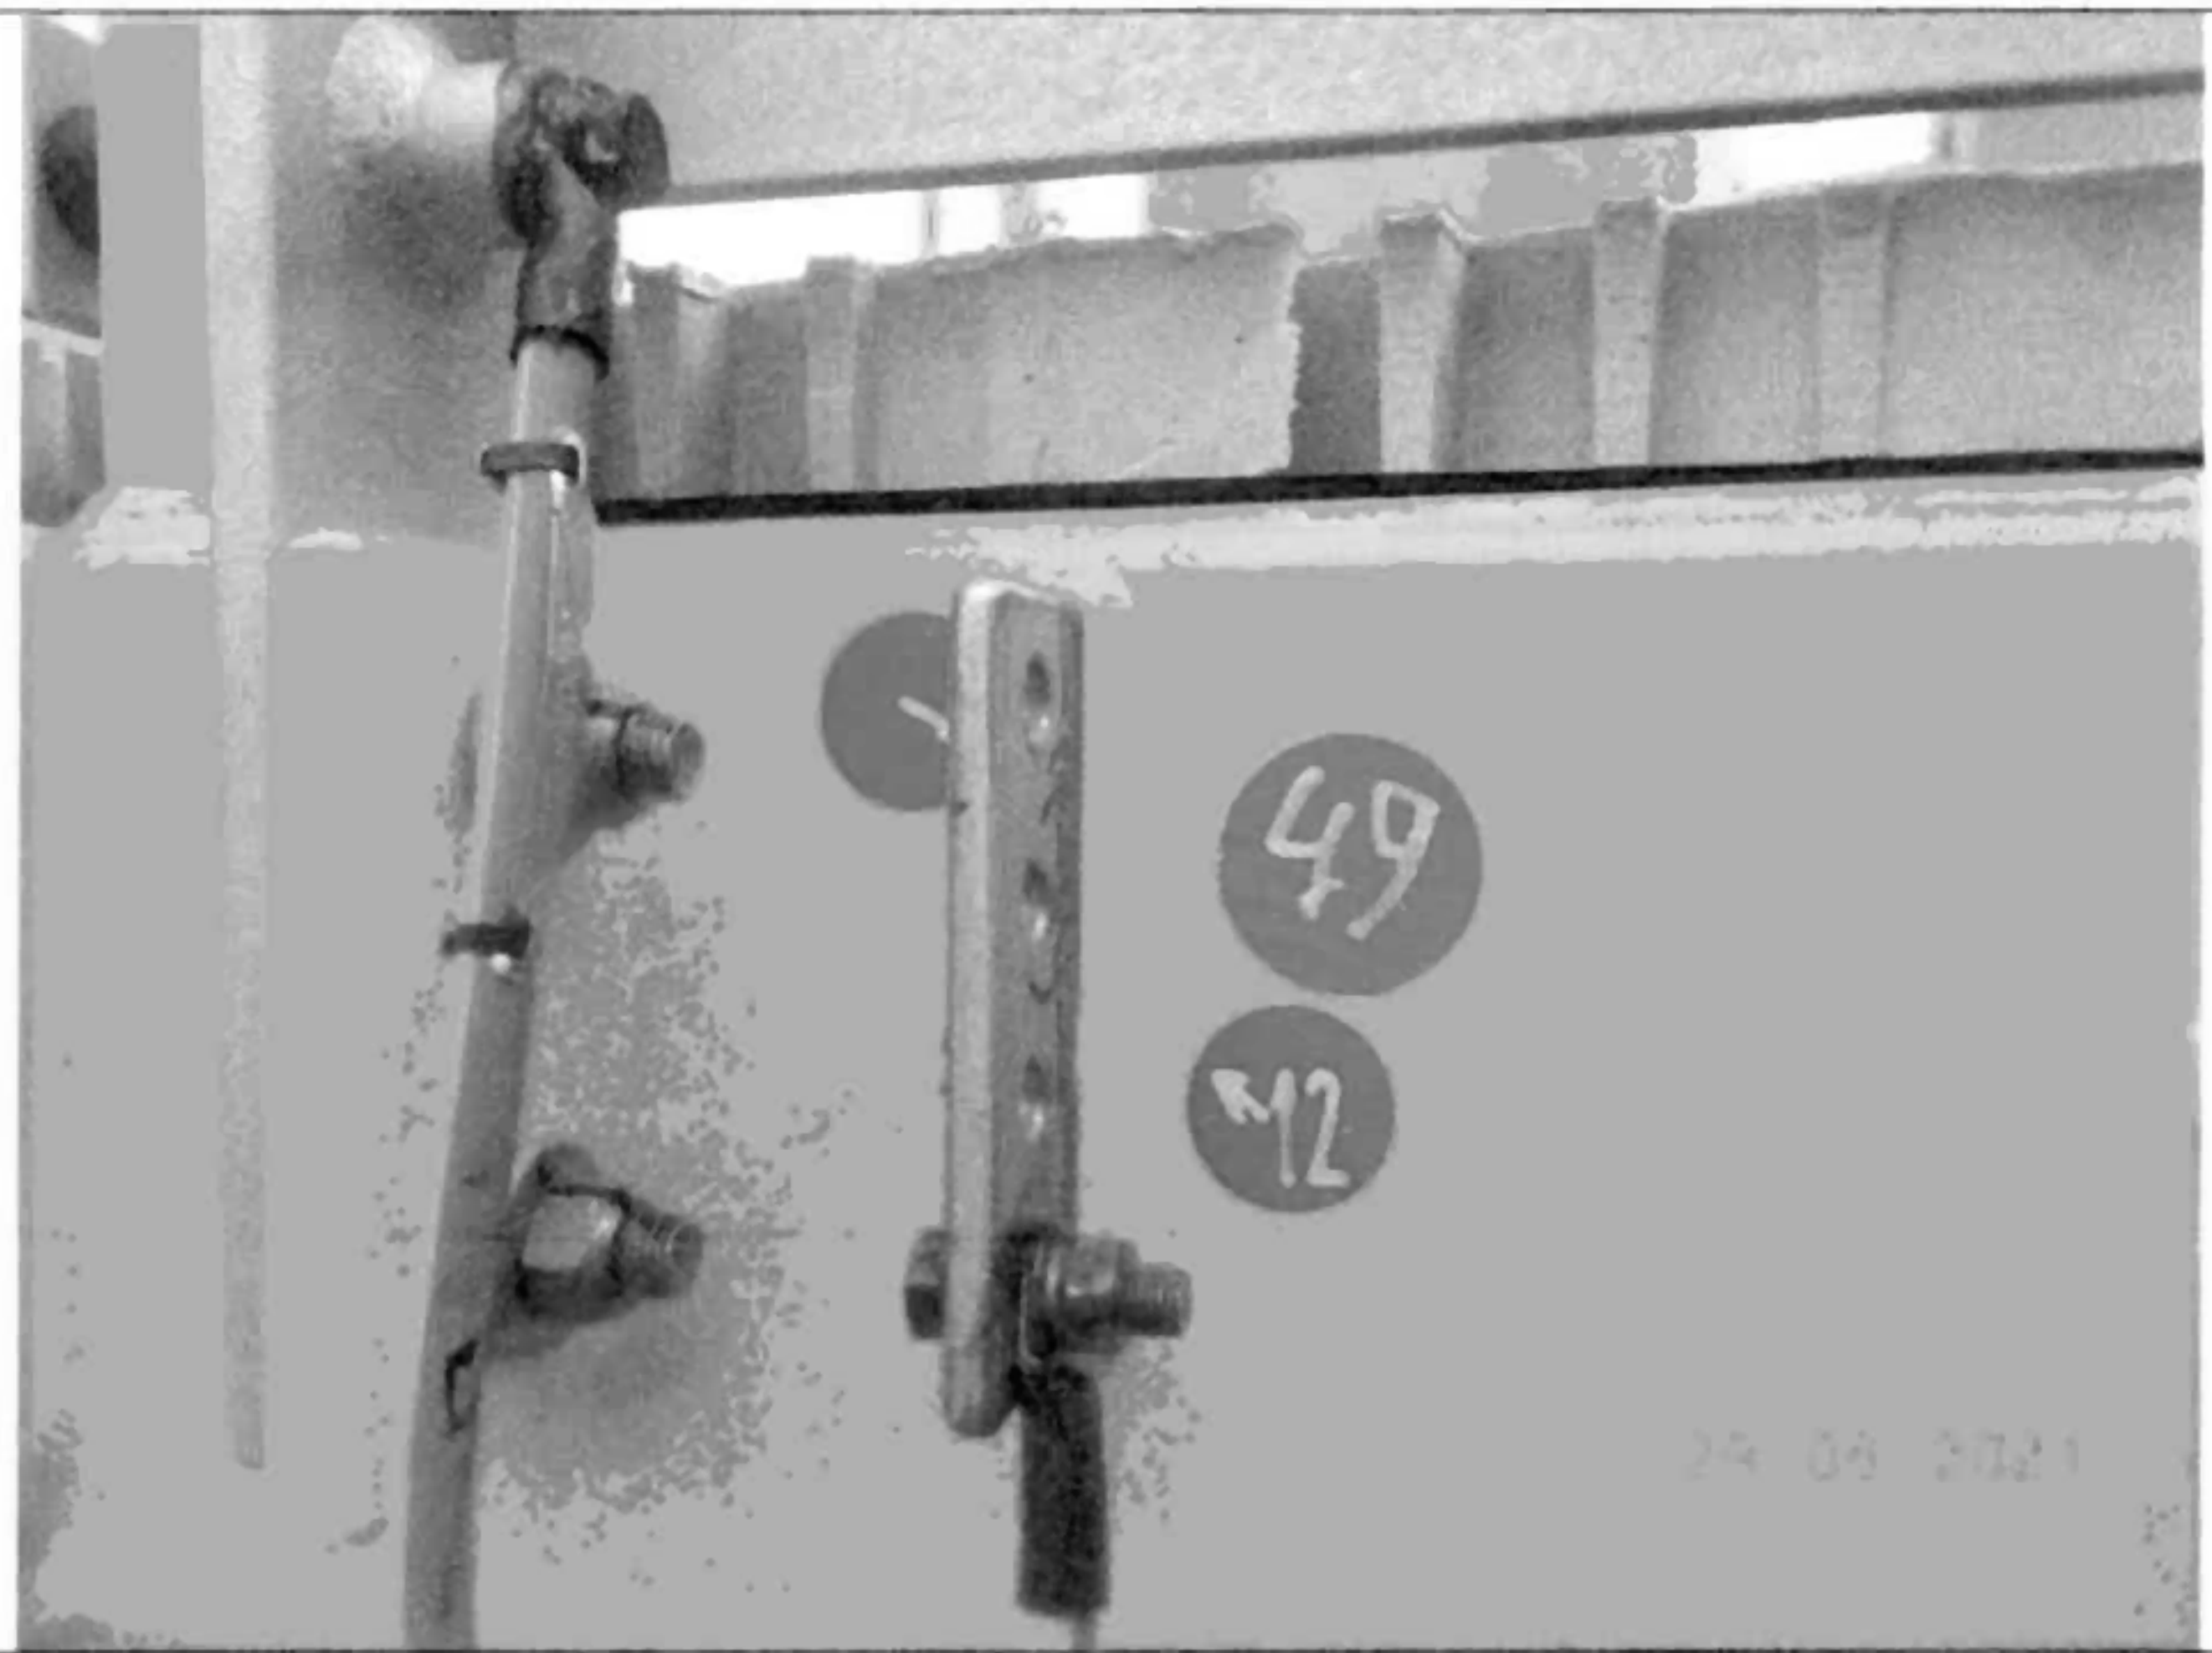
| H3M | | Rev. 2 | Date: 29.06.2021 |
|---|--|---|---|
| No. 11 – Mechanical damage to coating. | | No. 12 – Full coat system must be applied 20 mm up face of plate. See drawing 8522. | |
