| | <p align="center"><b>EWP G1</b><br/>External work platform – FAT documentation</p> | <p align="center">25220<br/>Hollandse Kust Zuid</p> |

## Mechanical Release Note EWP Rev 2 #19

## Punchlist mechanical

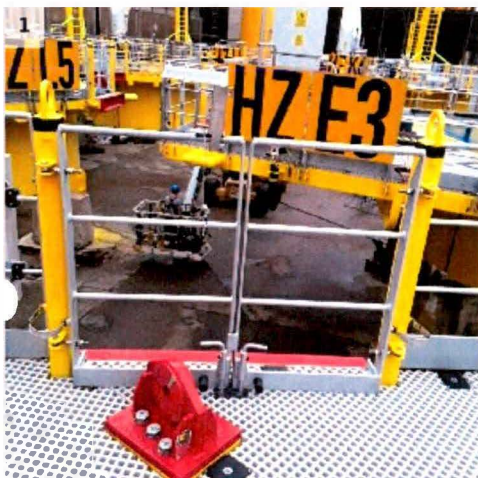
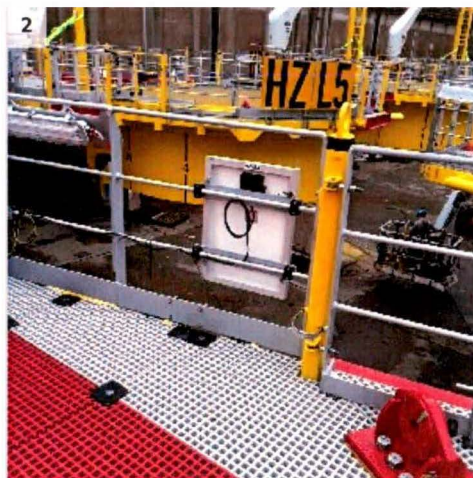
● **#1404 - Video missing for the double gate**

| Ben Herygers | Video missing for the double gate @Mechanical @dawid_kaminski @kevin_kemps #client | |
| Ben Herygers | For opening from the gate | |

| Marcin Witkowski | Check task #1509 | |

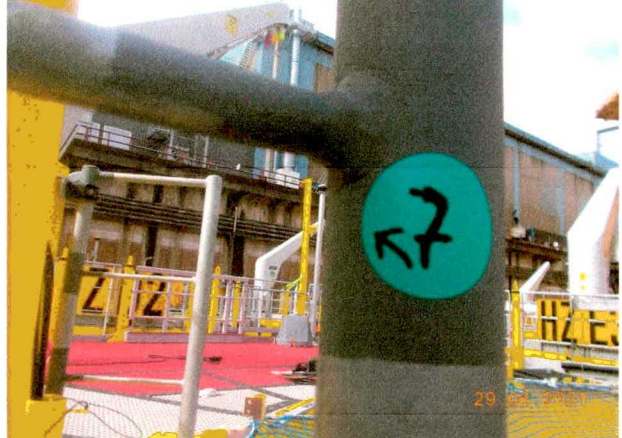
| H3M3 | | Rev. 2 | Date: 29.06.2021 |
|---|---|---|---|
| No. 7 – HDG railings, touch up rework required. | | No. 8 – Fly rust and tape residue, cleaning required. | |

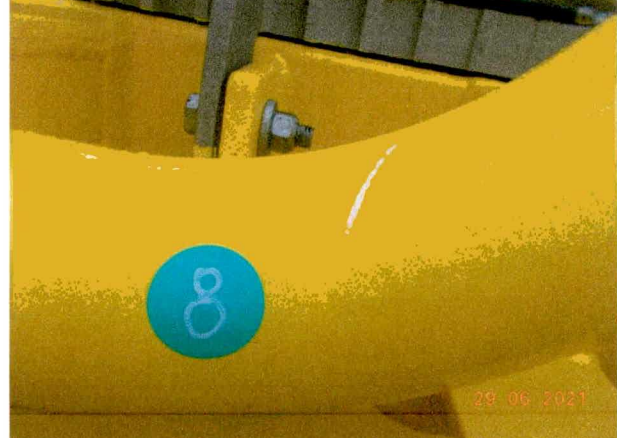
| N° | Description | Completion<br>Signature + Date | |
|---|---|---|---|
| 8 | Fly rust and tape residues, cleaning required. | | |

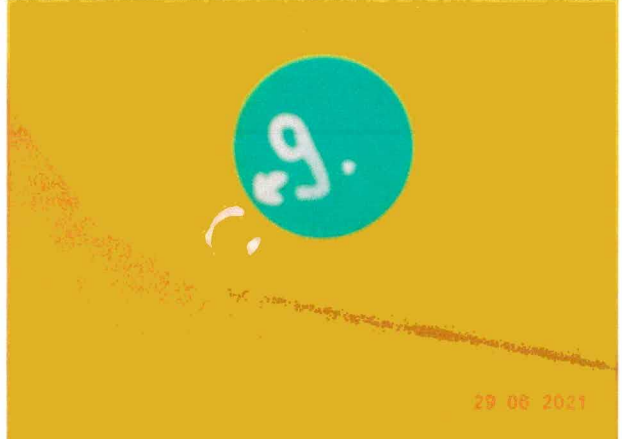
| N° | Description | Completion<br>Signature + Date | |
|---|---|---|---|
| 9 | Mechanical damages to coating. | | |

| H3M3 | | Rev. 2 | Date: 29.06.2021 |
|---|---|---|---|
| No. 9 – Mechanical damage to coating. | | No. 10 – Full coat system must be applied 20 mm up face of plate. See drawing 8522. | |

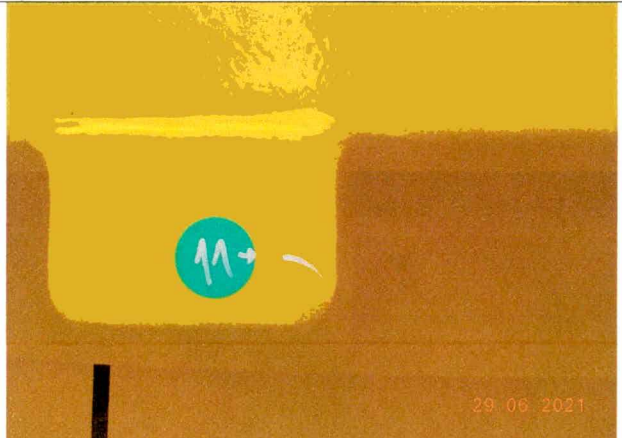
| N° | Description | Completion<br>Signature + Date | |
|---|---|---|---|
| 11 | Mechanical damages to coating. | | |

| H3M3 | | Rev. 2 | Date: 29.06.2021 |
|---|---|---|---|
| No. 11 – Mechanical damage to coating. | | No. 12 – Full coat system must be applied 20 mm up face of plate. See drawing 8522. | |
