| <b>SMULDERS</b> | <b>EWP G1</b><br>External work platform – FAT documentation | 25220<br>Hollandse Kust Zuid |

1. FAT mechanical
  - Final release note
  - Punch list
2. FAT electrical
  - Final release note
  - Punch list
3. FAT coating
  - Final release note
  - Punch list
4. Overview NCR's and TQ's

## Mechanical Release Note EWP Rev 2 #19

25220-GEN-RE05-XXX\_04 - EWP - Electrical Release Note Rev 4 #12

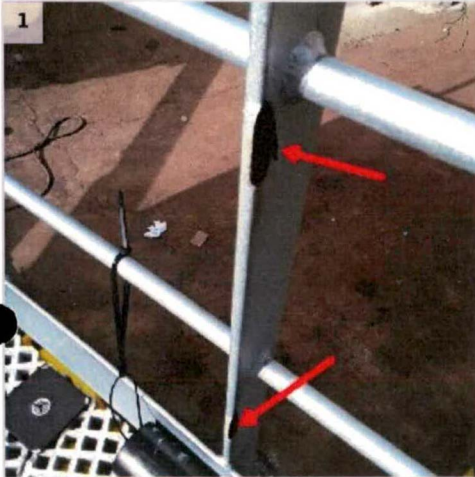
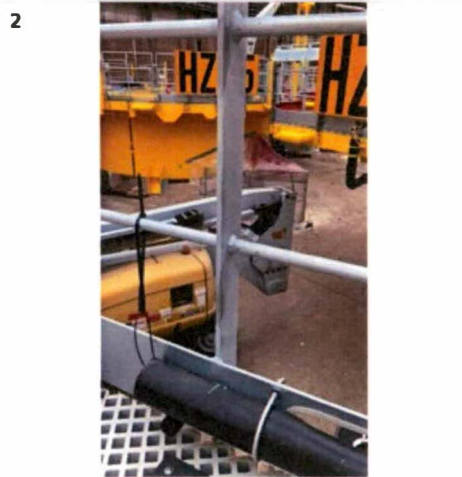
## #1382 - Sharp edges

Ben Herygers Photo 1  
Ben Herygers Sharp edges @Mechanical @kevin\_kempis #client  
Jens Daelemans Photo 2

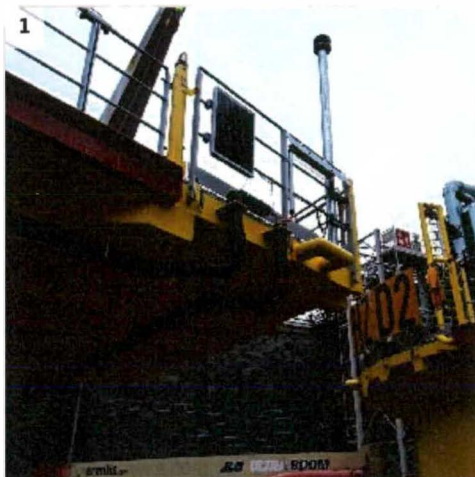
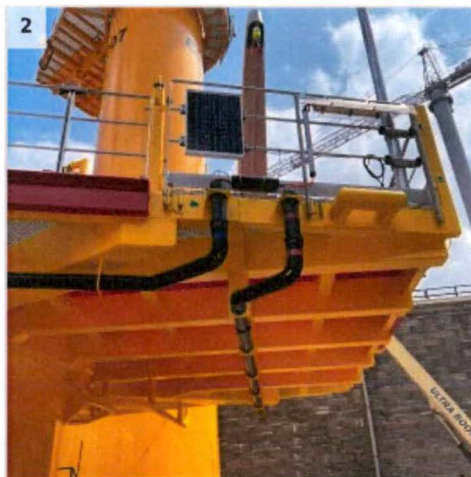
## #1399 - Pipe not straight

Ben Herygers Photo 1  
Ben Herygers Pipe not straight @Mechanical @kevin\_kempis #client  
Marcin Witkowski Photo 2

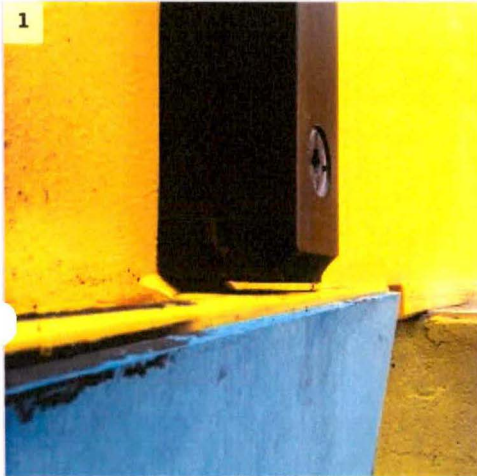
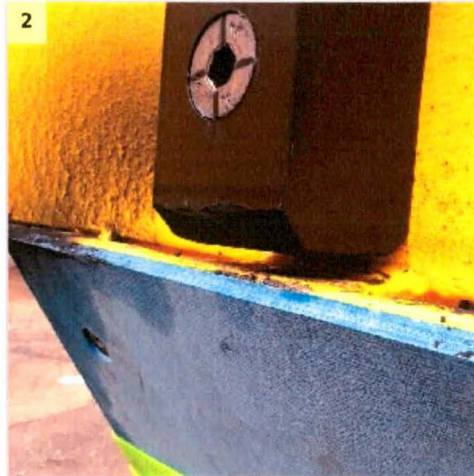
## ● #1400 - To big gap on the finger guide

| Ben Herygers | To big gap on the finger guide @Mechanical #client @kevin_kemps | 26 Jun 08:07 |

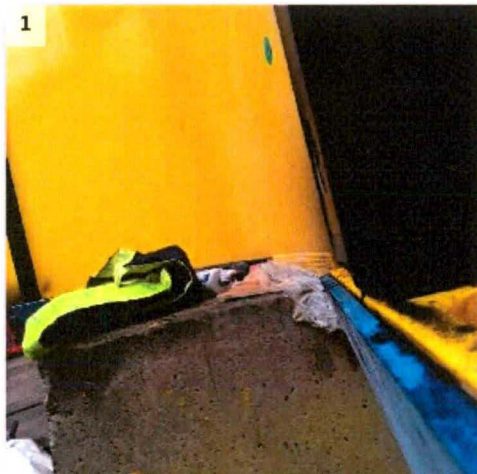
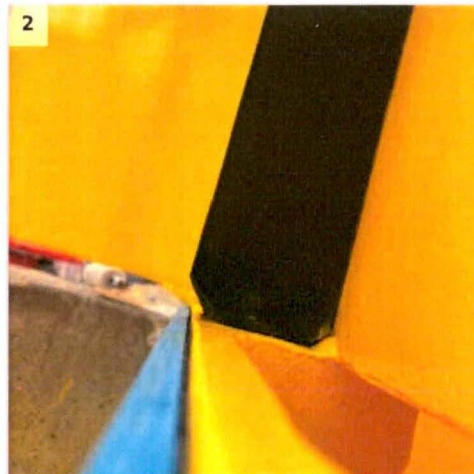
## ● #1401 - Needs better chamfer

| Ben Herygers | Needs better chamfer @Mechanical @kevin_kemps #client | 26 Jun 08:08 |

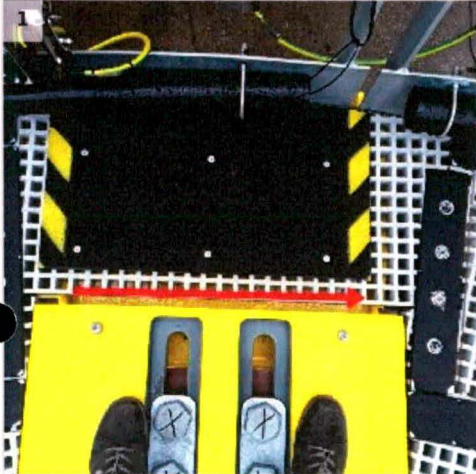
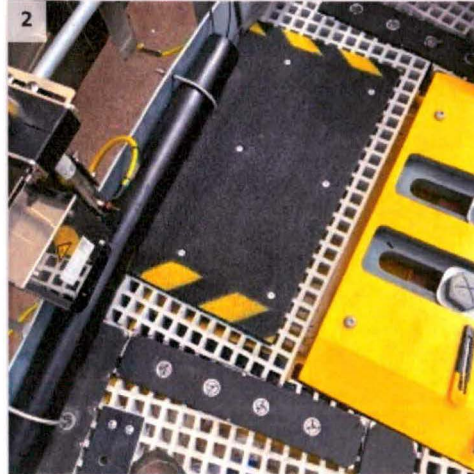
## ● #1402 - Plate needs more adjustment ( better in the middle)

| Ben Herygers | Plate needs more adjustment ( better in the middle) @Mechanical @kevin_kemps #client | 26 Jun 08:16 |

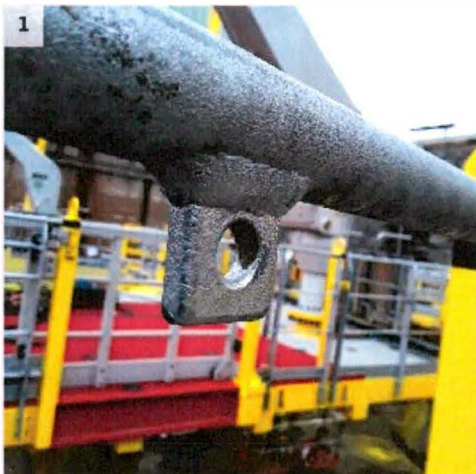
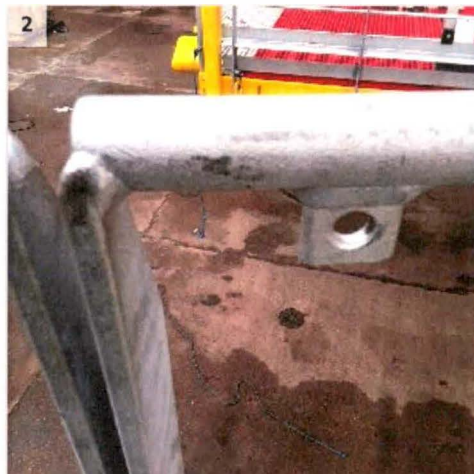
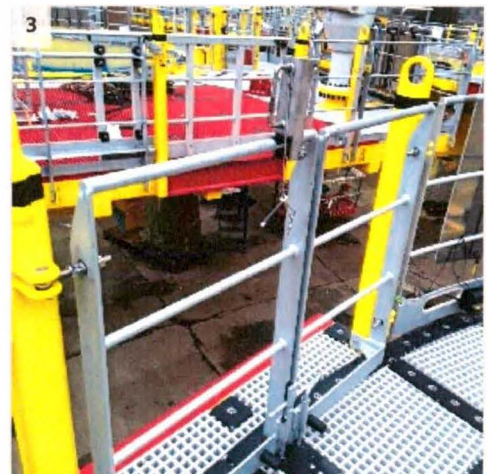
## ● #1403 - Coating missing

| Ben Herygers | Coating missing @TouchUp @ilchan_chanko #client | 26 Jun 08:26 |

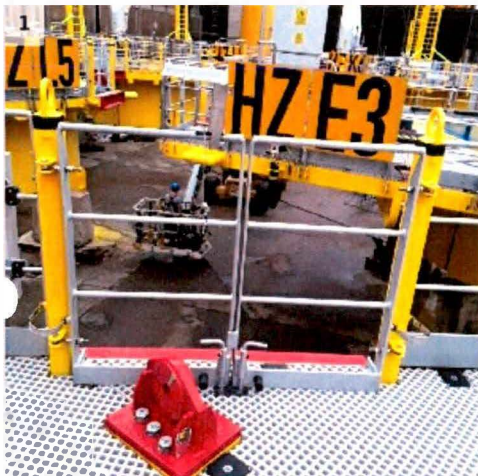
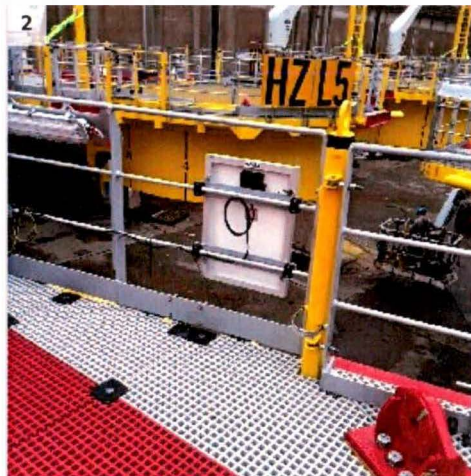
## ● #1404 - Video missing for the double gate

| Ben Herygers | Video missing for the double gate | @Mechanical @dawid_kaminski @kevin_kemps #client |
| Ben Herygers | For opening from the gate | |

| Marcin Witkowski | Check task #1509 | |

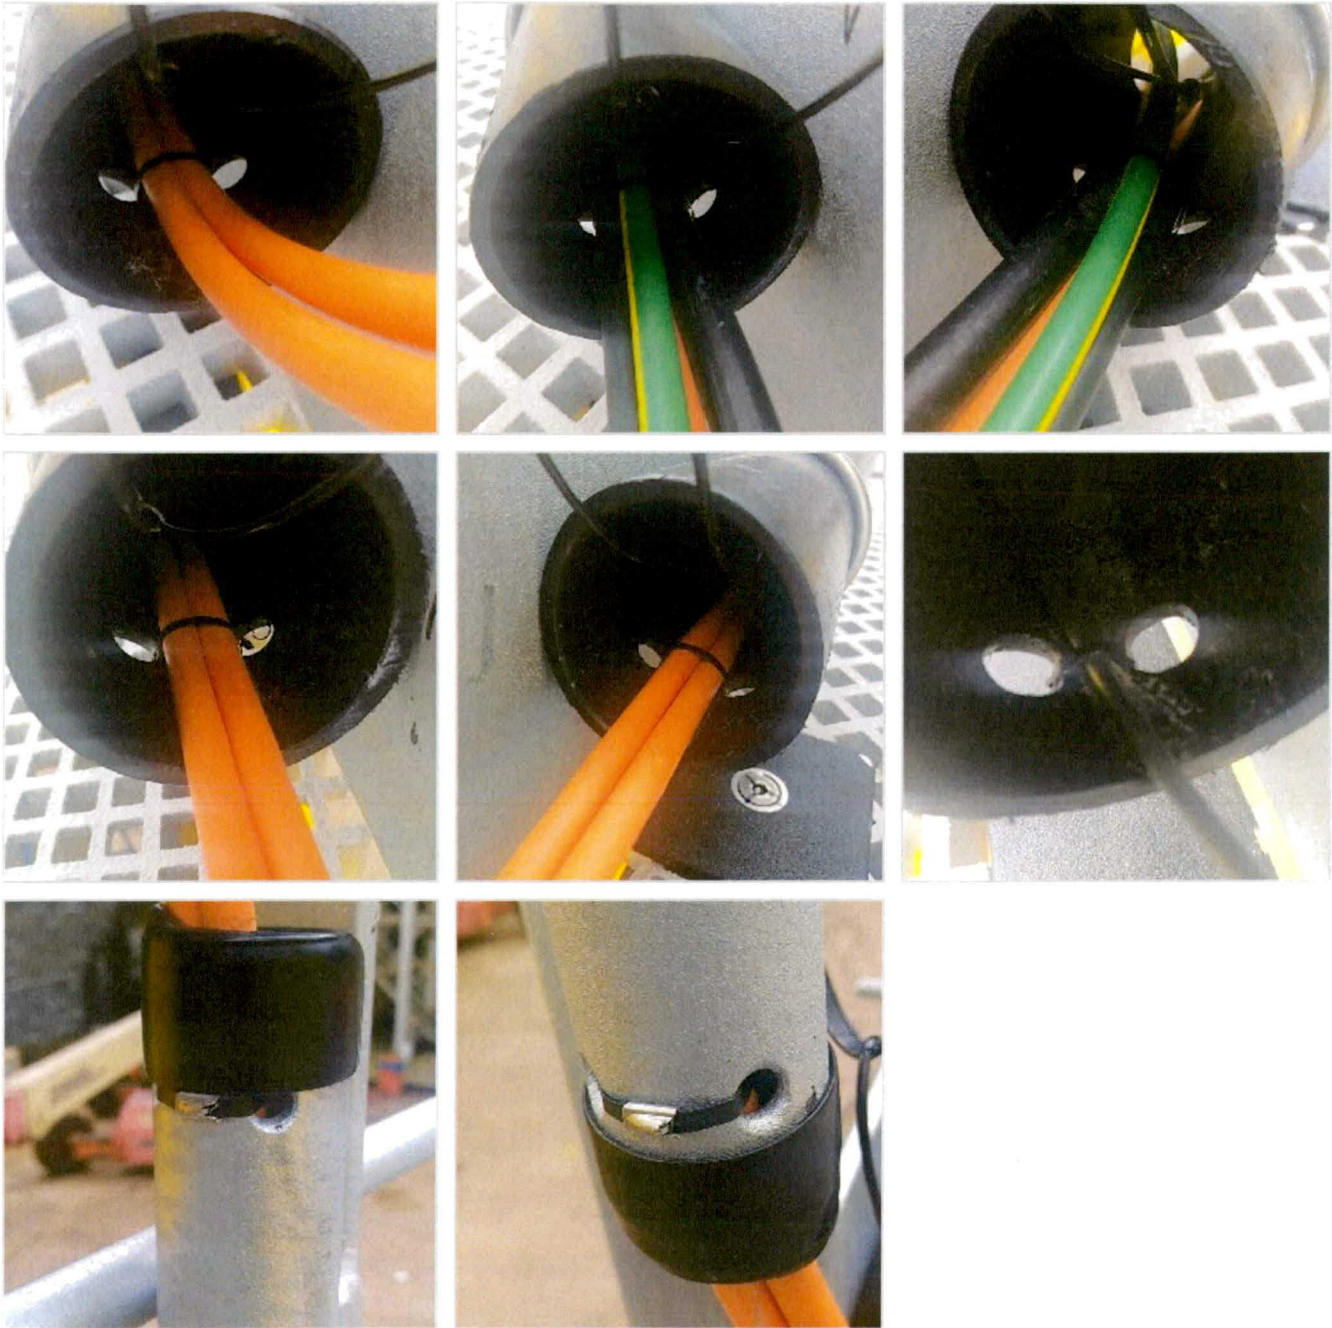
2.4 SS-Coated tie wraps are used

Remarks: Single cable from ID-Lights position 3, can be attached with plastic cable-ties.

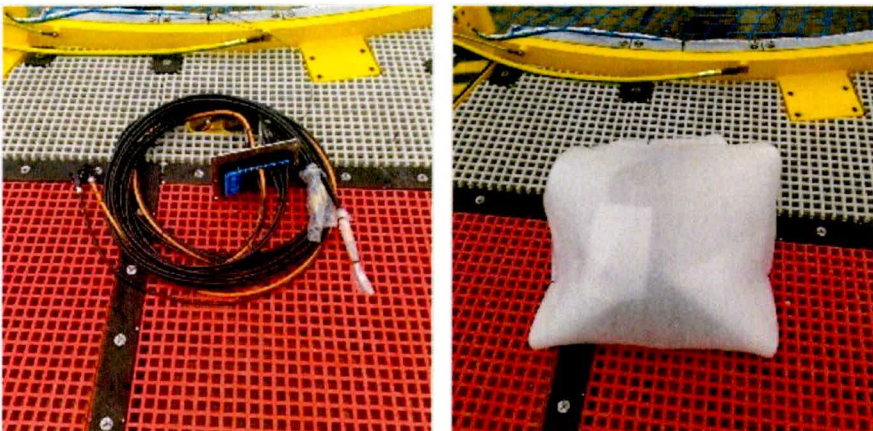
## 2.22 Over-length applied on cables where applicable and stored correctly

=XMM13\_MZ001-WD001: To be cut on length at MV II - to be checked in hoboken if cable is long enough ( Roxtec: 2,5m -2,7m / WTG: min 3,8m)

Remarks: TQ 4126 regarding storage is pending.

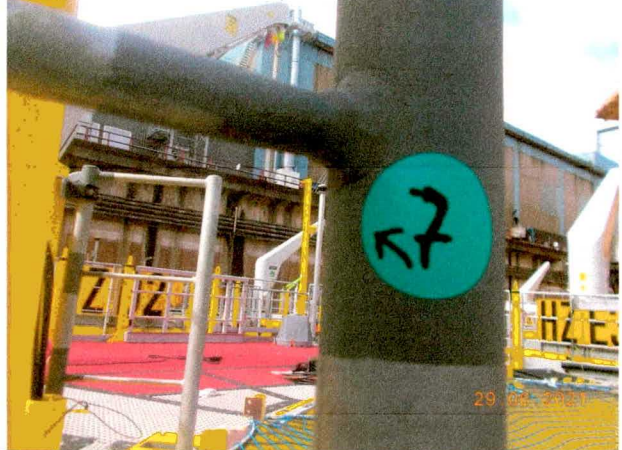
| H3M3 | | Rev. 2 | Date: 29.06.2021 |
|---|--|---|---|
| No. 7 – HDG railings, touch up rework required. | | No. 8 – Fly rust and tape residue, cleaning required. | |

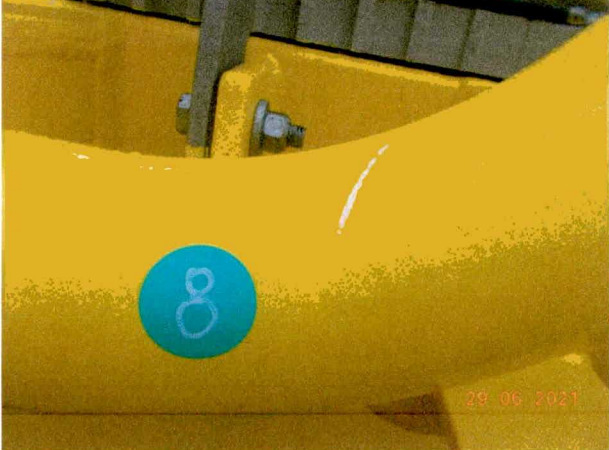
| N° | Description | Completion<br>Signature + Date | |
|---|---|---|---|
| 8 | Fly rust and tape residues, cleaning required. | | |

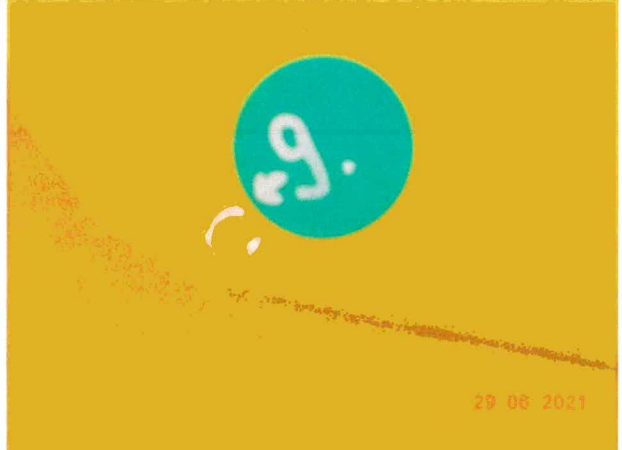
| N° | Description | Completion<br>Signature + Date | |
|---|---|---|---|
| 9 | Mechanical damages to coating. | | |

| H3M3 | | Rev. 2 | Date: 29.06.2021 |
|---|--|---|---|
| No. 9 – Mechanical damage to coating. | | No. 10 – Full coat system must be applied 20 mm up face of plate. See drawing 8522. | |

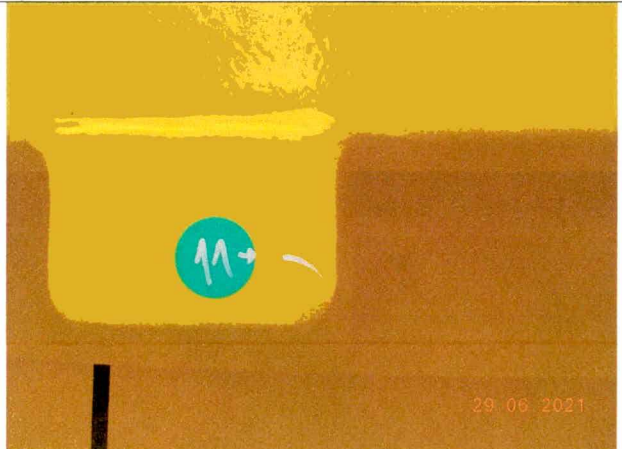
| N° | Description | Completion<br>Signature + Date | |
|---|---|---|---|
| 11 | Mechanical damages to coating. | | |

| H3M3 | | Rev. 2 | Date: 29.06.2021 |
|---|--|---|---|
| No. 11 – Mechanical damage to coating. | | No. 12 – Full coat system must be applied 20 mm up face of plate. See drawing 8522. | |

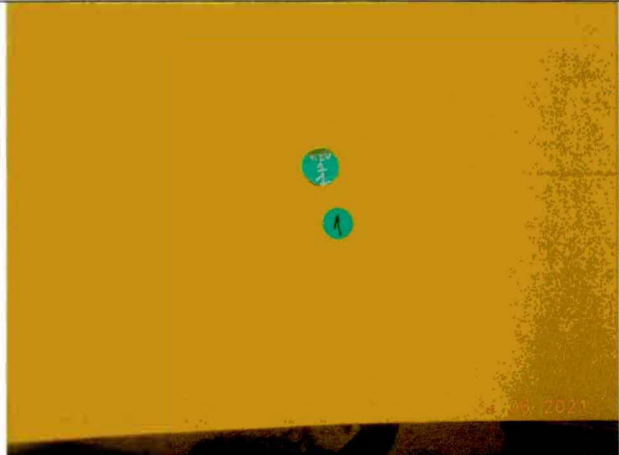
| N° | Description | Completion<br>Signature + Date | |
|---|---|---|---|
| 1 | Fly rust and tape residues and dirt, cleaning required. | | |

| HZG1 | | Rev. 2 | Date: 29.06.2021 |
|---|--|---|---|
| No. 1 – Fly rust and tape residue and dirt, cleaning required. | | No. 2 – Touch up rework required. | |

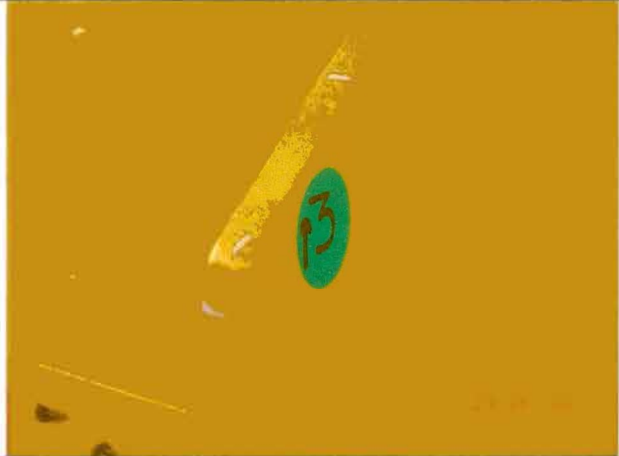
| HZG1 | | Rev. 2 | Date: 29.06.2021 |
|---|--|---|---|
| No. 3 – Touch up rework required. | | No. 4 - Touch up rework required. | |

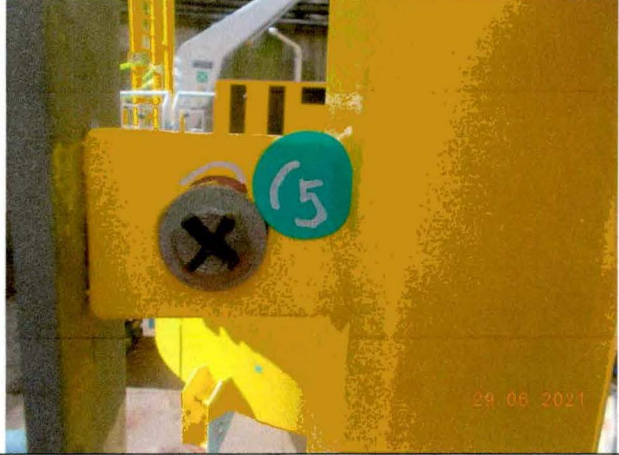
| N° | Description | Completion<br>Signature + Date | |
|---|---|---|---|
| 5 | Mechanical damages to coating. | | |

| HZG1 | | Rev. 2 | Date: 29.06.2021 |
|---|--|---|---|
| No. 5 – Mechanical damages to coating. | | No. 6 - Full coat system must be applied 20 mm up face of plate. See drawing 8522. | |
