| | <b>EWP M3</b><br>External work platform – FAT documentation | 25220<br>Hollandse Kust Zuid |

**Mechanical Release Note EWP Rev 2 #15**

**Final Checklist Mechanical**

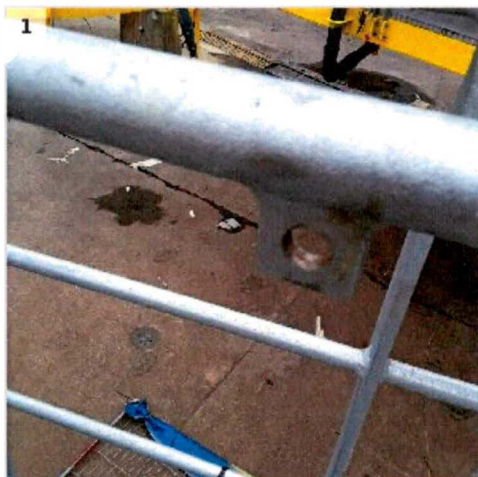
● **#1230 - Needs some coating**

Needs some coating @TouchUp @ilchan\_chanko #client

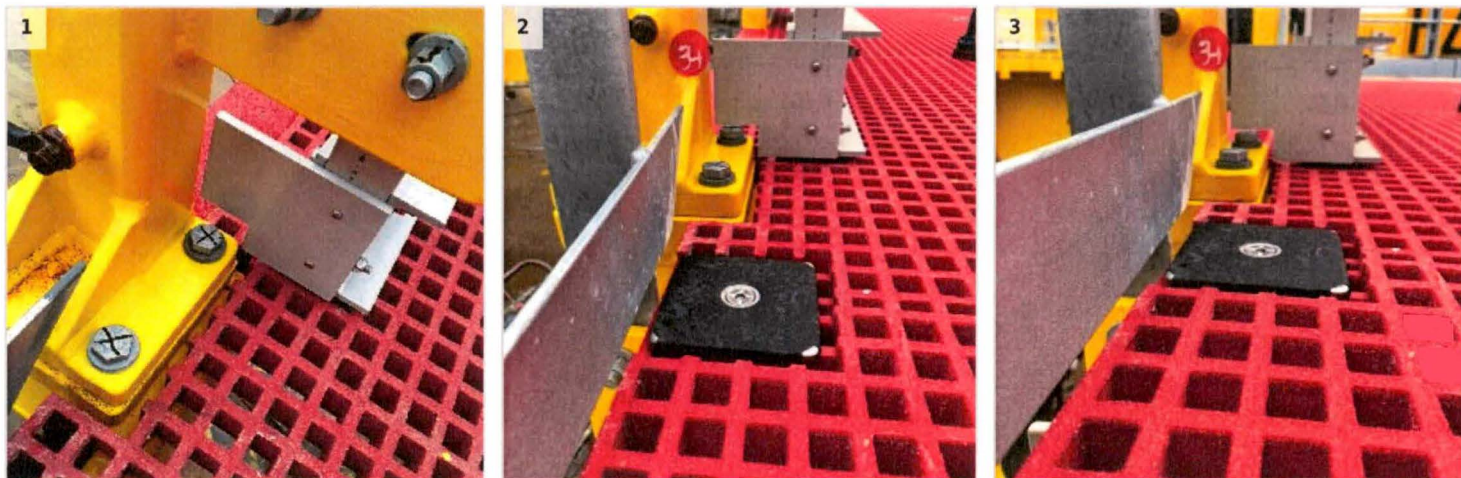
## ● #1233 - Cut more the plate

| Ben Herygers | Cut more the plate @Mechanical @kevin_kemps #client | 19 jun 09:56 |

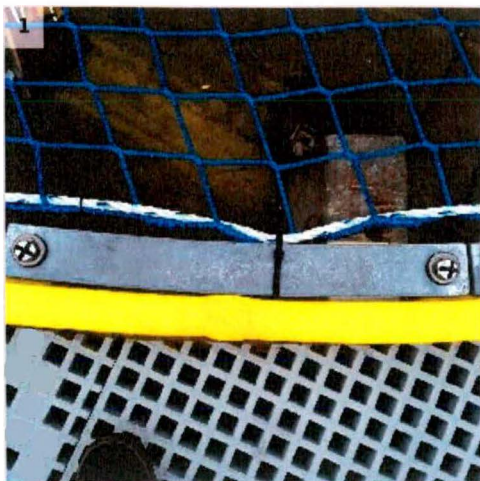
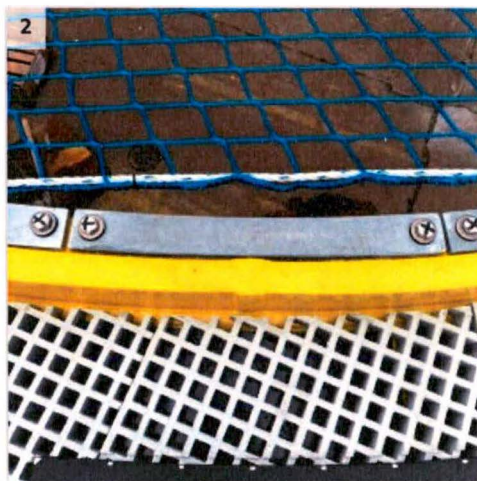
#1221 - Bracket touches the plate

| Ben Herygers | Bracket touches the plate @Mechanical @kevin_kemps #client | 19 jun 09:37 |

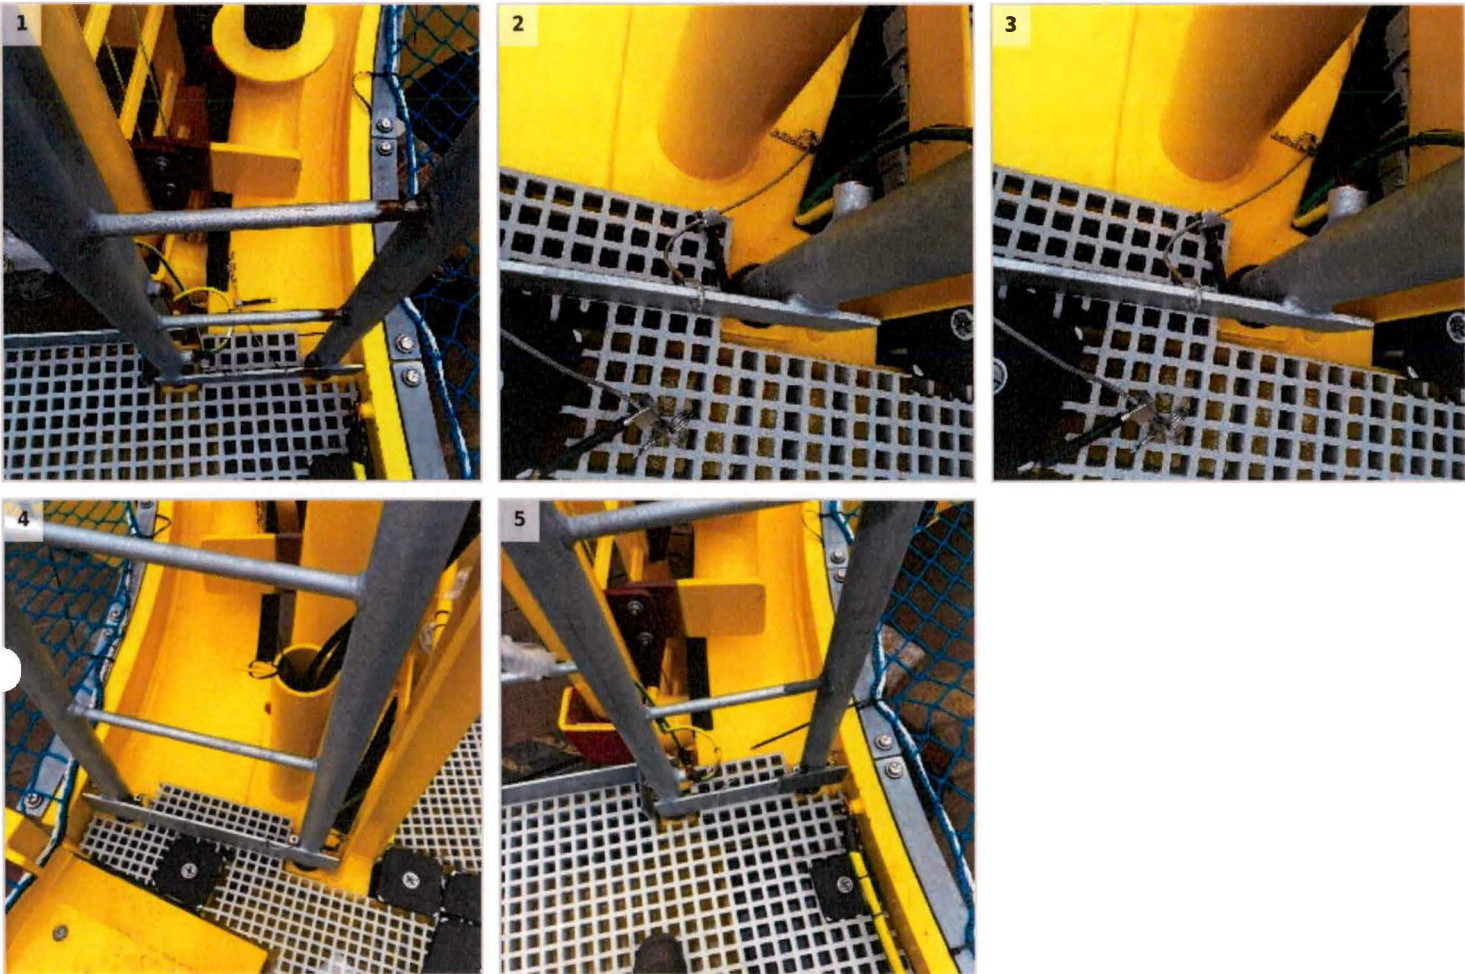
#### ● #1225 - Lockpins don't fit well

| Ben Herygers | Lockpins don't fit well @Mechanical @kevin_kemps #client | 19 jun 09:45 |

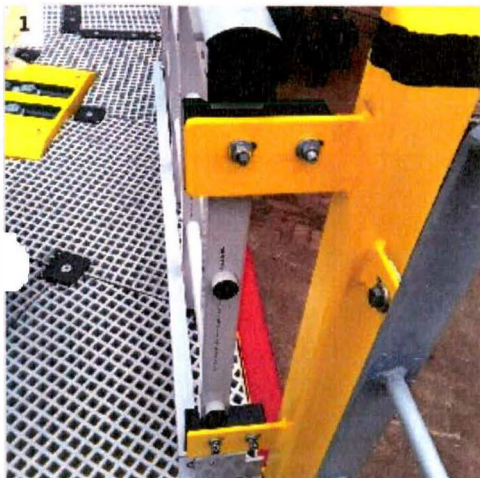
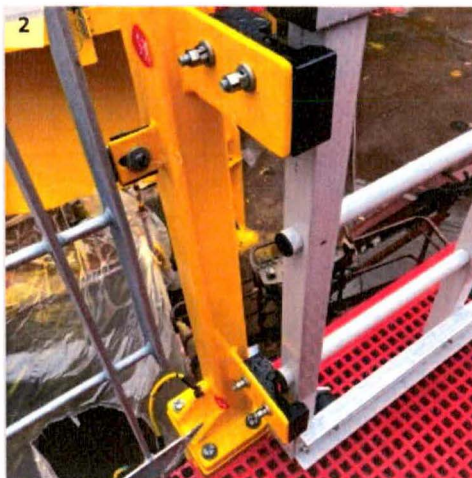
● #1224 - Nuts are missing

Nuts are missing @Mechanical @kevin\_kemps #client

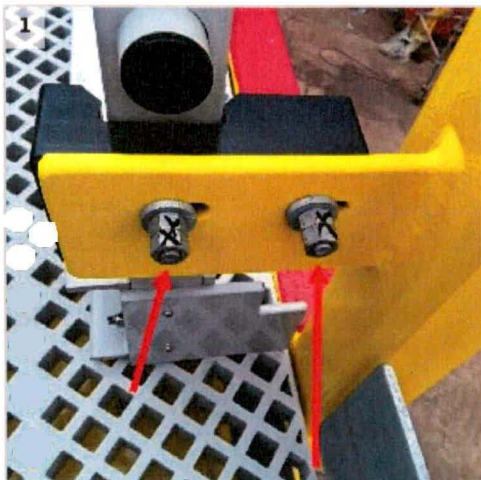
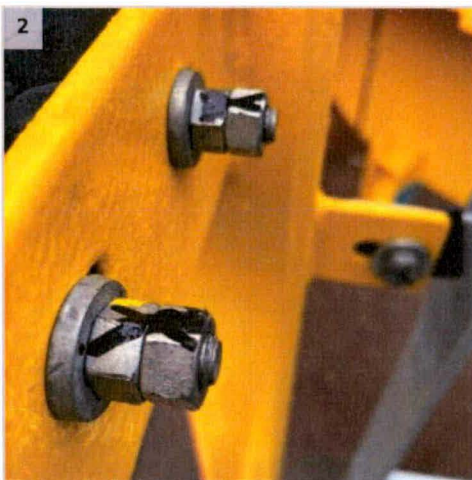
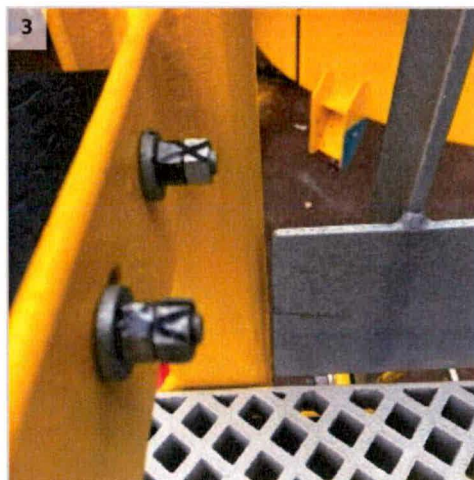
### #1227 - Bolts are too short

Ben Herygers Bolts are too short @Mechanical @kevin\_kemps #client  
Marcin Witkowski Photo 2  
Marcin Witkowski Photo 3

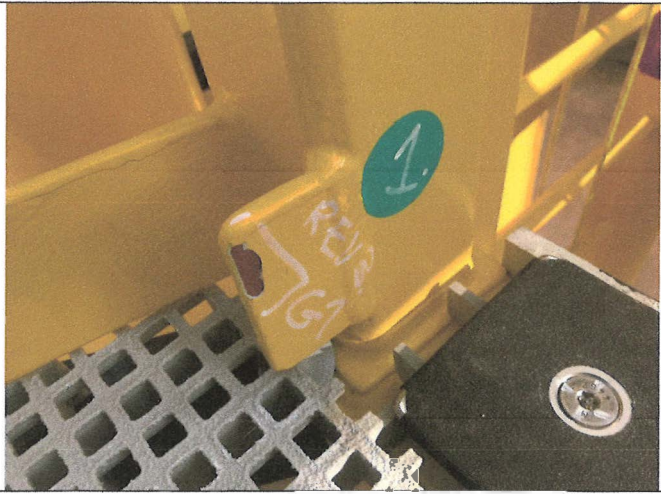
| No. 1 – New mechanical damage on the kick plate, next to the swing gate. | No. 2 – | |

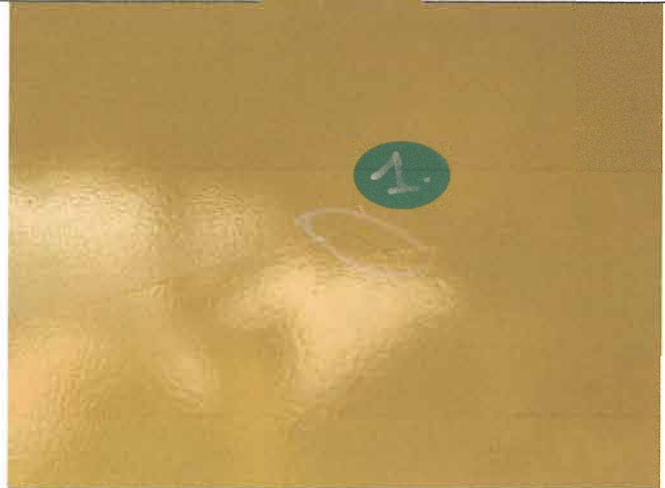
| H3M3 | Rev. 2 | Date: 24.06.2021 |
|---|---|---|
| No. 1 – Top coat repair, smoothing of the edge required. | No. 2 – Burn marks, fly rust, cleaning and topcoat repair required. | |

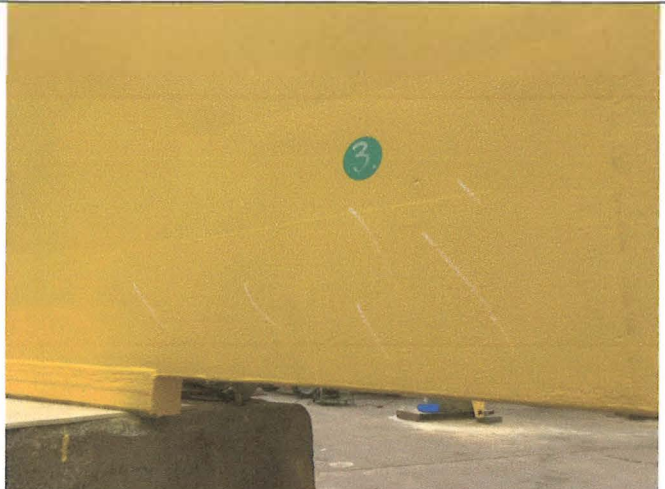
| H3M3 | Rev. 2 | Date: 24.06.2021 |
|---|---|---|
| No. 3 – Pour touch up, inclusions, topcoat repair required. | No. 4 – General comment, cleaning required. | |

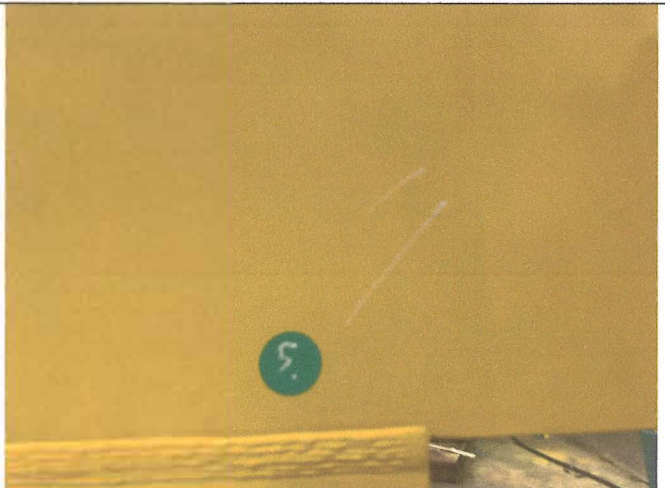
| H3M3 | Rev. 2 | Date: 24.06.2021 |
|---|---|---|
| No. 5 – Fly rust and burn marks, cleaning and topcoat repair required. | No. 6 – Another layer of topcoat required. | |

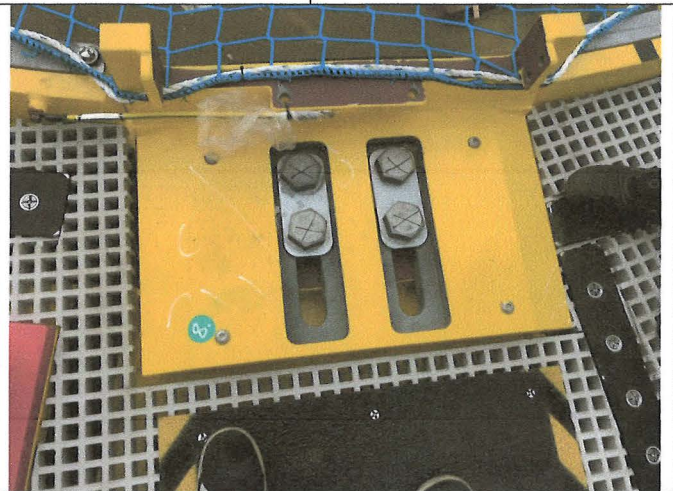
No. 8 – Mechanical damages, topcoat repair required.

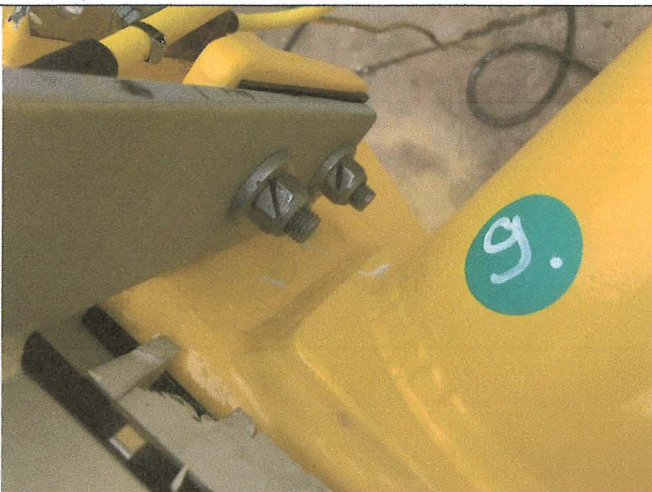
No. 9 – Pour touch up, sanded but not painted.

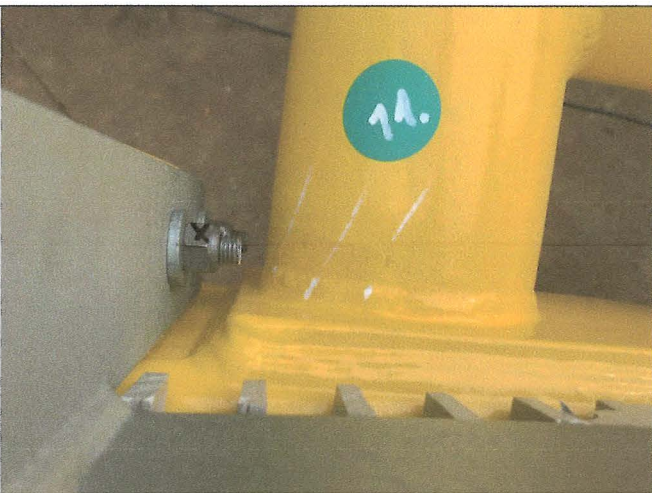
No. 11 – Top coat repair required.

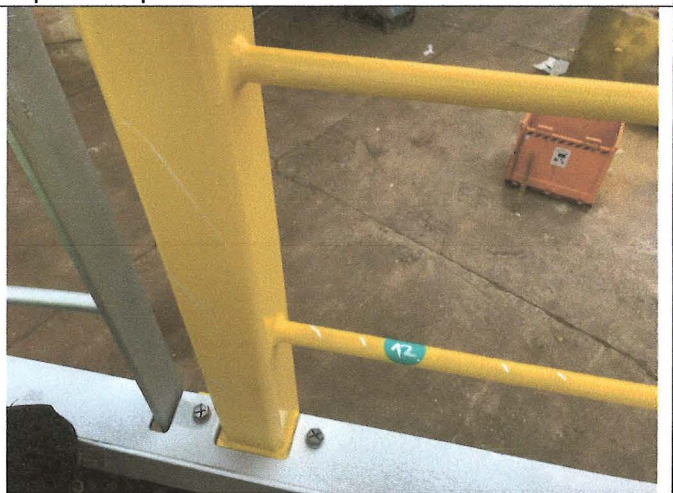
No. 12 – Topcoat repair required.

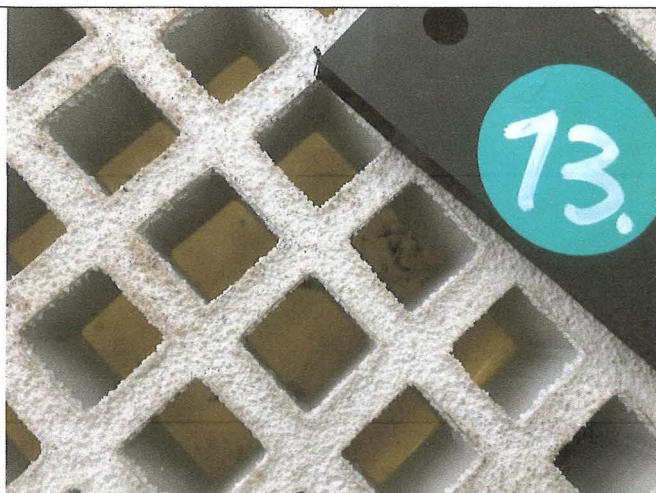
No. 13 - Dirt and fly rust under the gratings. Cleaning required.

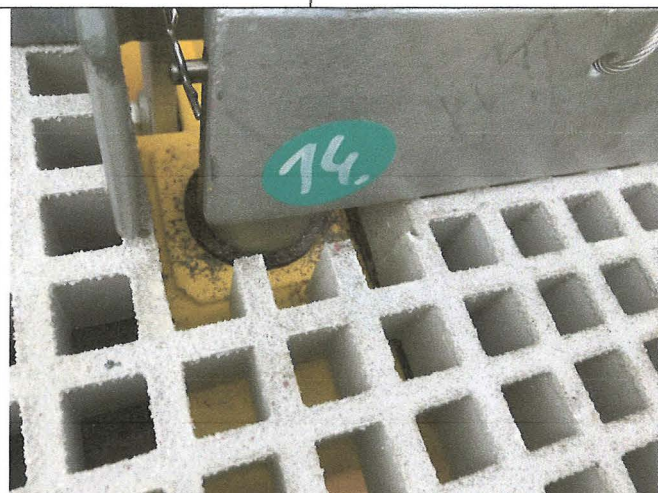
No. 14 - Dirt and fly rust under the gratings. Cleaning required.

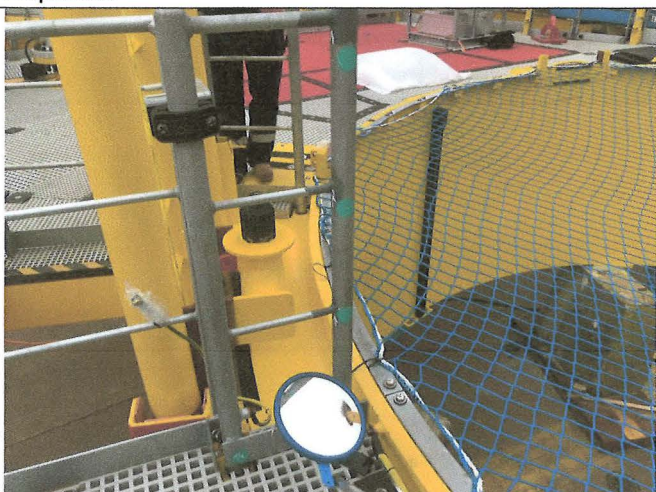
No. 15 – HDG handrails, not closed film, surface preparation and paint application required.

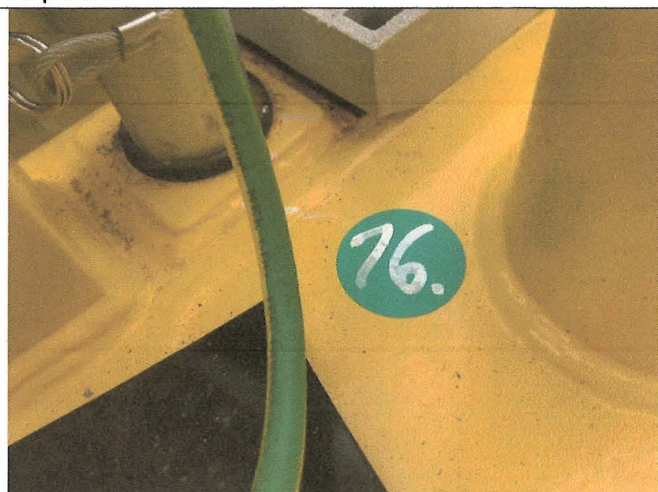
No. 16 - Dirt and fly rust. Cleaning required.

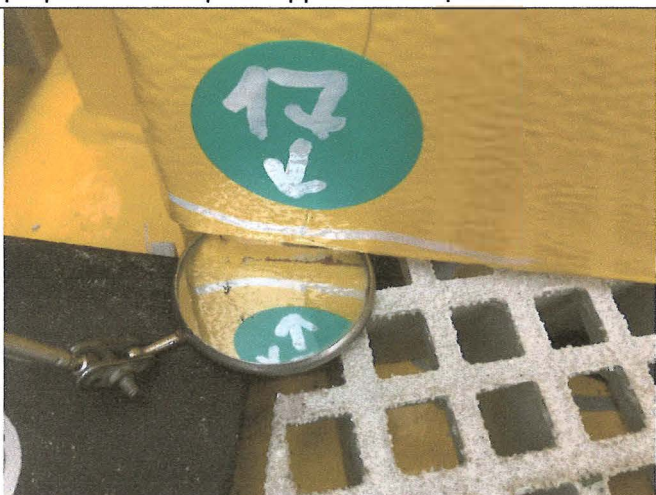
No. 17 – Kick plate edge, topcoat shall be removed, epoxy repair required.

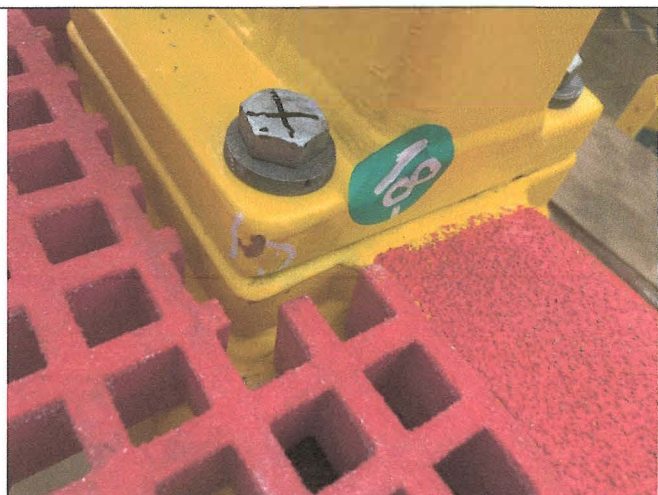
No. 18 – Mechanical damage.

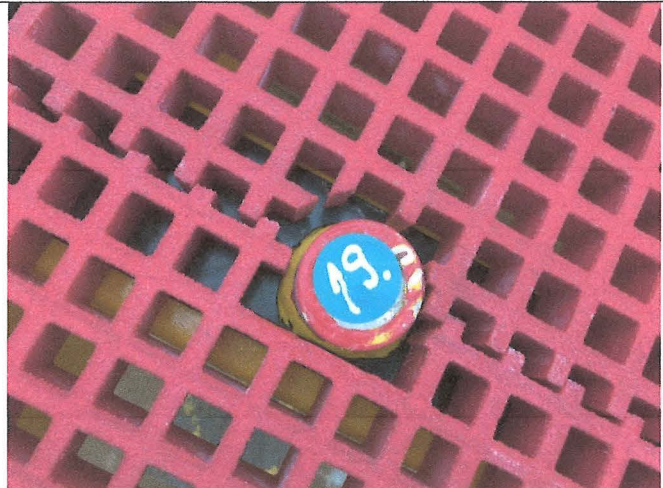
| H2M3 | Rev. 2 | Date: 24.06.2021 |
|---|---|---|
| No. 19 – Top coat repair required. | No. 20 – Dirt and fly rust under the gratings. Cleaning required. | |

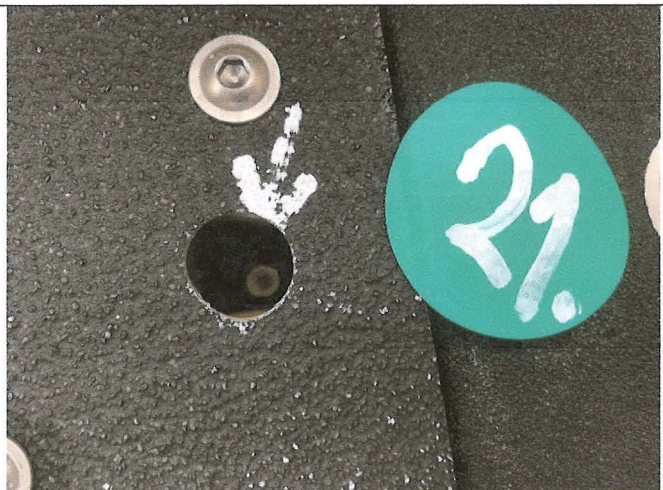
| H2M3 | Rev. 2 | Date: 24.06.2021 |
|---|---|---|
| No. 21 – Mechanical damage to coating, epoxy repair required. | No. 22 – Mechanical damage. Swing gate, S side. | |

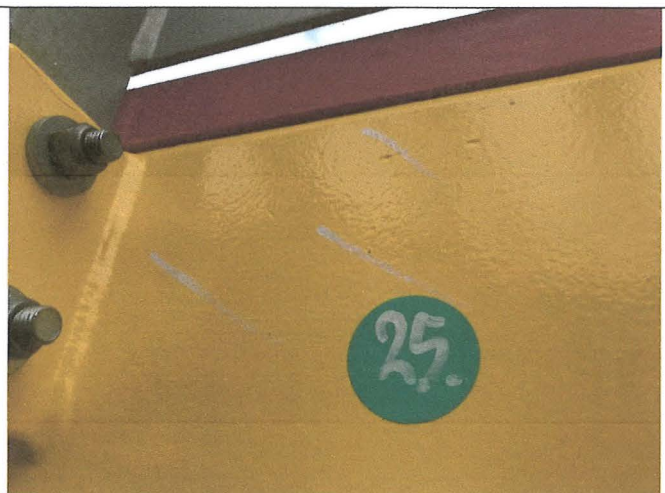
| HZM3 | Rev. 2 | Date: 24.06.2021 |
|---|---|---|
| No. 25 – Topcoat repair required. | No. 26 – Inclusions in topcoat. | |

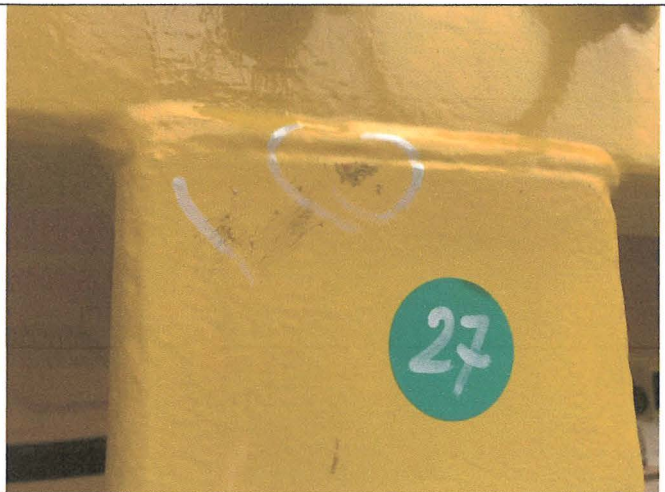
| HZM3 | Rev. 2 | Date: 24.06.2021 |
|---|---|---|
| No. 27 – Cleaning and Topcoat application required. | No. 28 – Not finished touch up, topcoat application required. | |

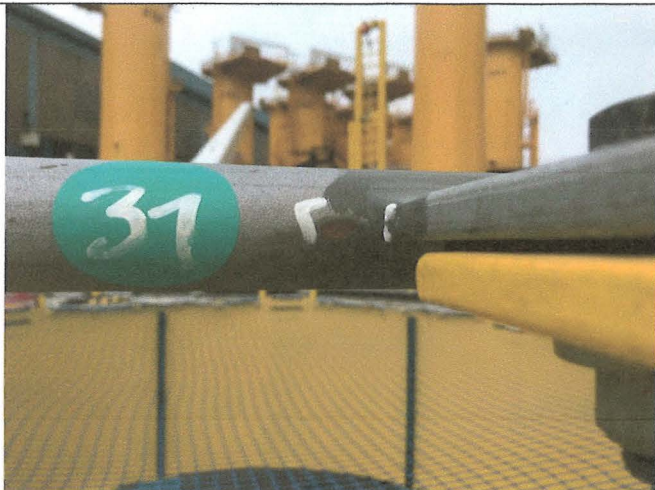
| HZM3 | Rev. 2 | Date: 24.06.2021 |
|---|---|---|
| No. 31 - Nord side sliding gate, HDG handrail, mechanical damage. Surface preparation and paint application required. | No. 32 – Nord side sliding gate, HDG handrail, mechanical damage. Surface preparation and paint application required. | |
