| <b>SMULDERS</b> | <b>EWP M3</b><br>External work platform – FAT documentation | 25220<br>Hollandse Kust Zuid |

**Mechanical Release Note EWP Rev 2 #15**

## Punchlist mechanical

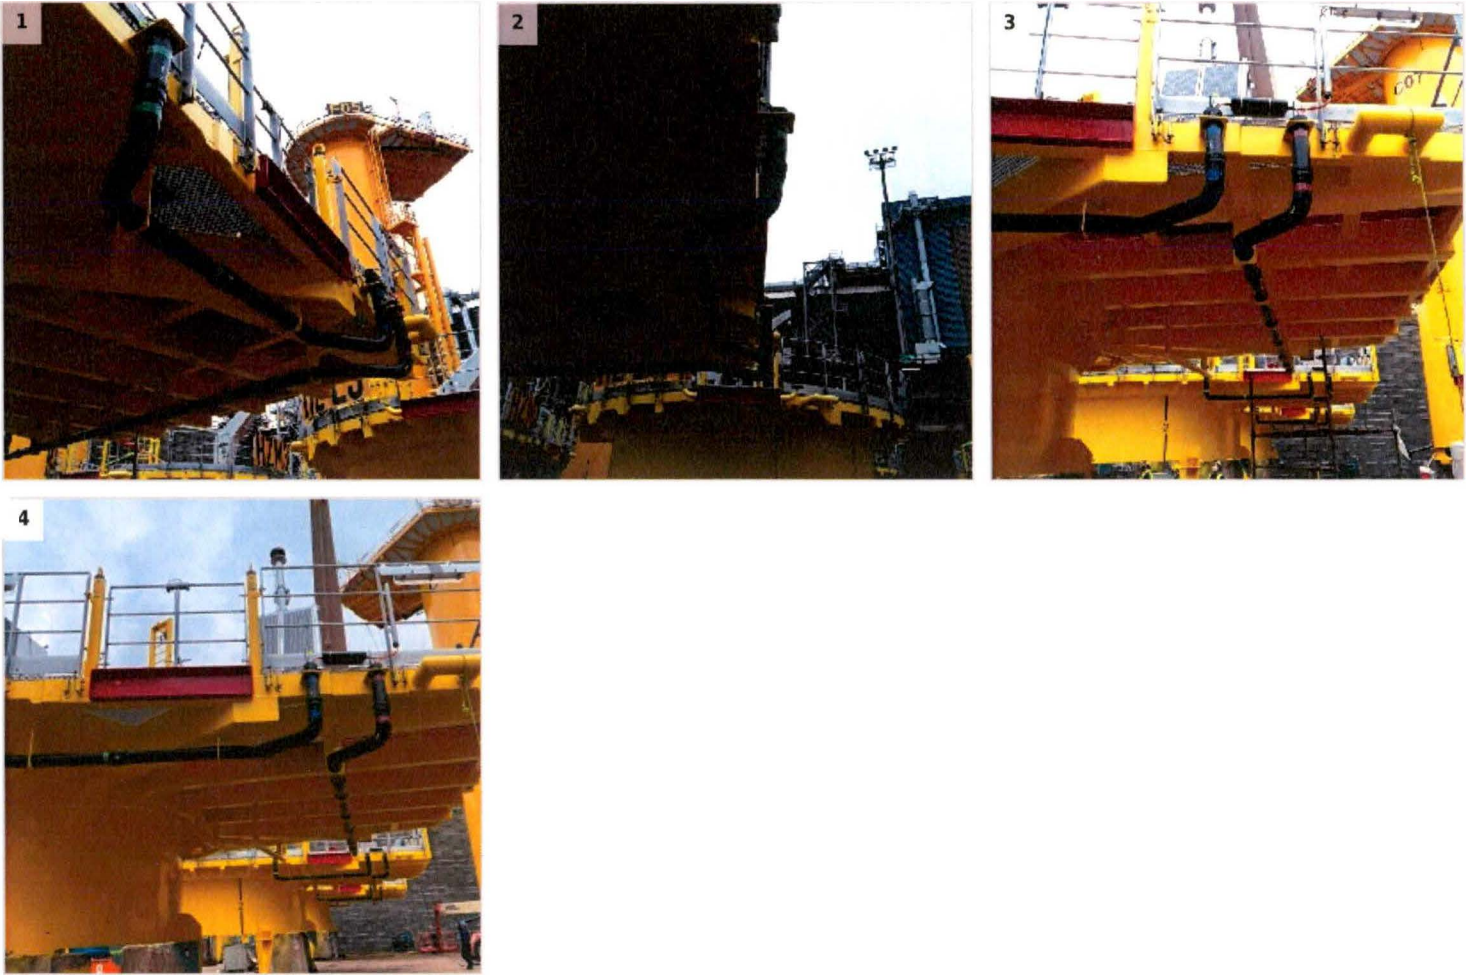
## ● #1217 - Pipe not straight

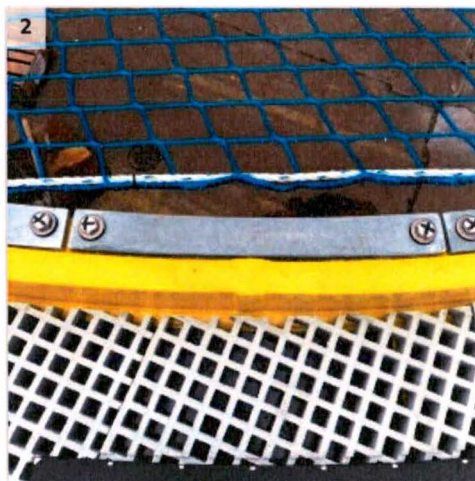
#1221 - Bracket touches the plate

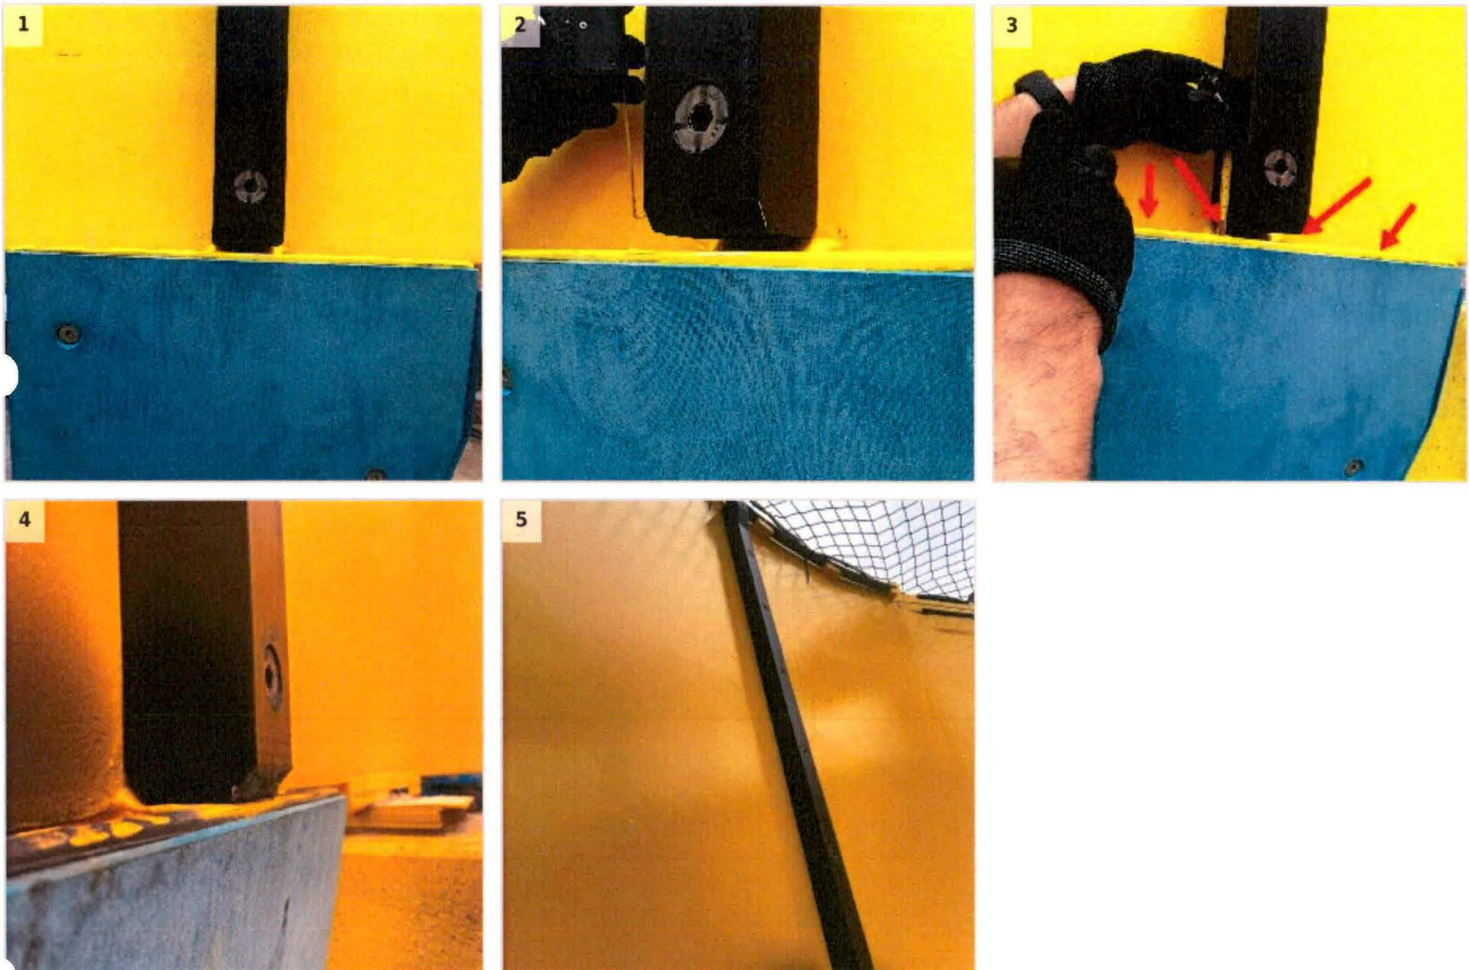
#1218 - To big gap on the finger guide

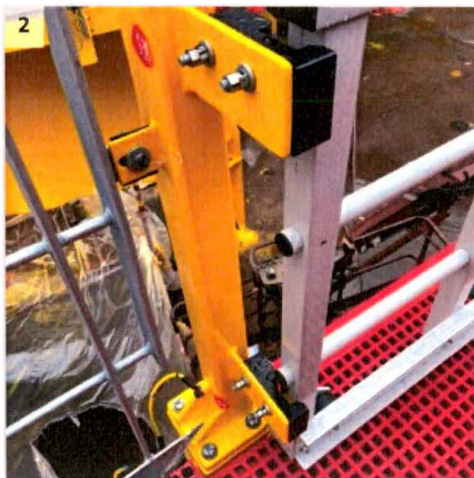
● #1224 - Nuts are missing

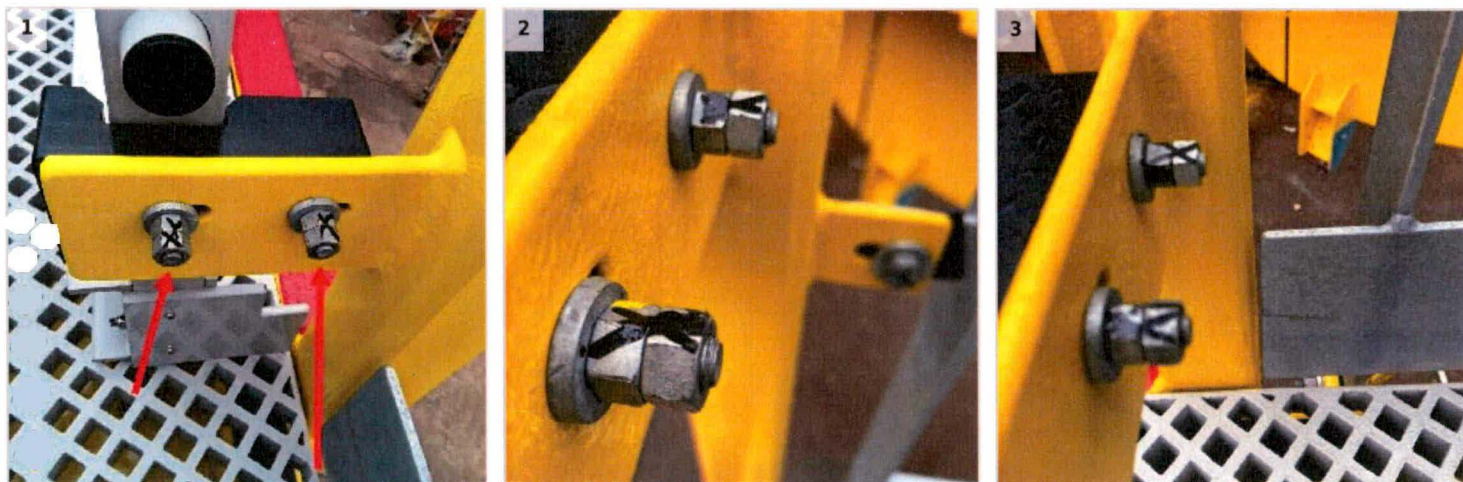
### #1220 - Put new bolt. Start already rusty

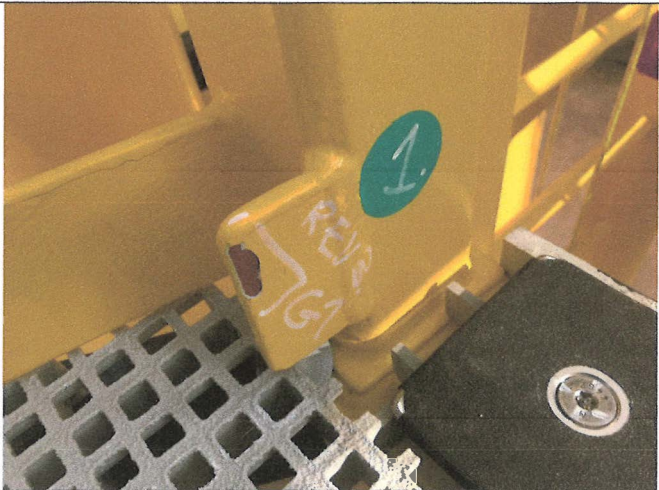
| No. 1 – New mechanical damage on the kick plate, next to the swing gate. | No. 2 – | |

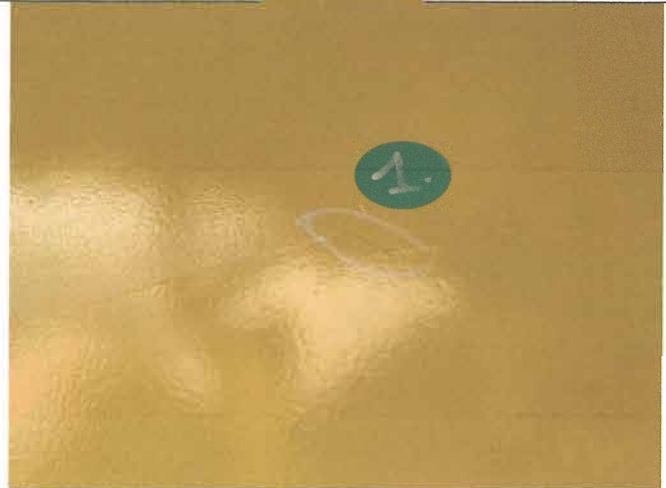
| H3M3 | Rev. 2 | Date: 24.06.2021 |
|---|---|---|
| No. 1 – Top coat repair, smoothing of the edge required. | No. 2 – Burn marks, fly rust, cleaning and topcoat repair required. | |

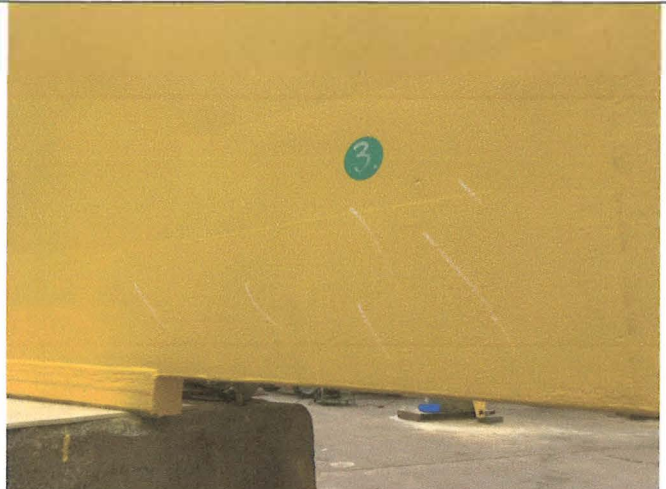
| H3M3 | Rev. 2 | Date: 24.06.2021 |
|---|---|---|
| No. 3 – Pour touch up, inclusions, topcoat repair required. | No. 4 – General comment, cleaning required. | |

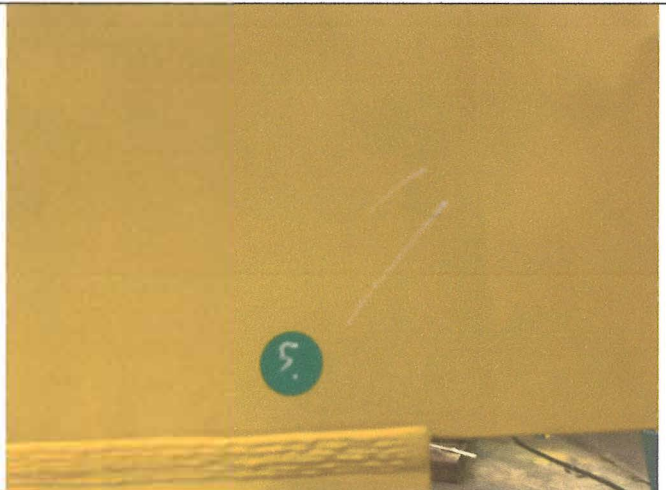
| H3M3 | Rev. 2 | Date: 24.06.2021 |
|---|---|---|
| No. 5 – Fly rust and burn marks, cleaning and topcoat repair required. | No. 6 – Another layer of topcoat required. | |

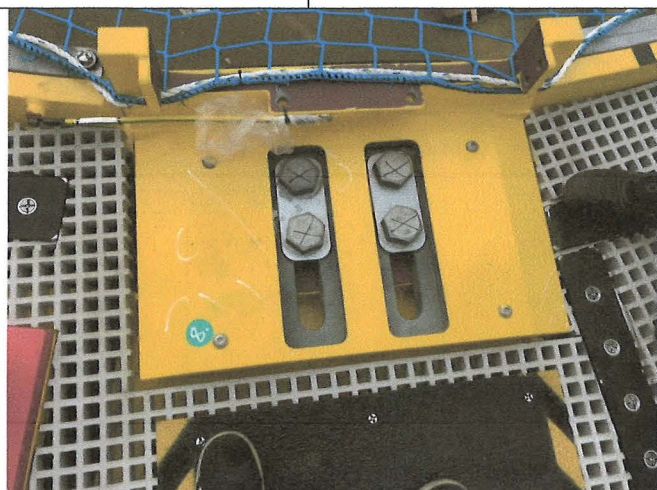
No. 8 – Mechanical damages, topcoat repair required.

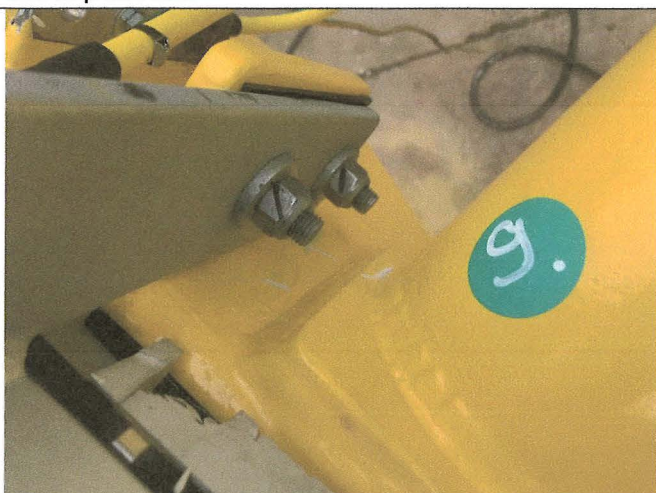
No. 9 – Pour touch up, sanded but not painted.

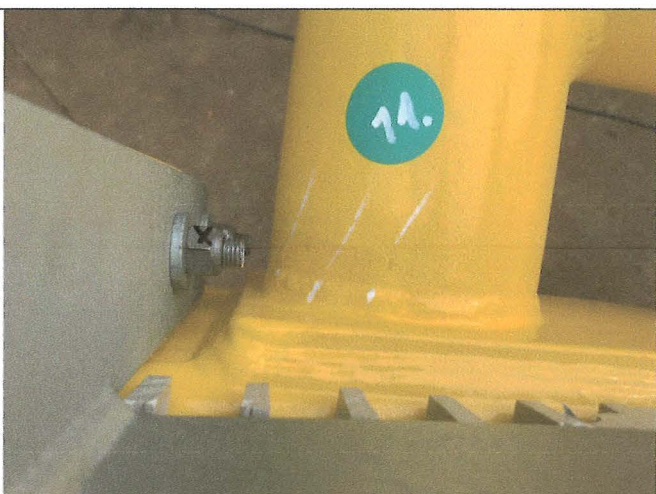
No. 11 – Top coat repair required.

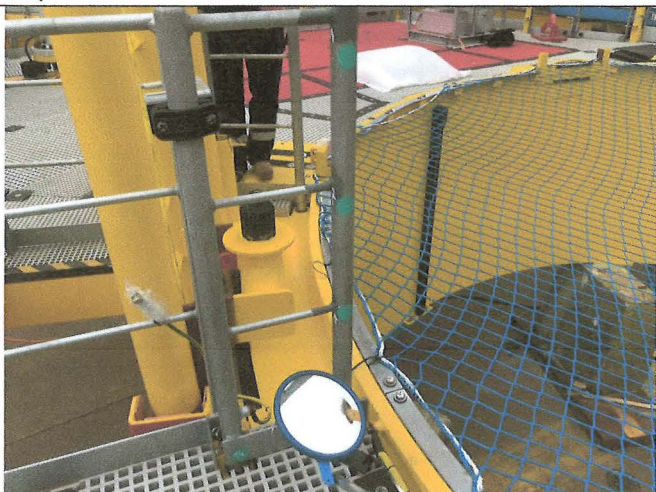
No. 15 – HDG handrails, not closed film, surface preparation and paint application required.

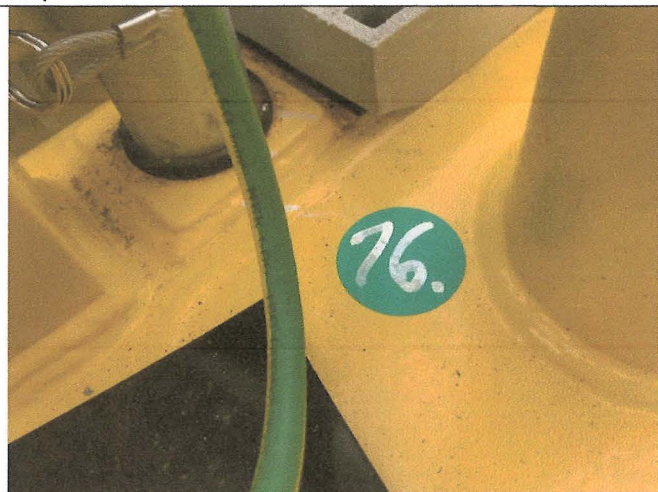
No. 16 - Dirt and fly rust. Cleaning required.

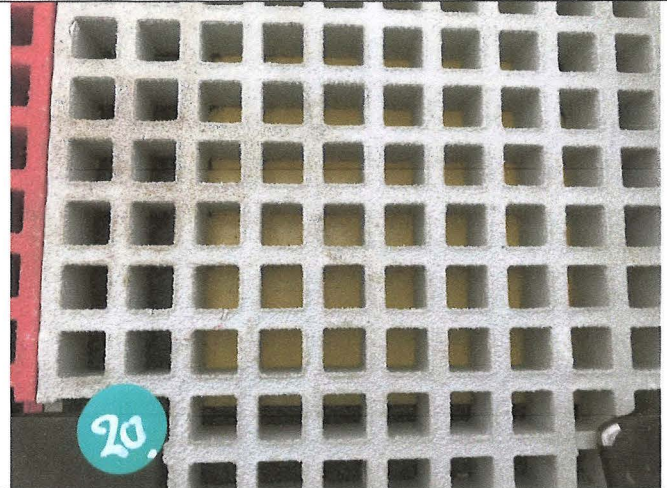
| H2M3 | Rev. 2 | Date: 24.06.2021 |
|---|---|---|
| No. 19 – Top coat repair required. | No. 20 – Dirt and fly rust under the gratings. Cleaning required. | |

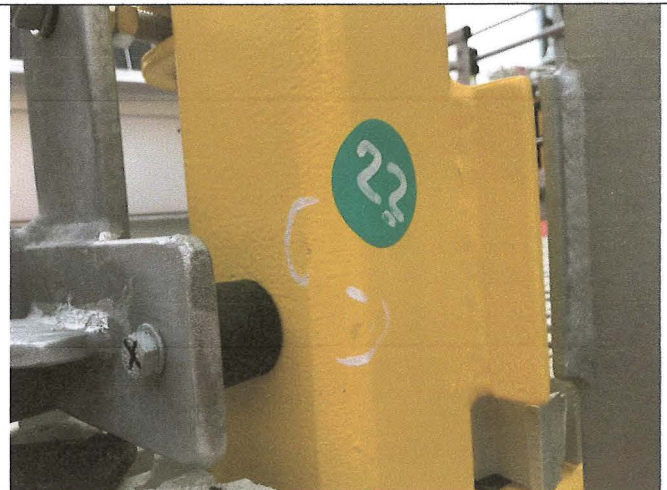
| H2M3 | Rev. 2 | Date: 24.06.2021 |
|---|---|---|
| No. 21 – Mechanical damage to coating, epoxy repair required. | No. 22 – Mechanical damage. Swing gate, S side. | |

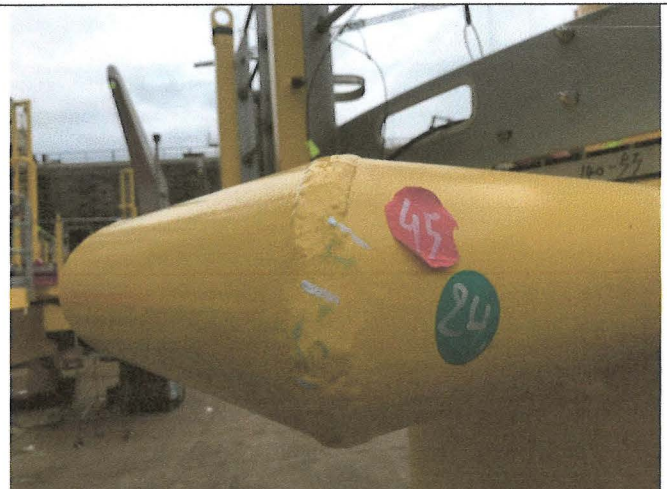
| H2M3 | Rev. 2 | Date: 24.06.2021 |
|---|---|---|
| No. 23 – Mechanical damage. W side UPN. | No. 24 – Topcoat application required. WS side. | |

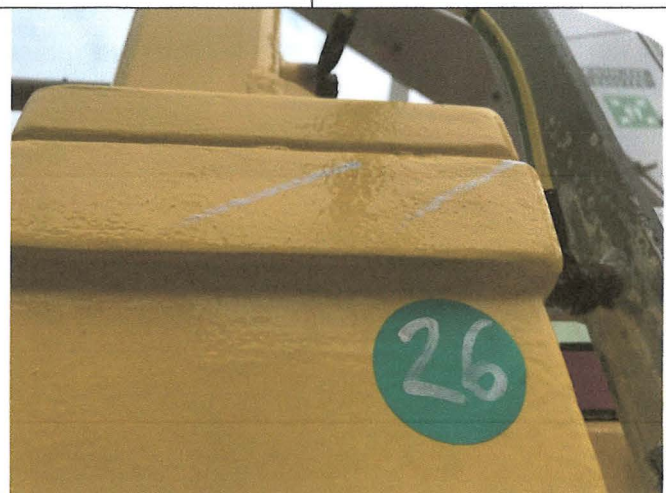
| HZM3 | Rev. 2 | Date: 24.06.2021 |
|---|---|---|
| No. 25 – Topcoat repair required. | No. 26 – Inclusions in topcoat. | |

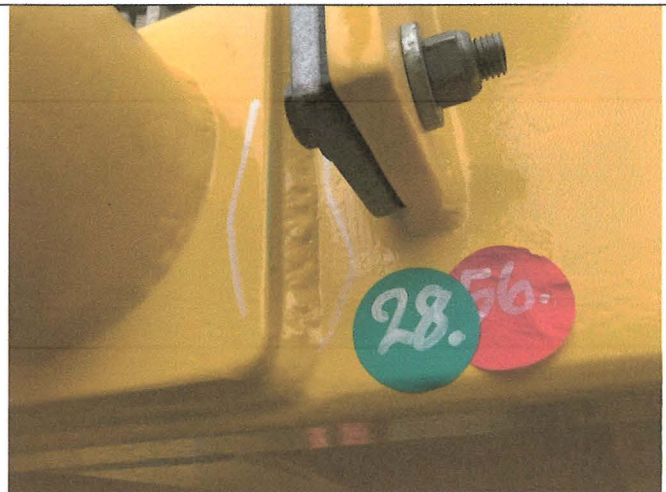
| HZM3 | Rev. 2 | Date: 24.06.2021 |
|---|---|---|
| No. 27 – Cleaning and Topcoat application required. | No. 28 – Not finished touch up, topcoat application required. | |

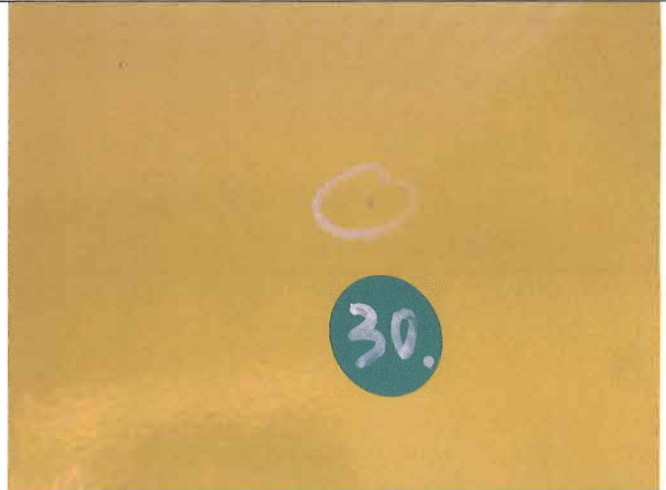
| HZM3 | Rev. 2 | Date: 24.06.2021 |
|---|---|---|
| No. 29 – HDG Handrail, mechanical damage. | No. 30 – Mechanical damage, topcoat. South side, outside can. | |

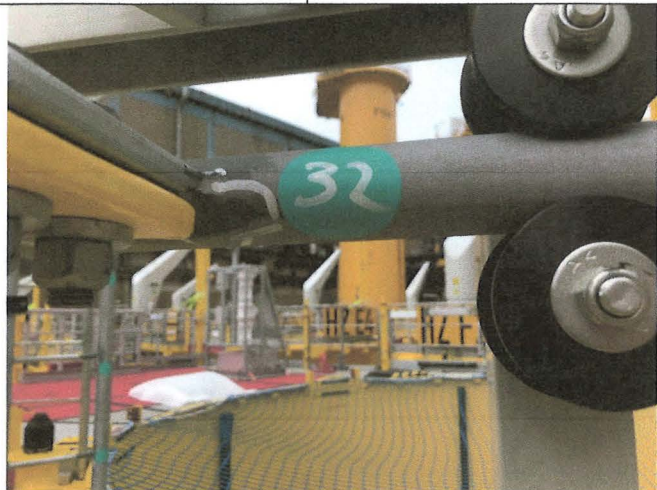
| HZM3 | Rev. 2 | Date: 24.06.2021 |
|---|---|---|
| No. 31 - Nord side sliding gate, HDG handrail, mechanical damage. Surface preparation and paint application required. | No. 32 – Nord side sliding gate, HDG handrail, mechanical damage. Surface preparation and paint application required. | |
