| | <b>EWP M3</b><br>External work platform – FAT documentation | 25220<br>Hollandse Kust Zuid |

**Mechanical Release Note EWP Rev 2 #15**

## Punchlist mechanical

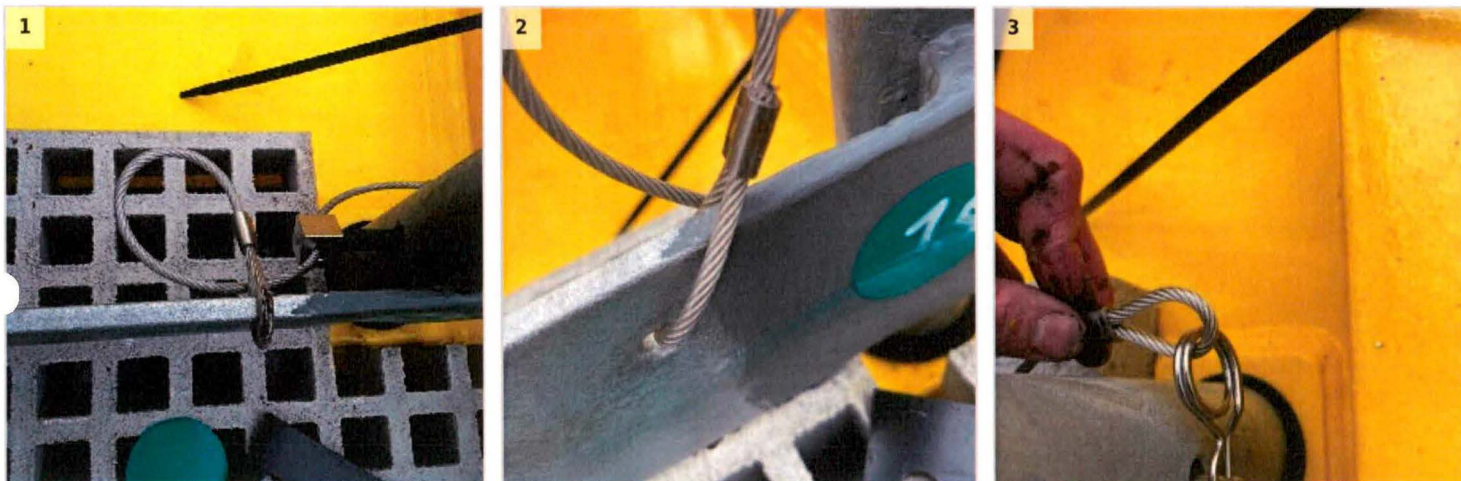
## ● #1371 - Cable damaged on the wire

| Ben Herygers | Cable damaged on the wire @Mechanical @kevin_kemps #client | 24 jun 13:33 |

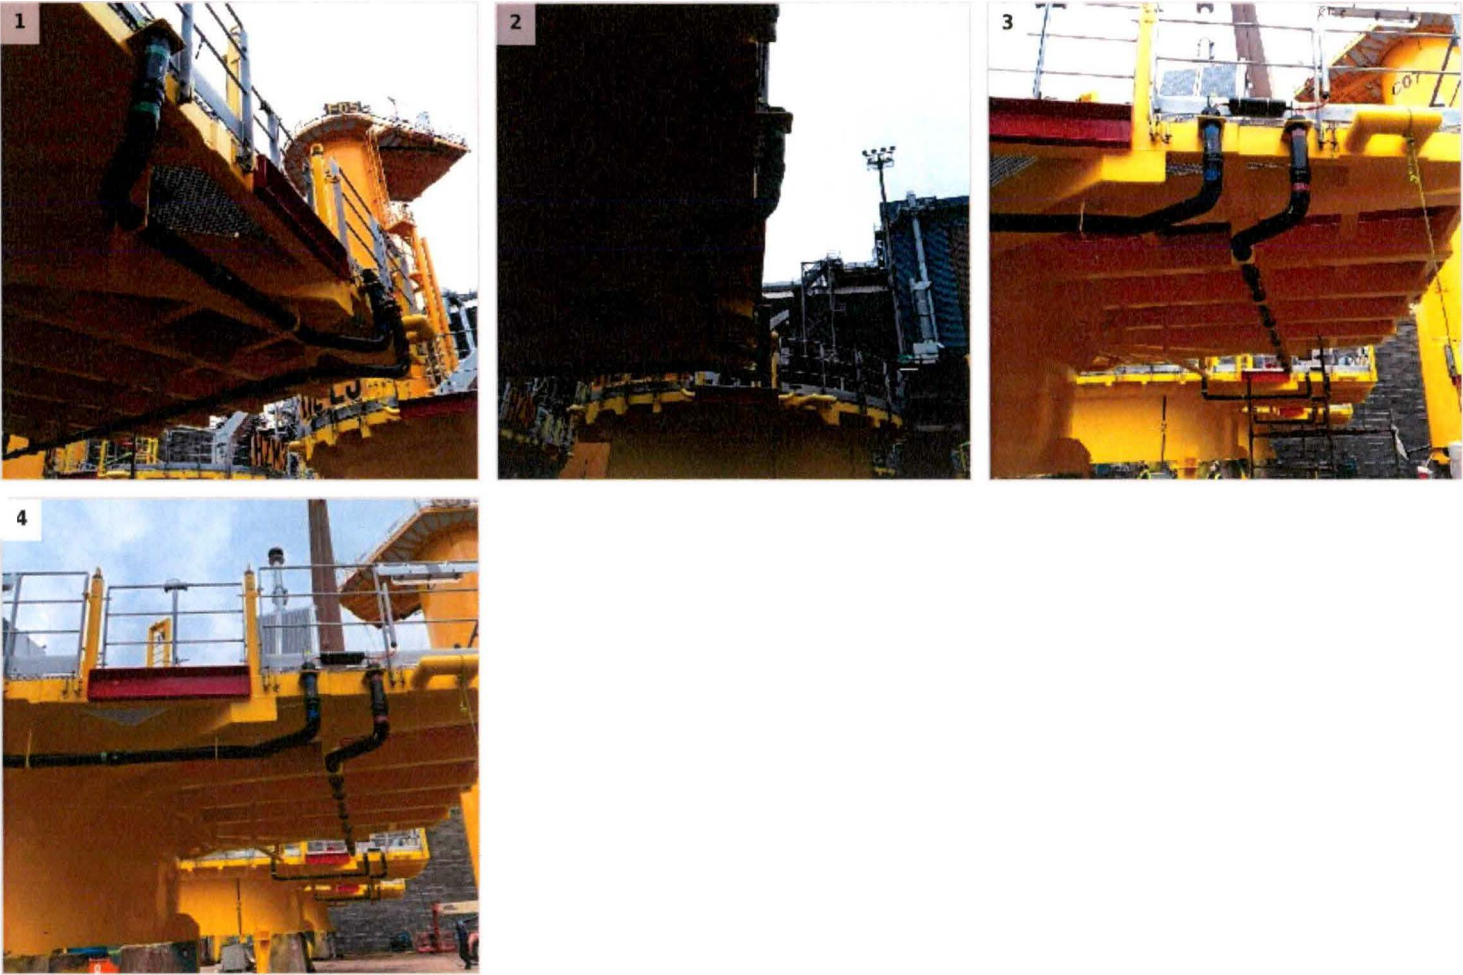
## ● #1217 - Pipe not straight

| Ben Herygers | Pipe not straight @Mechanical @kevin_kemps #client | 19 jun 09:19 |

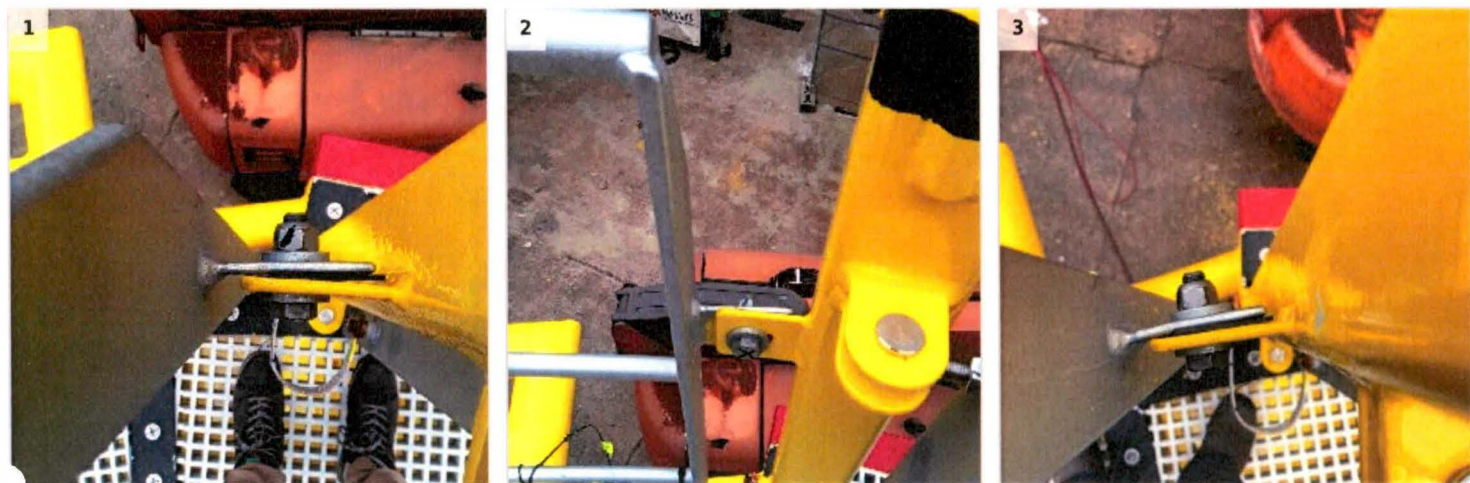
### #1229 - Needs to be adjusted

| Ben Herygers | Needs to be adjusted @Mechanical @kevin_kemps #client | 19 jun 09:52 |

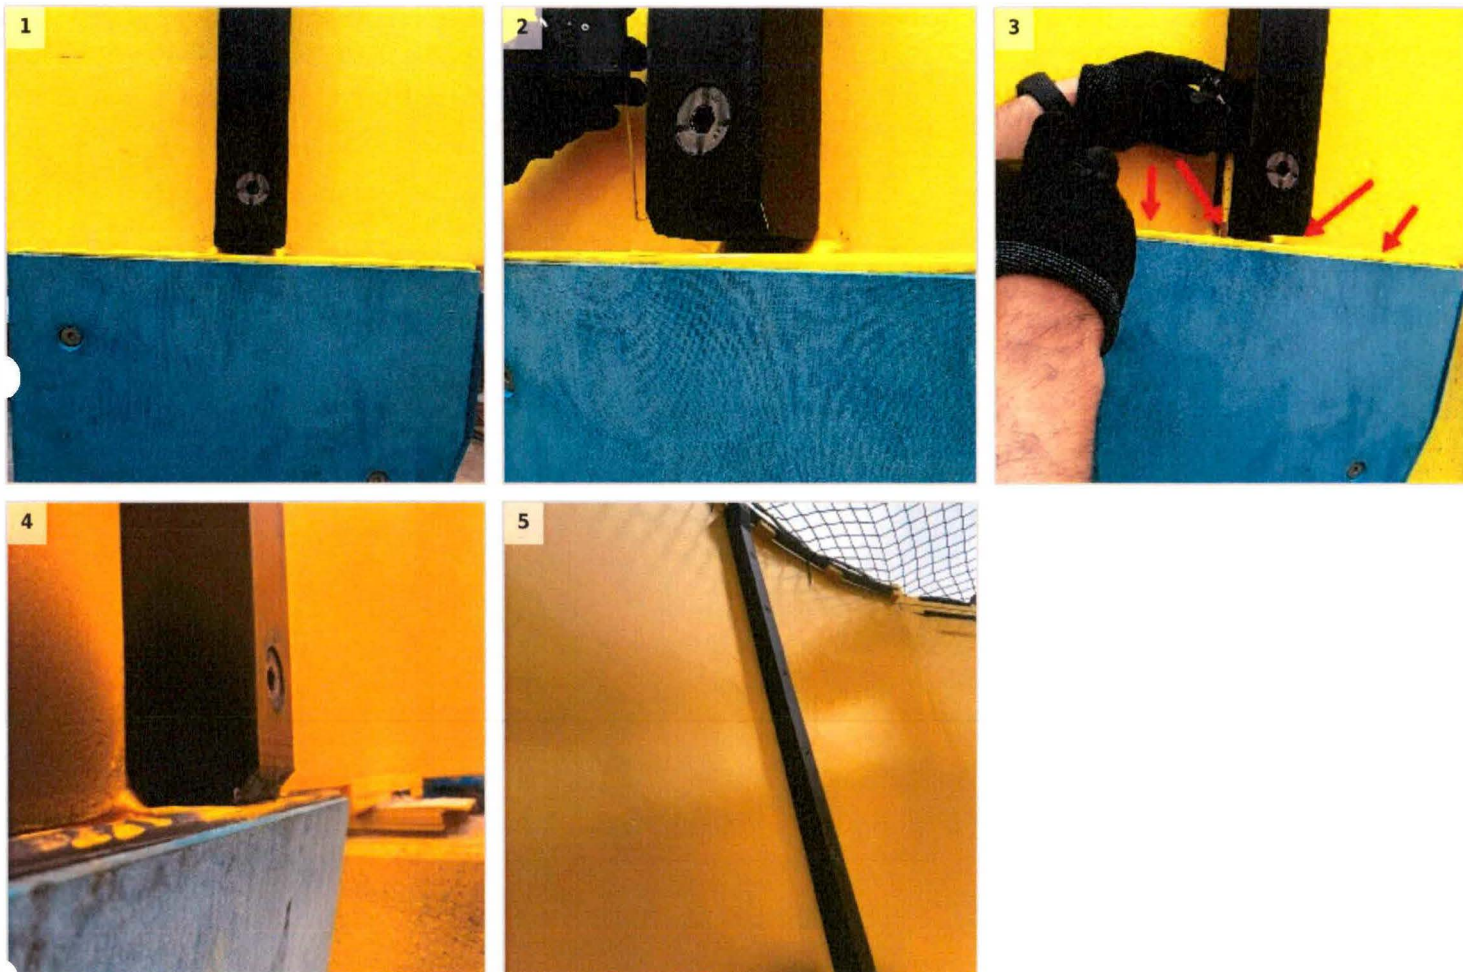
#1218 - To big gap on the finger guide

| Ben Herygers | To big gap on the finger guide @Mechanical @kevin_kemps #client | 19 jun 09:30 |

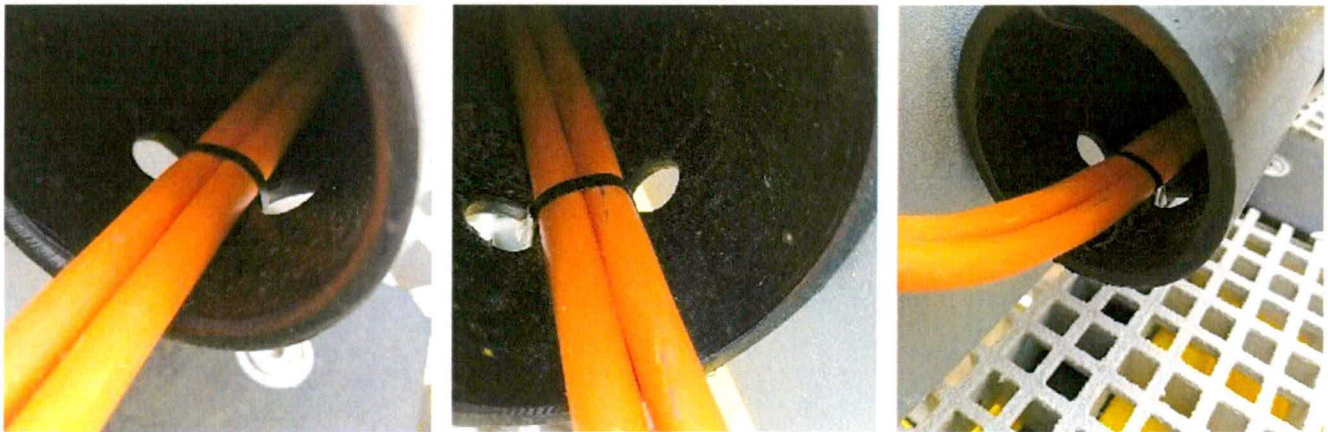
2.4 SS-Coated tie wraps are used

Remarks: Single cable from ID-Lights position 3, can be attached with plastic cable-ties.

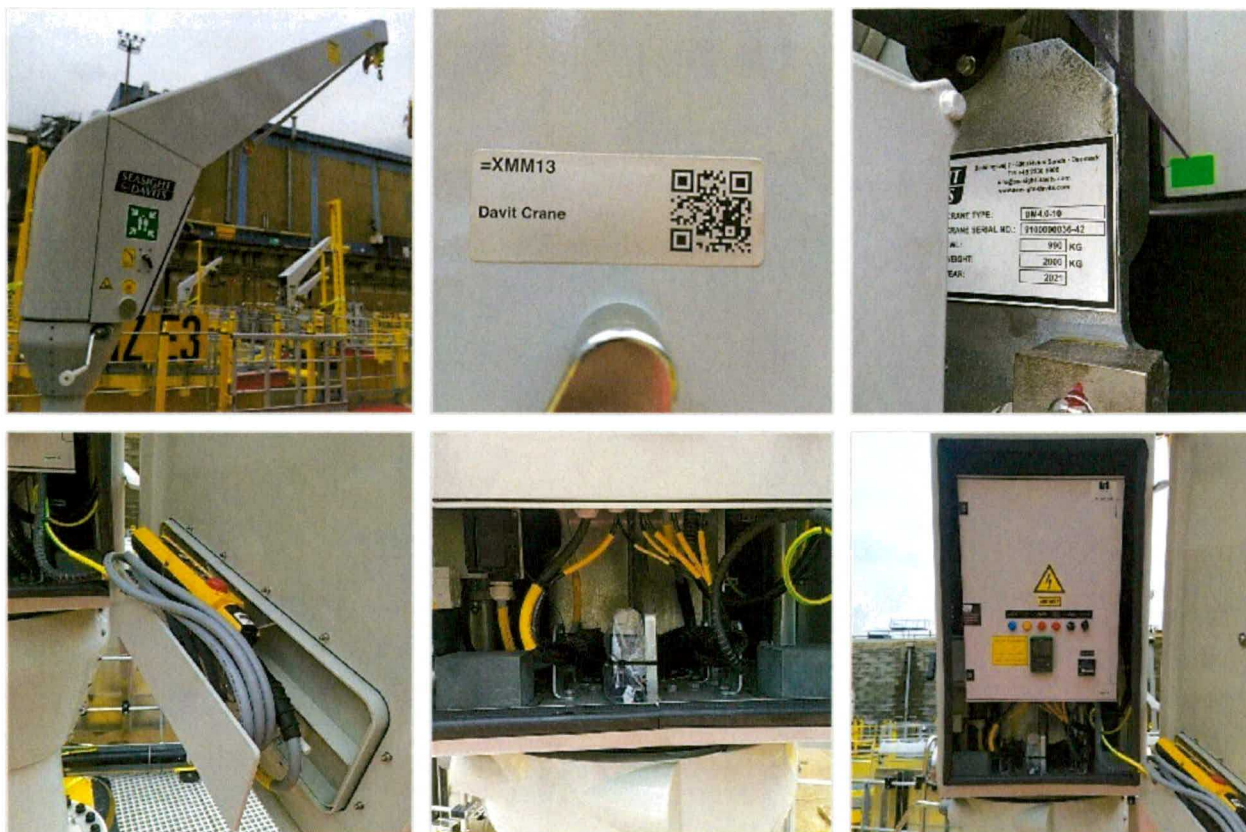
Remarks: RDS-PP label Davit Crane =XMM13

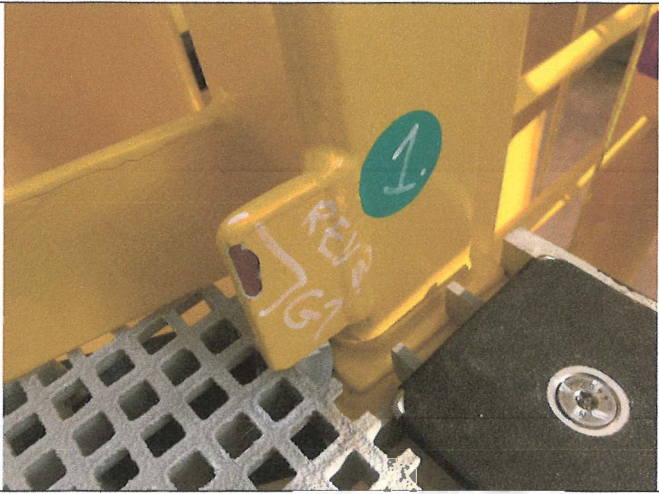
| N° | Description | Completion<br>Signature + Date | |
|---|---|---|---|
| 1 | New mechanical damage on the kick plate, next to the swing gate. | | |

| No. 1 – New mechanical damage on the kick plate, next to the swing gate. | No. 2 – | |

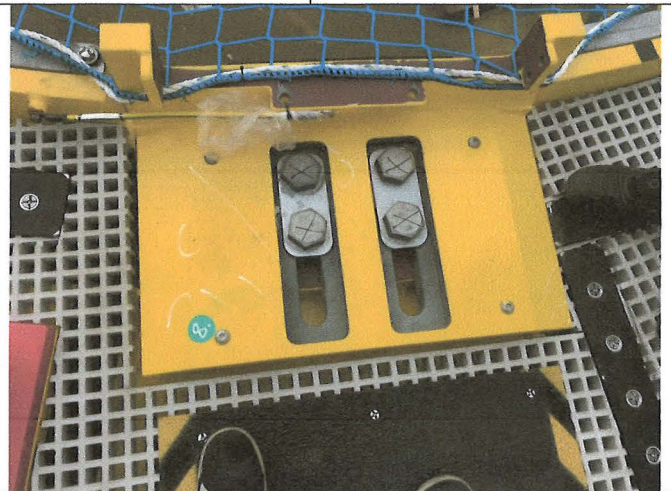
No. 8 – Mechanical damages, topcoat repair required.

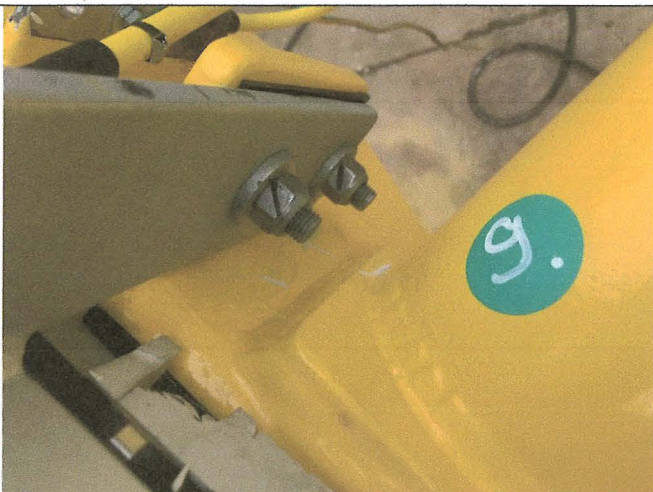
No. 9 – Pour touch up, sanded but not painted.

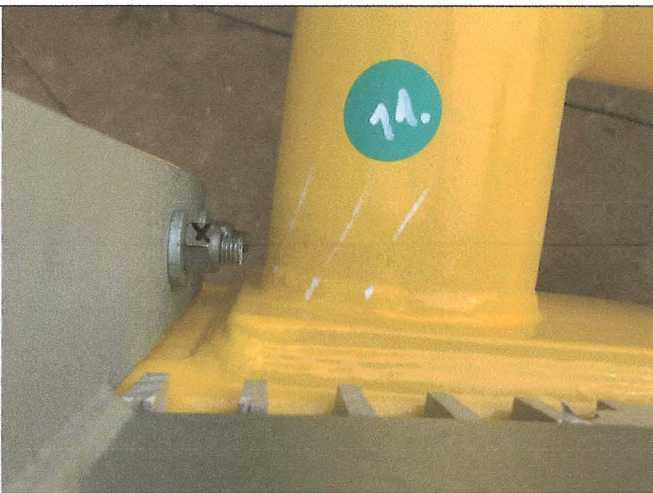
No. 11 – Top coat repair required.

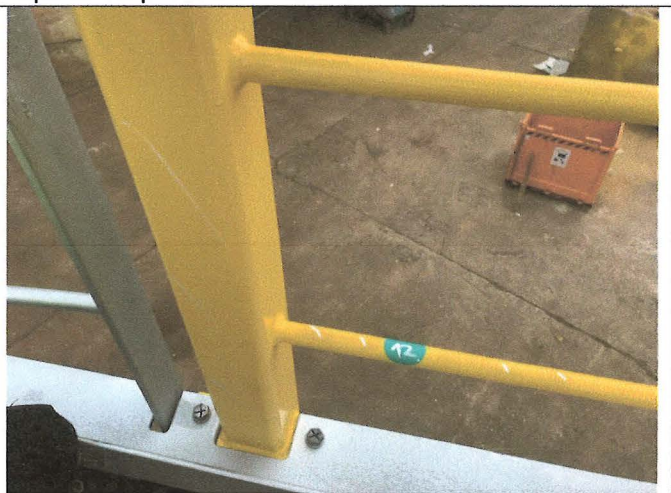
No. 12 – Topcoat repair required.

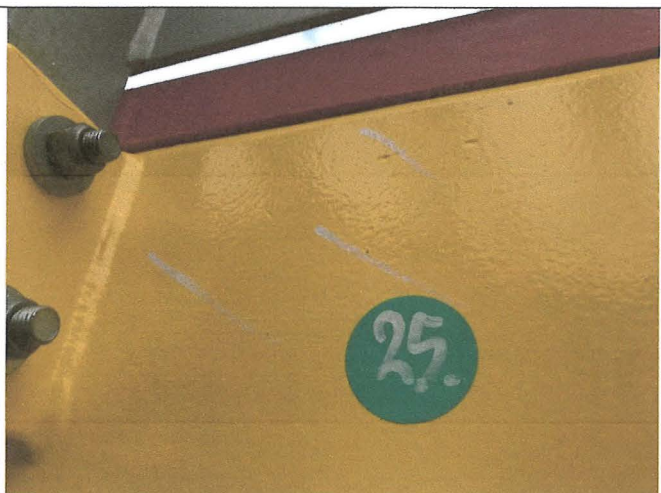
| HZM3 | | Rev. 2 | Date: 24.06.2021 |
|---|--|---|---|
| No. 25 – Topcoat repair required. | | No. 26 – Inclusions in topcoat. | |

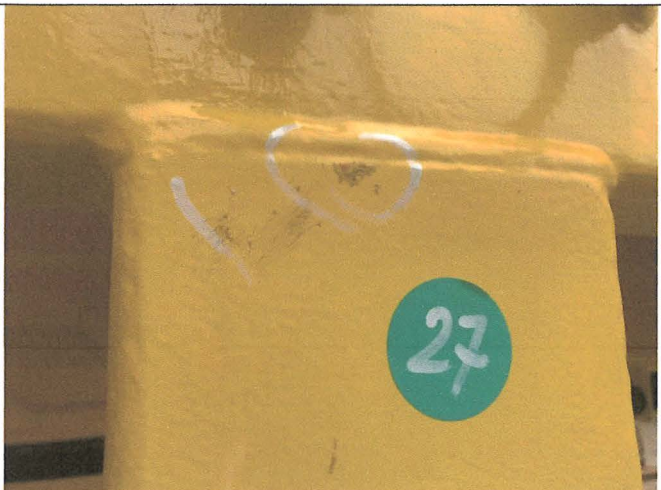
| HZM3 | | Rev. 2 | Date: 24.06.2021 |
|---|--|---|---|
| No. 27 – Cleaning and Topcoat application required. | | No. 28 – Not finished touch up, topcoat application required. | |

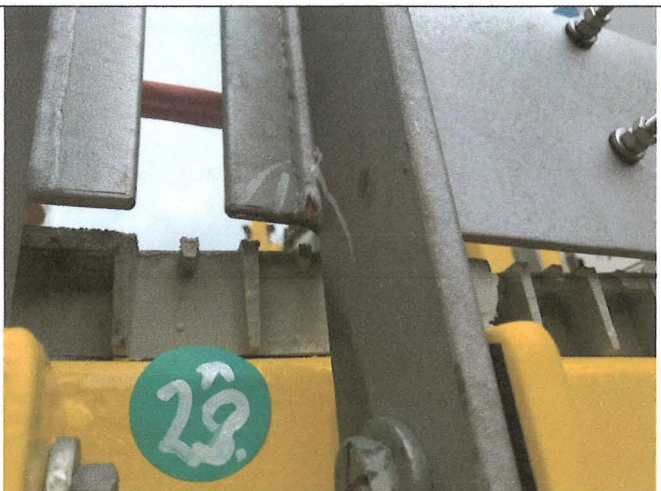
| HZM3 | | Rev. 2 | Date: 24.06.2021 |
|---|--|---|---|
| No. 29 – HDG Handrail, mechanical damage. | | No. 30 – Mechanical damage, topcoat. South side, outside can. | |

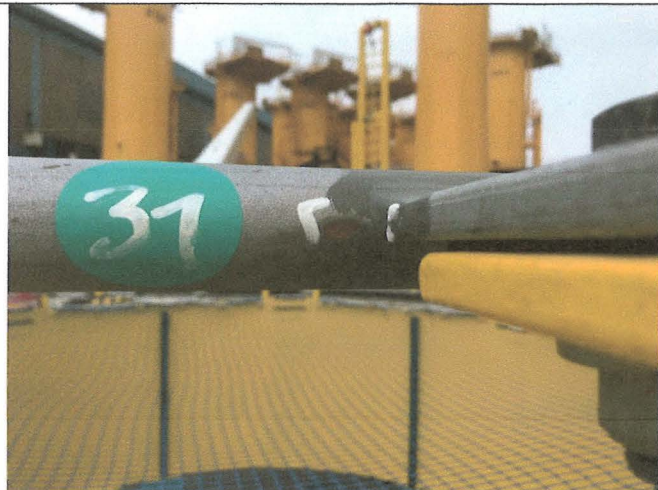
| 31 | Nord side sliding gate, HDG handrail, mechanical damage. Surface preparation and paint application required. | [Signature] | | [Signature] Paveche | |

| HZM3 | Rev. 2 | Date: 24.06.2021 |
|---|---|---|
| No. 31 - Nord side sliding gate, HDG handrail, mechanical damage. Surface preparation and paint application required. | No. 32 – Nord side sliding gate, HDG handrail, mechanical damage. Surface preparation and paint application required. | |

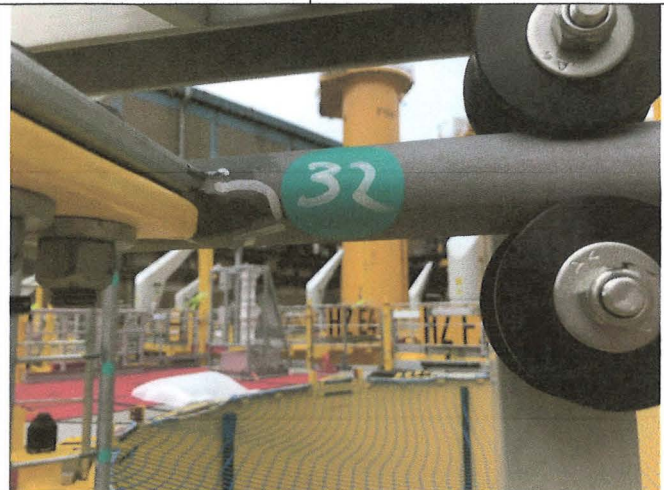
| 32 | Nord side sliding gate, HDG handrail, mechanical damage. Surface preparation and paint application required. | [Signature] | | [Signature] Paveche | |
