| <b>SMULDERS</b> | <b>EWP G1</b><br>External work platform – FAT documentation | 25220<br>Hollandse Kust Zuid |

## Mechanical Release Note EWP Rev 2 #19

## Punchlist mechanical

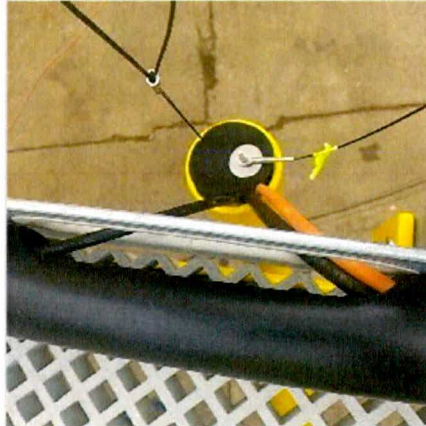
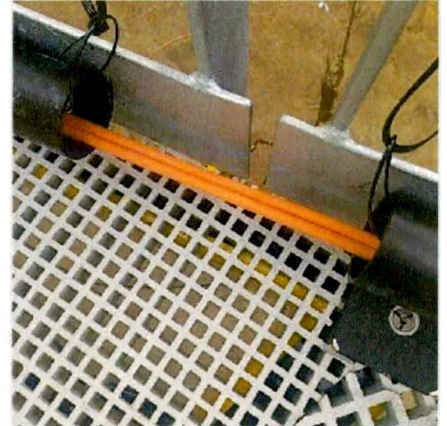
### 2.3 Power and signal cables

Correct selection of cable glands and routing / dressing of cables correct and free of damages. Cables are provided with ID labels

Status OK

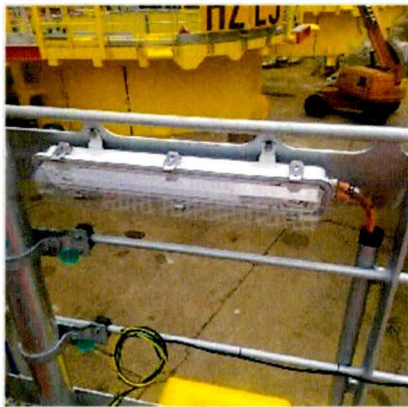
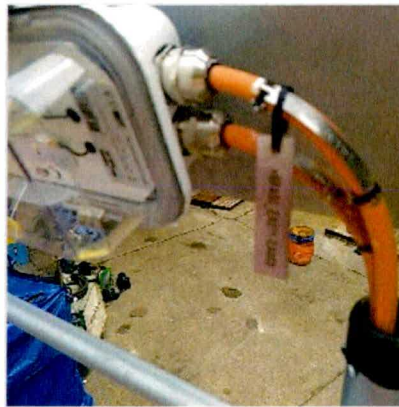
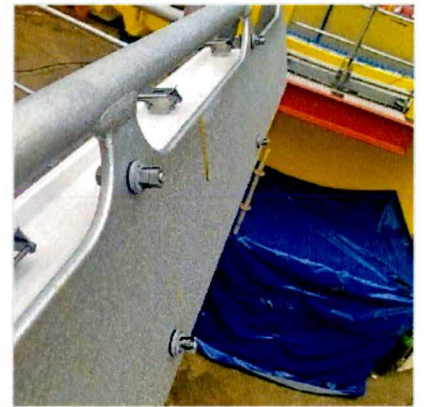
## 2.10 Normal Light Fixture 3 =BFA50\_EA011-EA003

Correctly installed & adequately supported, free of damages, connected and glands are tightened.  
RDS-PP labels are in place for equipment and cables, correct configuration off fixation bolt & washers are used and free of condensed water inside.

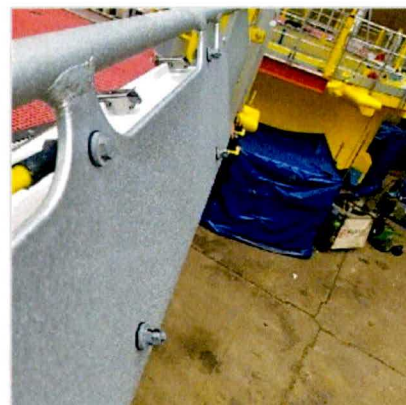
## 2.11 Normal Light Fixture 4 =BFA50\_EA011-EA004

Correctly installed & adequately supported, free of damages, connected and glands are tightened.
