| | <p align="center"><b>EWP G1</b><br/>External work platform – FAT documentation</p> | <p align="center">25220<br/>Hollandse Kust Zuid</p> |

## Mechanical Release Note EWP Rev 2 #19

## Punchlist mechanical

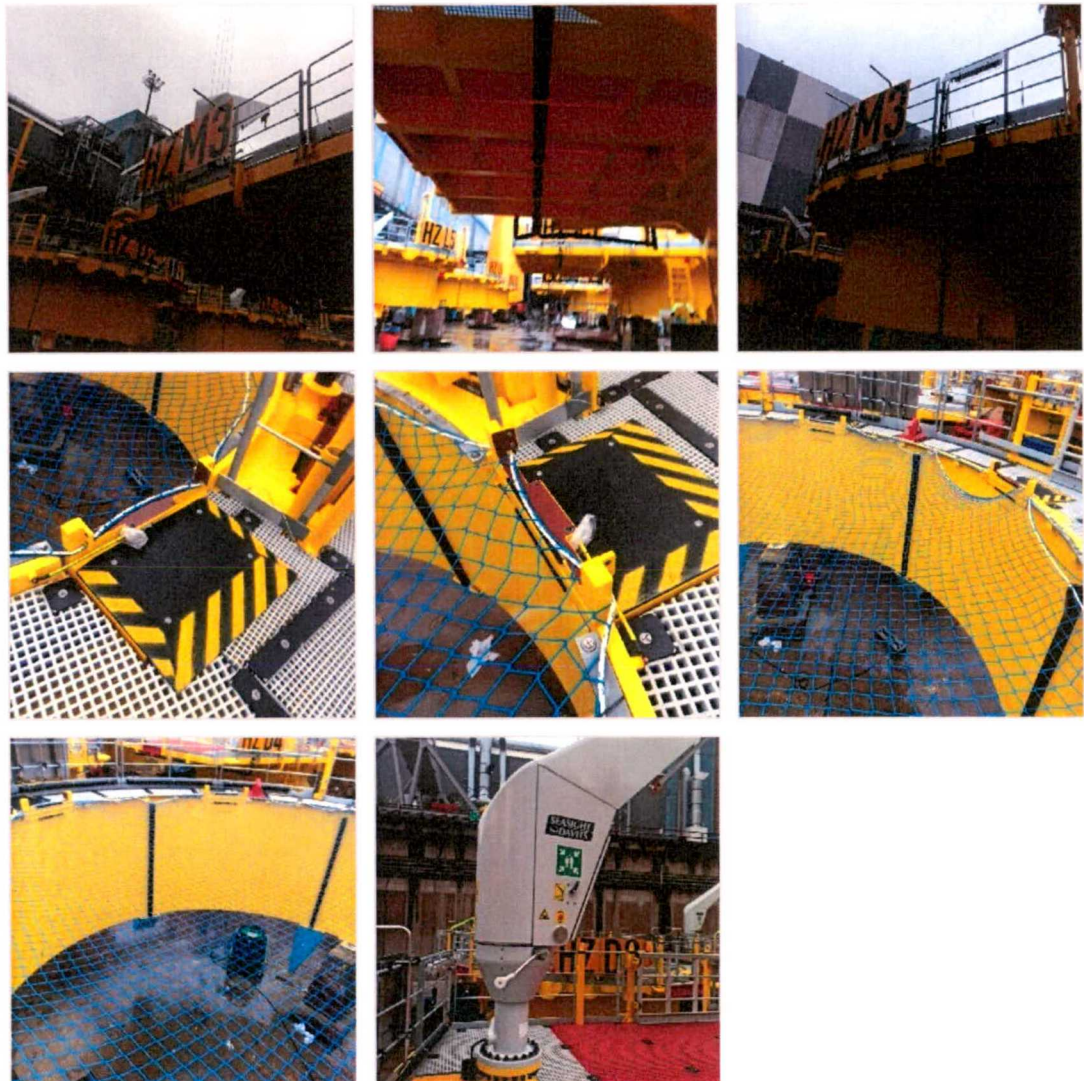
## 1 General

| 1.1 EWP is clean (Housekeeping) and free of damages | OK |
| 1.2 Annulus closer plates are correctly installed | OK |
| 1.3 Doubler plates (6x) are in place | OK |
| 1.4 Lifting padeyes (4x) are correctly installed with 6 x M36 fixation bolts on each and free of damages | OK |
| 1.5 Handrails are correctly installed and free of damages | OK |
| 1.6 Kick plates are present, correctly installed and free of damages | OK |
| 1.7 Stopper blocks (6x) are correctly installed(retracted) according to requirements, secured with 4 x M48 bolts incl. grp cover plates (3 x type 1 / 3 x type 2) and free of damages. | OK |

1.9 Davit crane is correctly installed, well oriented and free of damages OK

1.10 Signboards (6x) are correctly installed and free of damages. OK

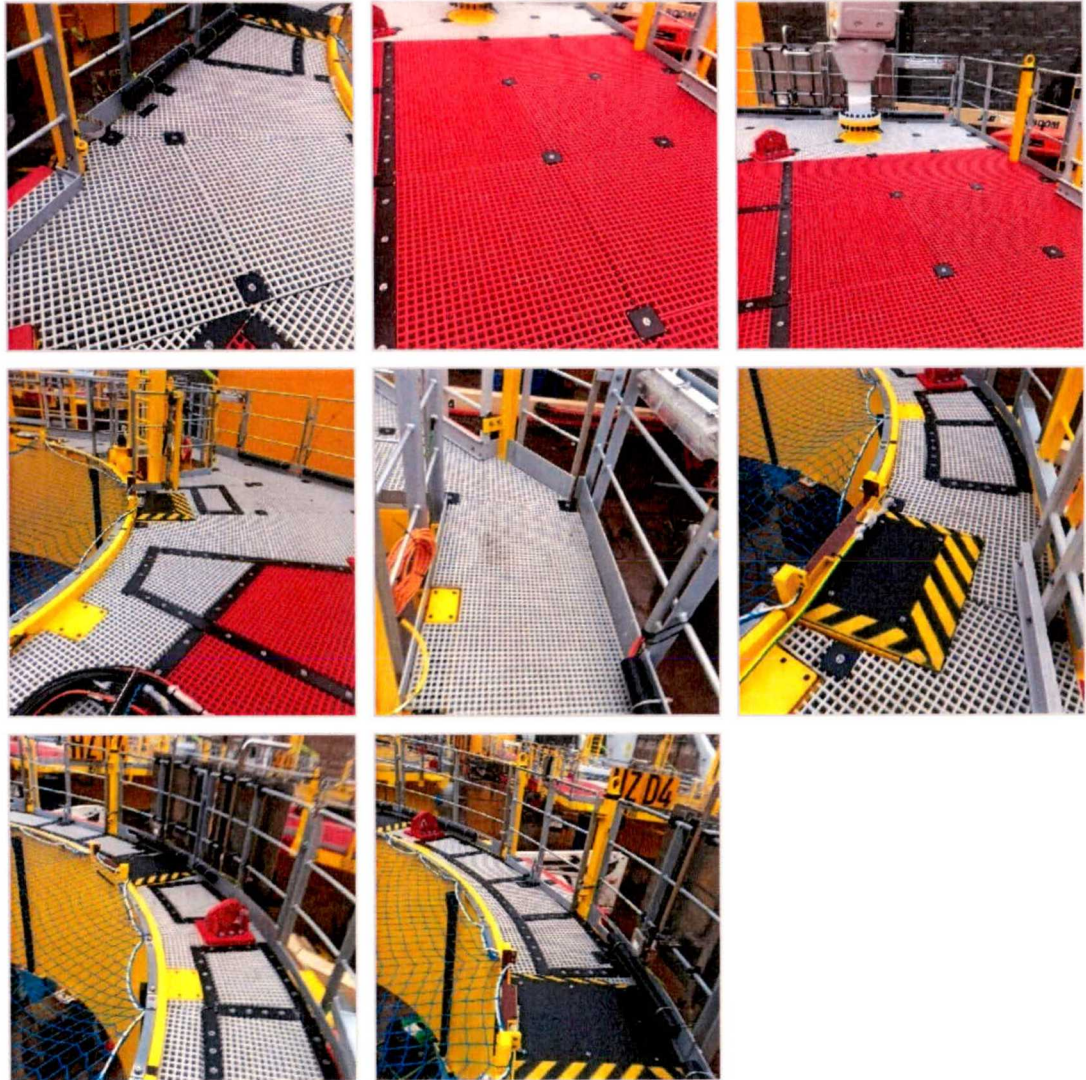
## 2 Gratings

2.1 Grating are correctly installed incl. grating clamps and free of damages

2.6 Wave-up runner plates are correctly installed and free of damages

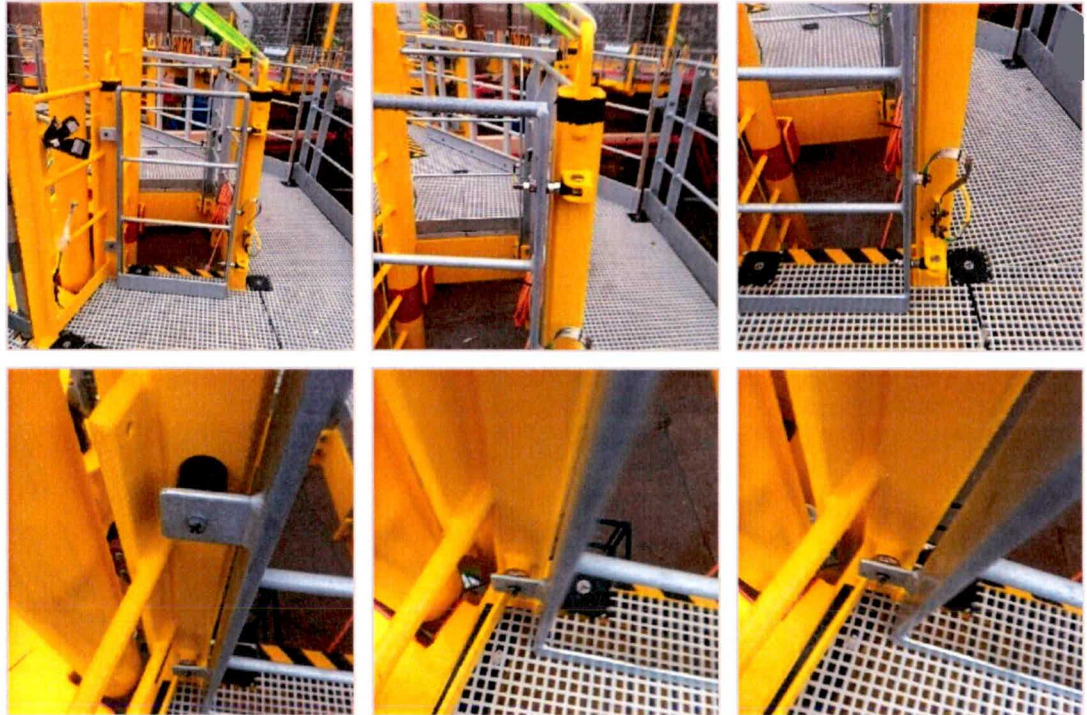
### 3 Swing gate at access ladder

3.1 Hook-on points (2x) are present OK  
on posts

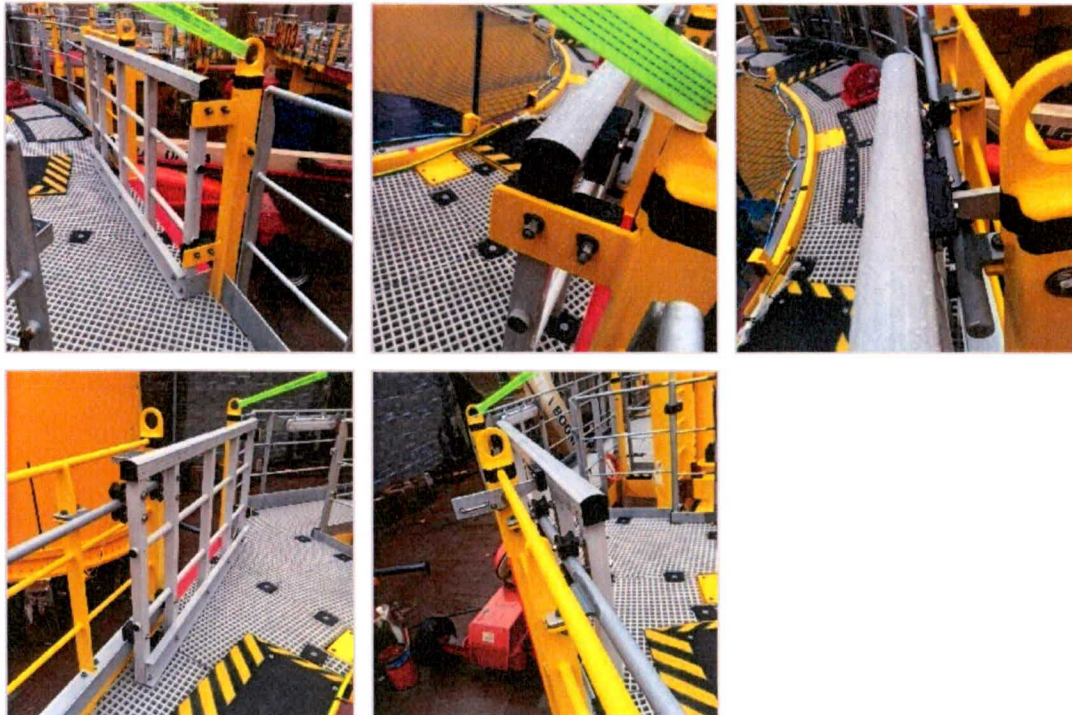
#### 4 Sliding gate at North-West

4.1 Hook-on points (2x) are present on posts OK

4.2 Sliding gate is correctly installed and free of damages OK

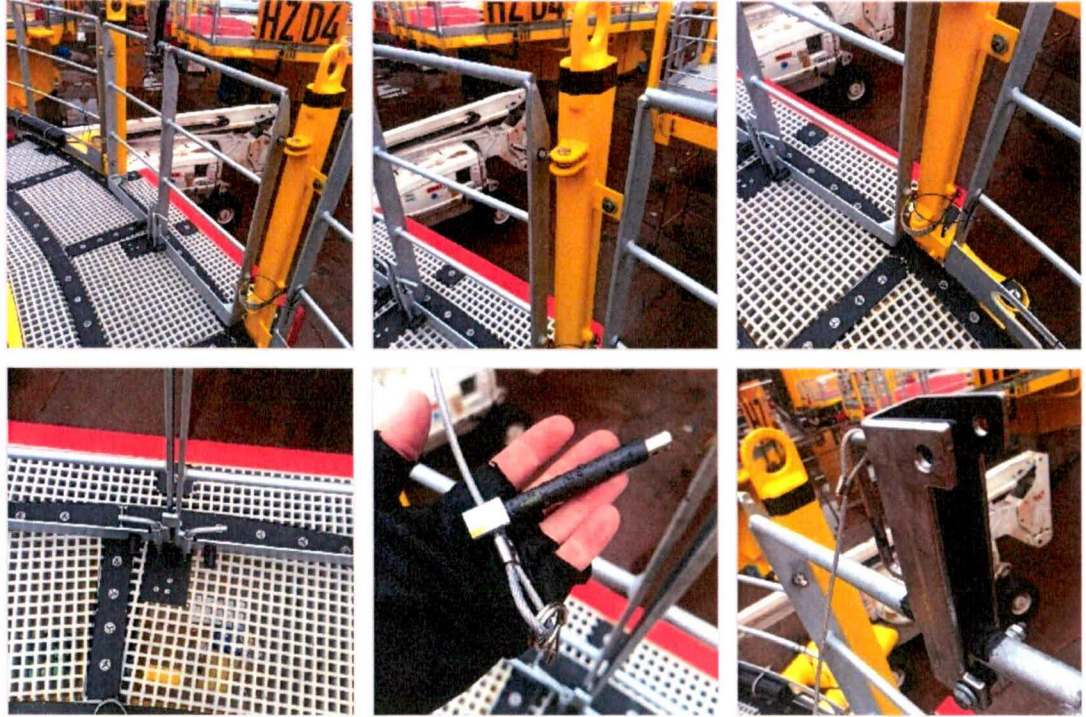
## 5 Double Swing gate West

5.1 Latch is correctly installed incl. locking pin, locking pin wires (2x), locking clip and fixation M10 bolt with HDPE shoulder/insulation washer and free of damages OK

5.3 Hook-on points (2x) are present on posts and free of damages OK

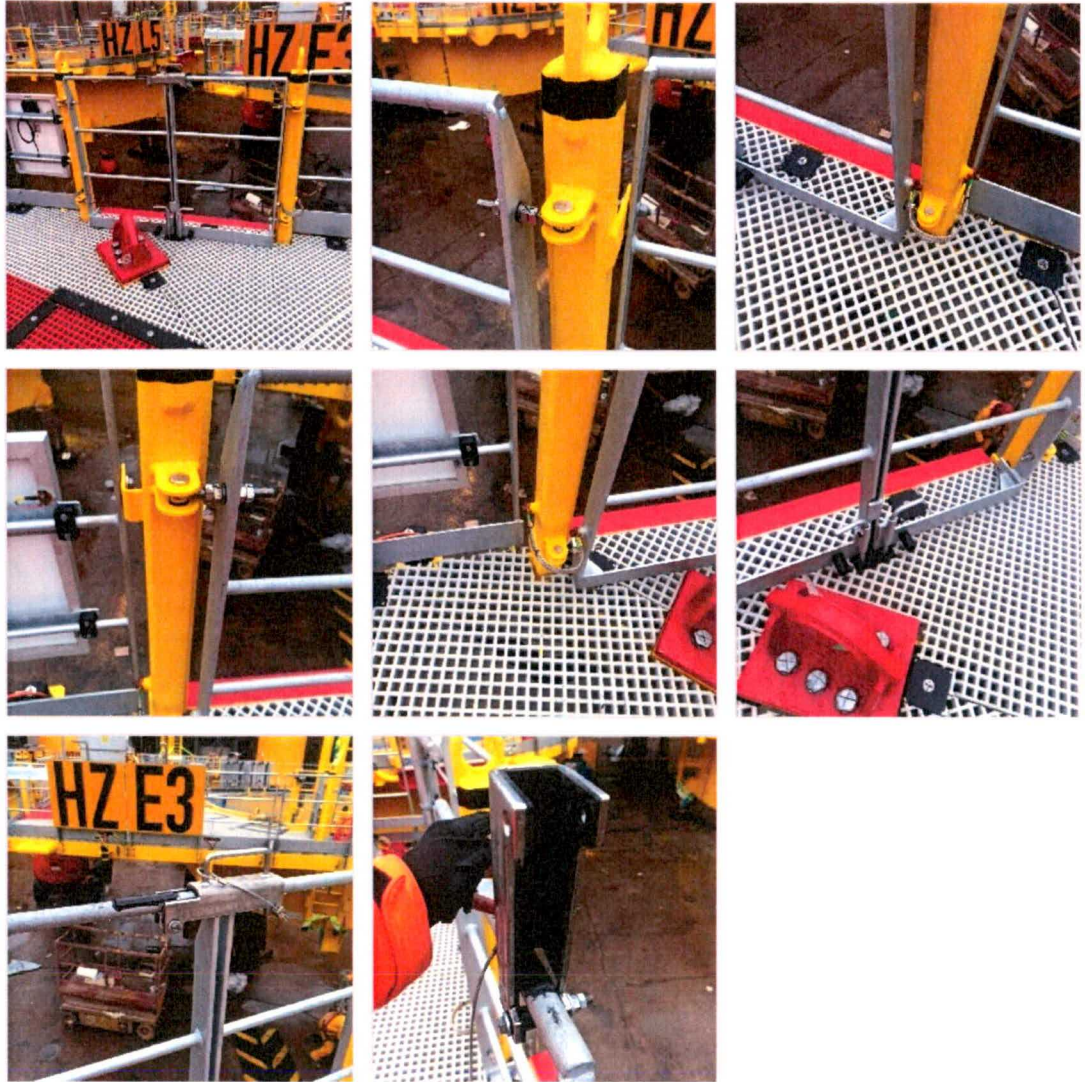
## 6 Double Swing gate South

| 6.1 Latch is correctly installed incl. locking pin, locking pin wires (2x), locking clip and fixation M10 bolt with HDPE shoulder/insulation washer and free of damages | OK |
| 6.3 Hook-on points (2x) are present on posts and free of damages | OK |

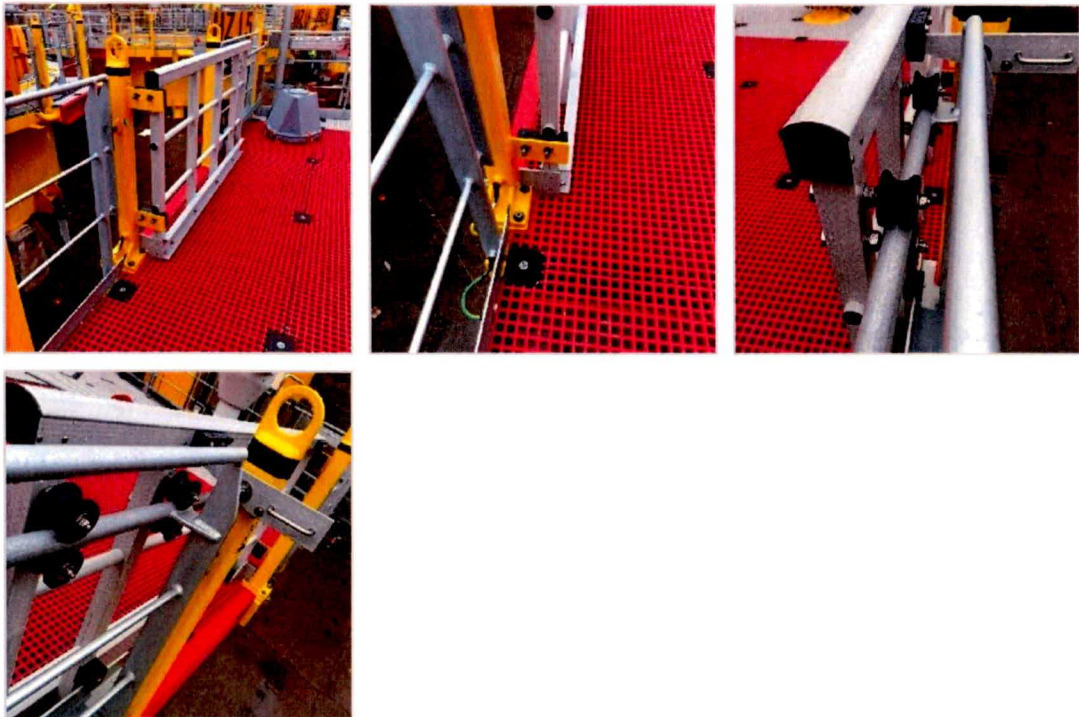
## 7 Sliding gate East

7.1 Hook-on points (2x) are present on posts OK

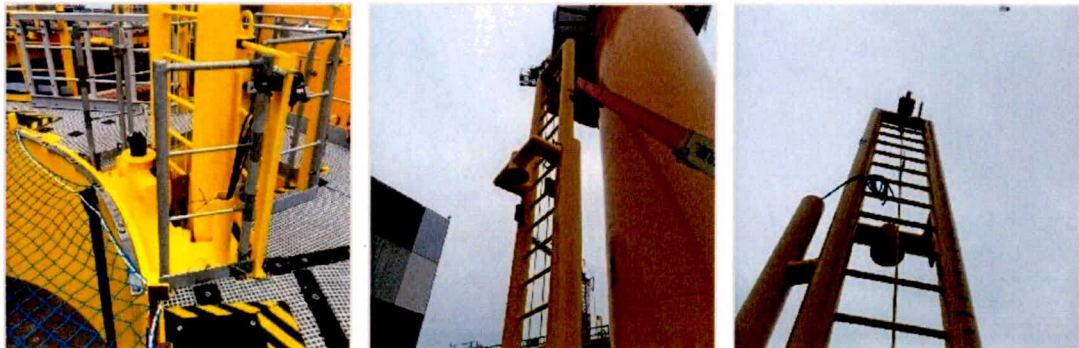
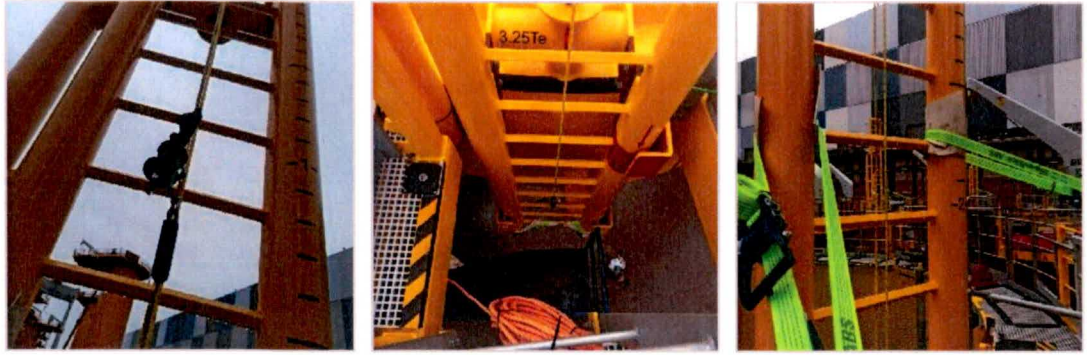
8 Access ladder

| 8.1 Railings at Access ladder location are correctly installed and free of damages | OK |

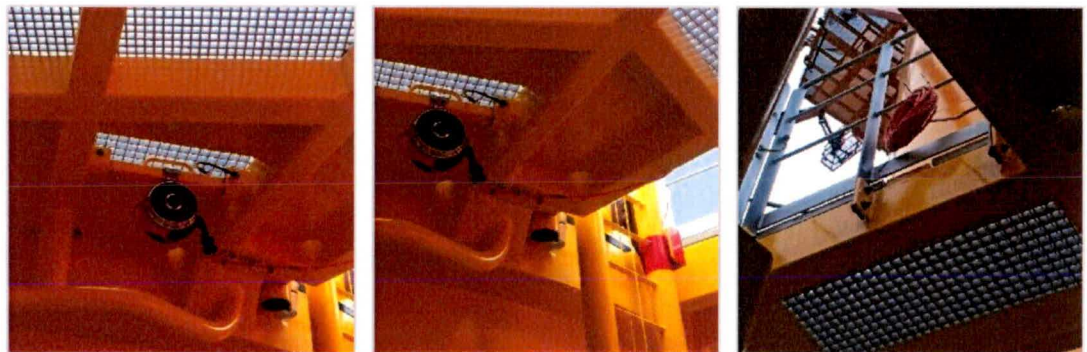
## 9 Fall arrest BL

TYPE 2 - 25m

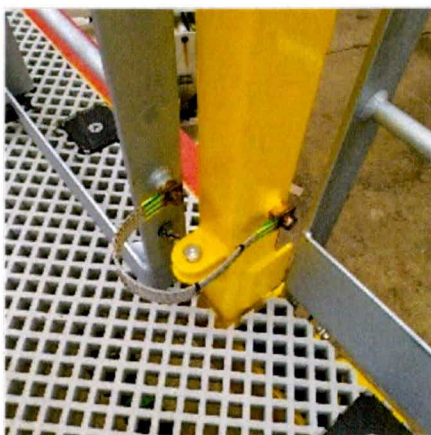
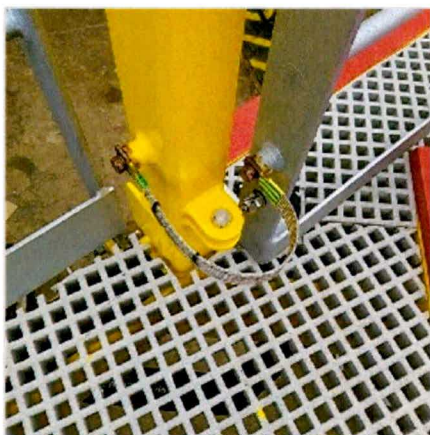
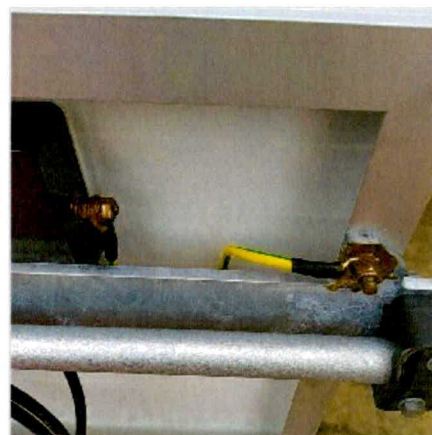
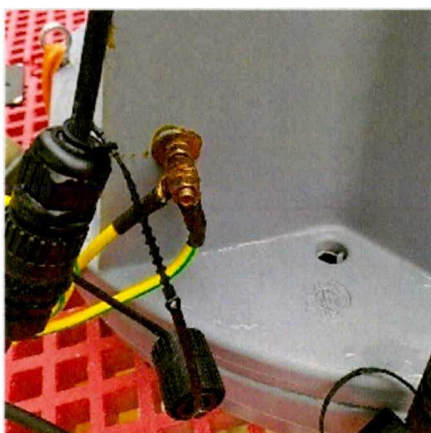
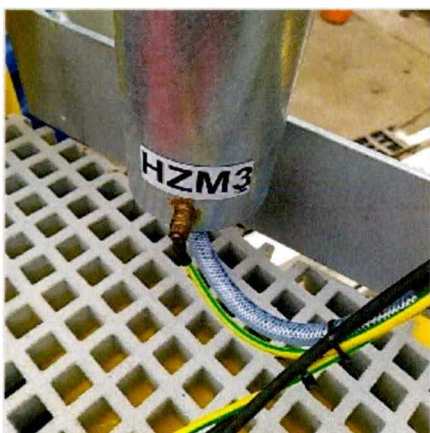
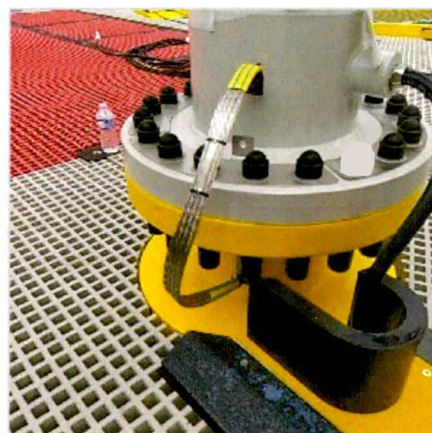
## 2.1 Earthing & bonding cables

Earthing & bonding cables correctly installed & adequately supported, free of damages, scotchkote applied on connections where needed  
Check shrink sleeve correctly applied and correct identification colour (Black for normal G/Y cable & G/Y for braided earth cables).  
Check cable termination lugs are correctly crimped and correct size according to cable cross section.

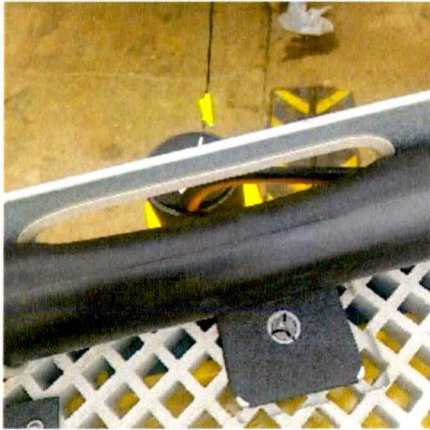
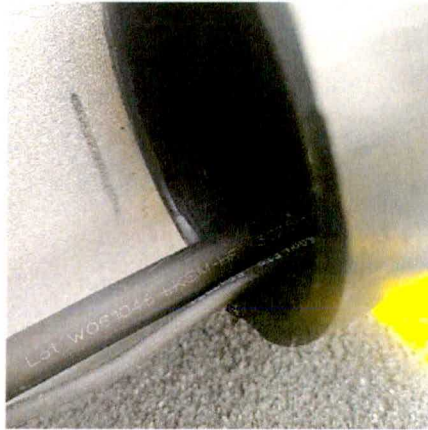
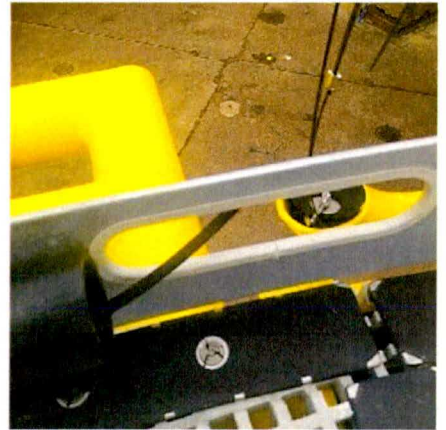
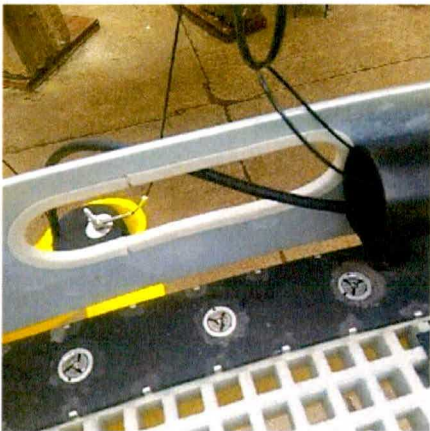
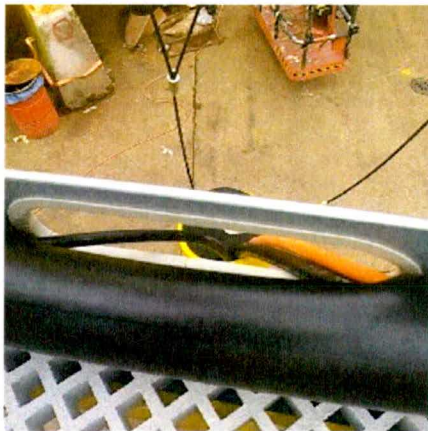
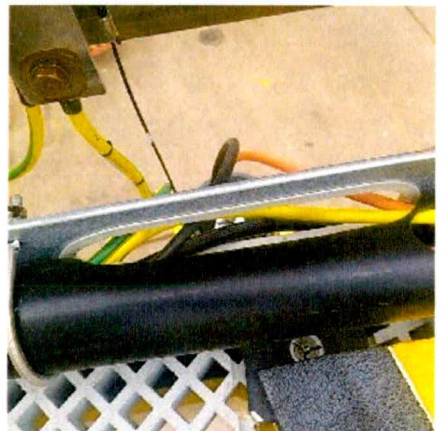
## 2.2 The path of cables are free of sharp edges

Status OK

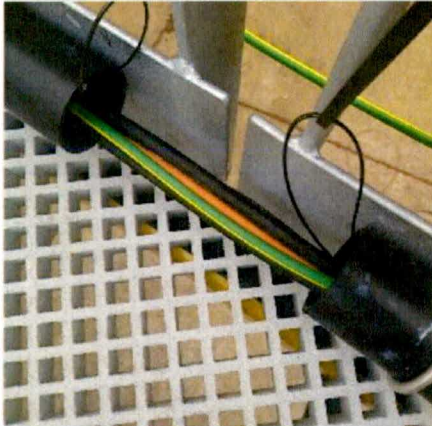
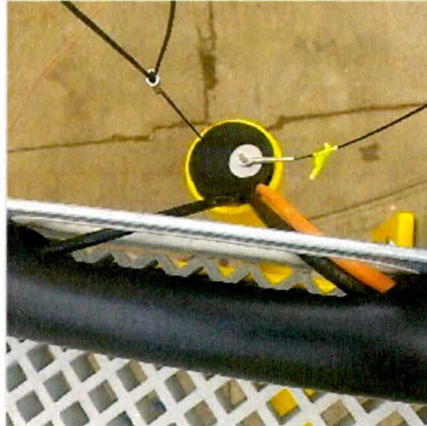
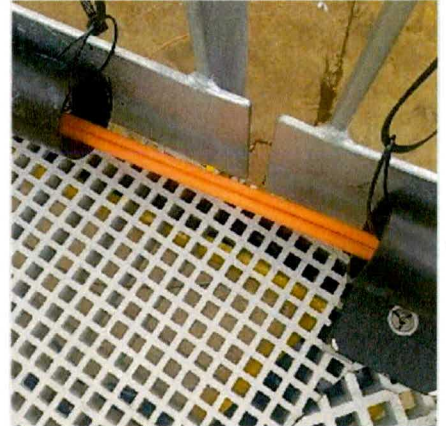
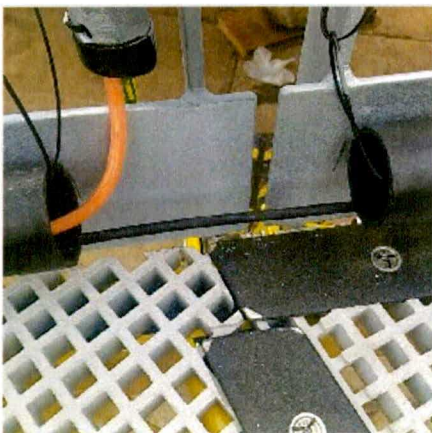
### 2.3 Power and signal cables

Correct selection of cable glands and routing / dressing of cables correct and free of damages. Cables are provided with ID labels

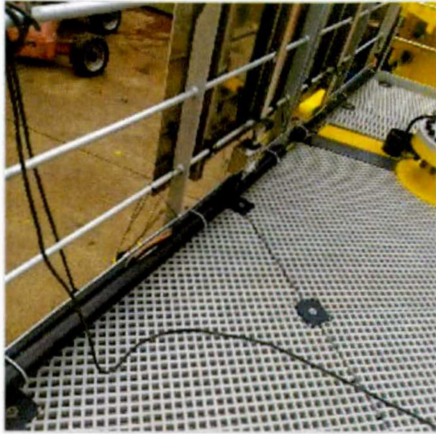
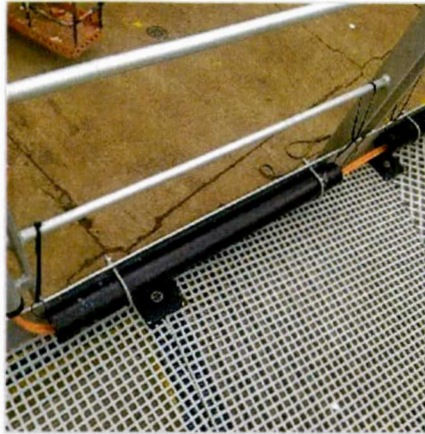
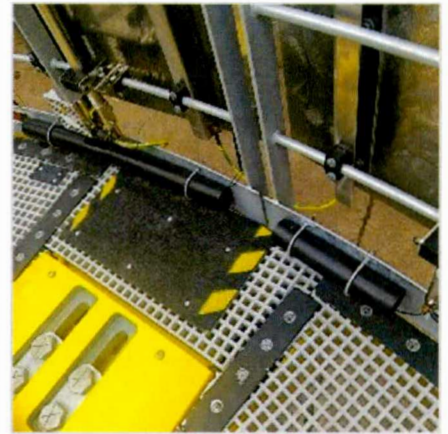
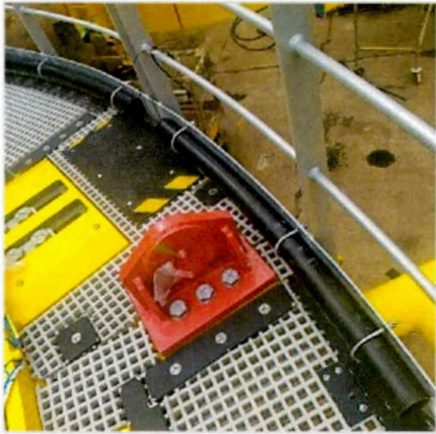
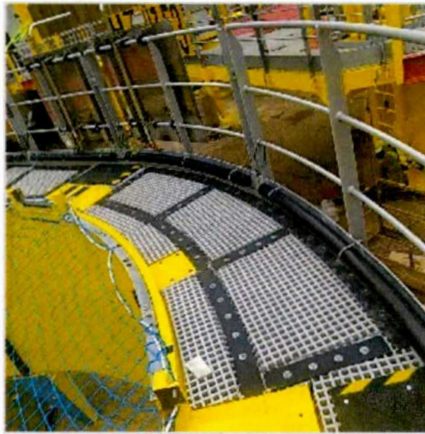
2.4 SS-Coated tie wraps are used

At the ends of cable pipes and every 300mm in cable trays (if applicable), maximum free span is respected.

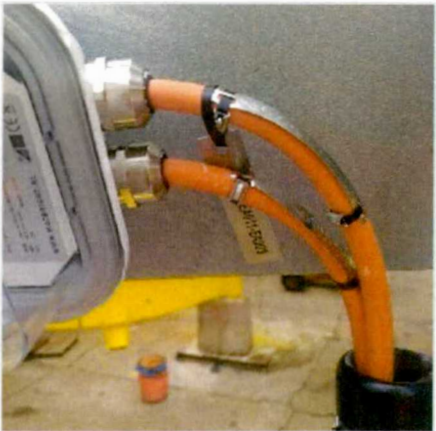
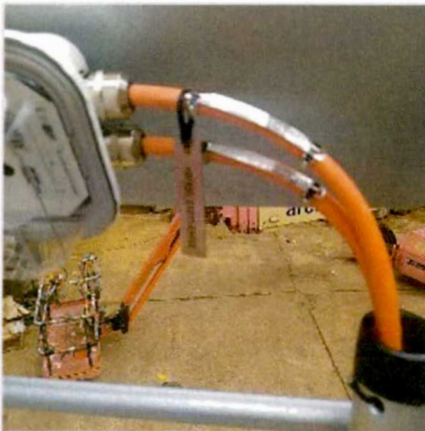
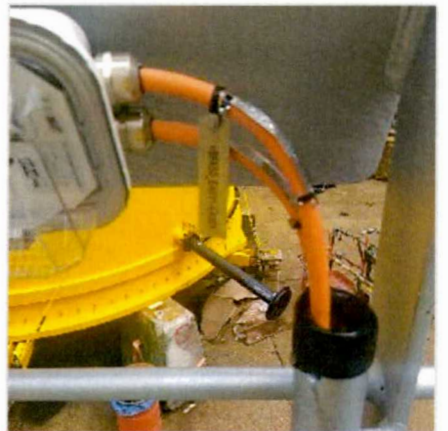
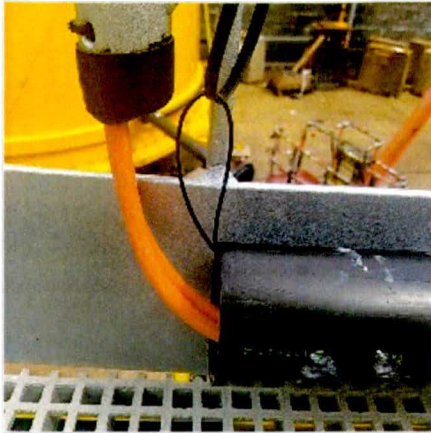
## 2.6 Bending radius on cables accepted & drip loops are present.

Status OK

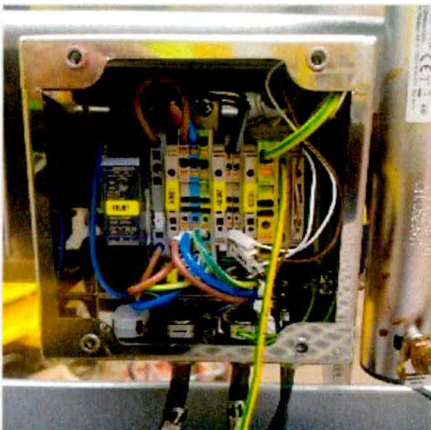
## 2.7 Cable terminations

Cable connections carry out correctly, conductor markers present (Conductors ID by markers or color code) & earthing lug is available and connected (PE) (if required).

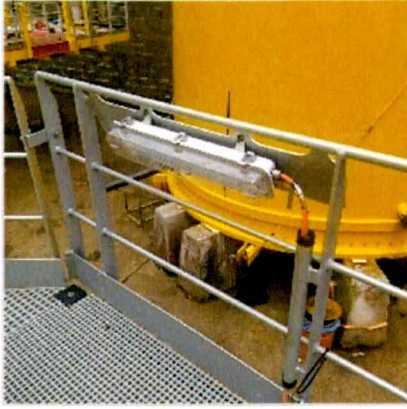
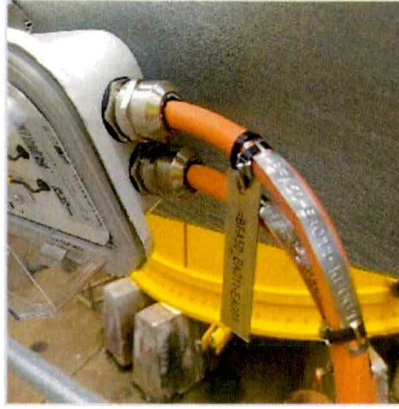
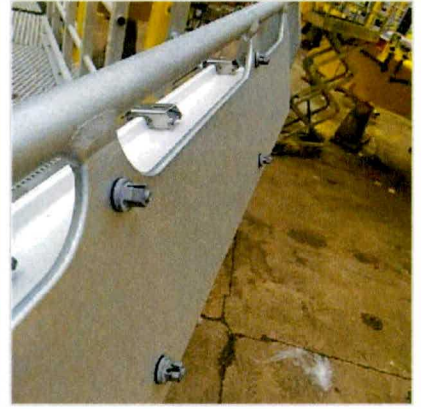
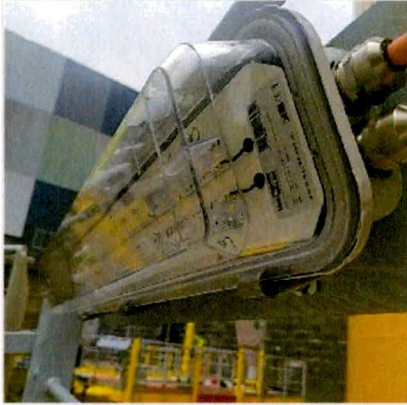
## 2.8 Normal Light Fixture 1 =BFA50\_EA011-EA001

Correctly installed & adequately supported, free of damages, connected and glands are tightened.  
RDS-PP labels are in place for equipment and cables, correct configuration off fixation bolt & washers are used and free of condensed water inside.

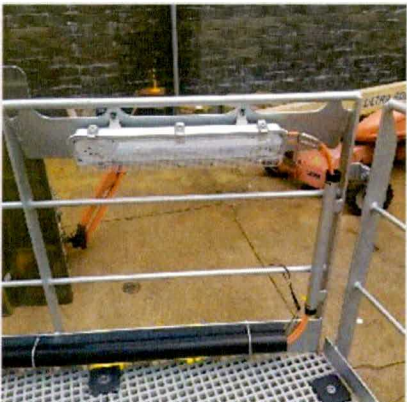
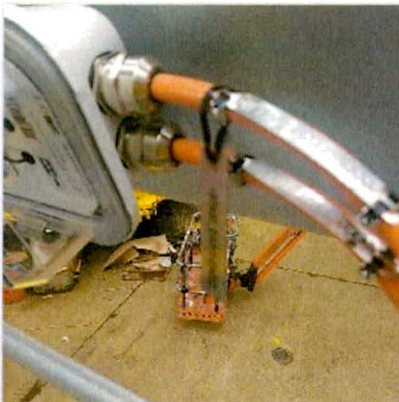
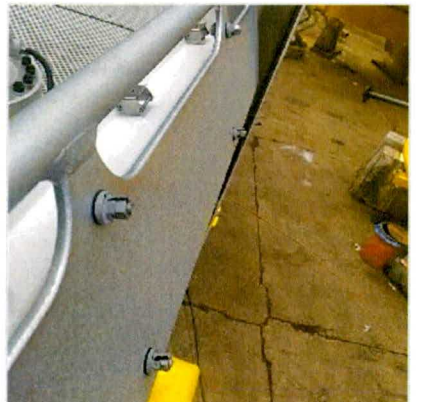
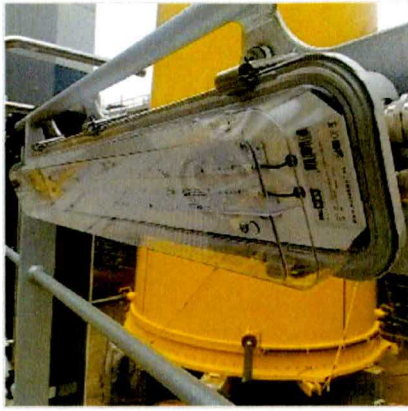
## 2.9 Normal Light Fixture 2 =BFA50\_EA011-EA002

Correctly installed & adequately supported, free of damages, connected and glands are tightened.  
RDS-PP labels are in place for equipment and cables, correct configuration off fixation bolt & washers are used and free of condensed water inside.

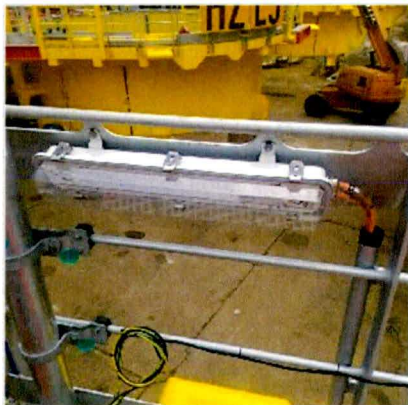
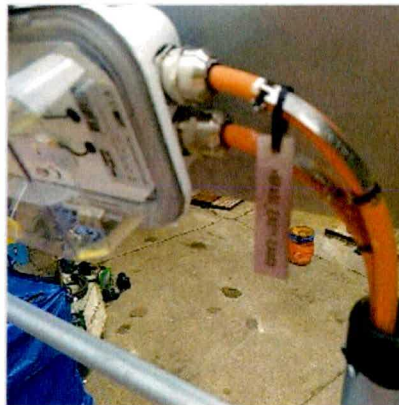
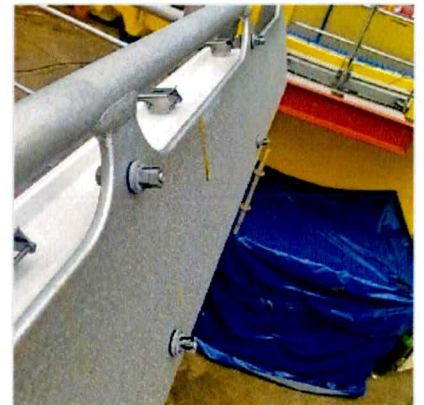
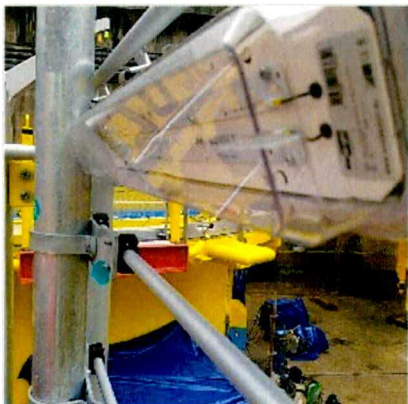
## 2.10 Normal Light Fixture 3 =BFA50\_EA011-EA003

Correctly installed & adequately supported, free of damages, connected and glands are tightened.  
RDS-PP labels are in place for equipment and cables, correct configuration off fixation bolt & washers are used and free of condensed water inside.

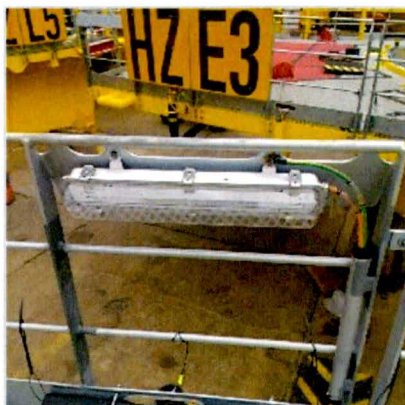
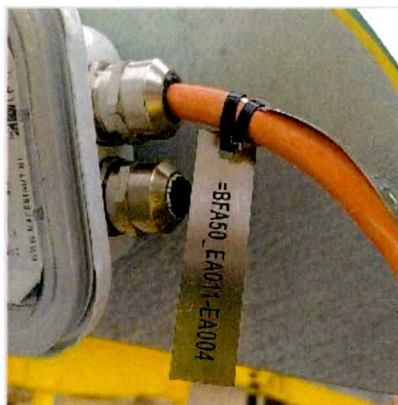
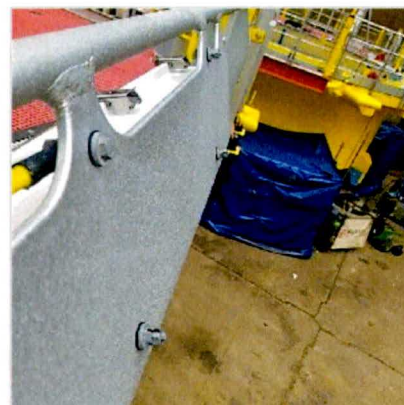
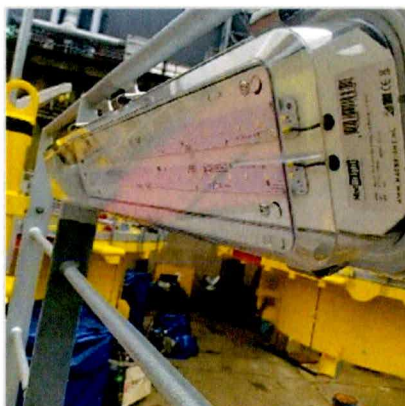
## 2.11 Normal Light Fixture 4 =BFA50\_EA011-EA004

Correctly installed & adequately supported, free of damages, connected and glands are tightened.

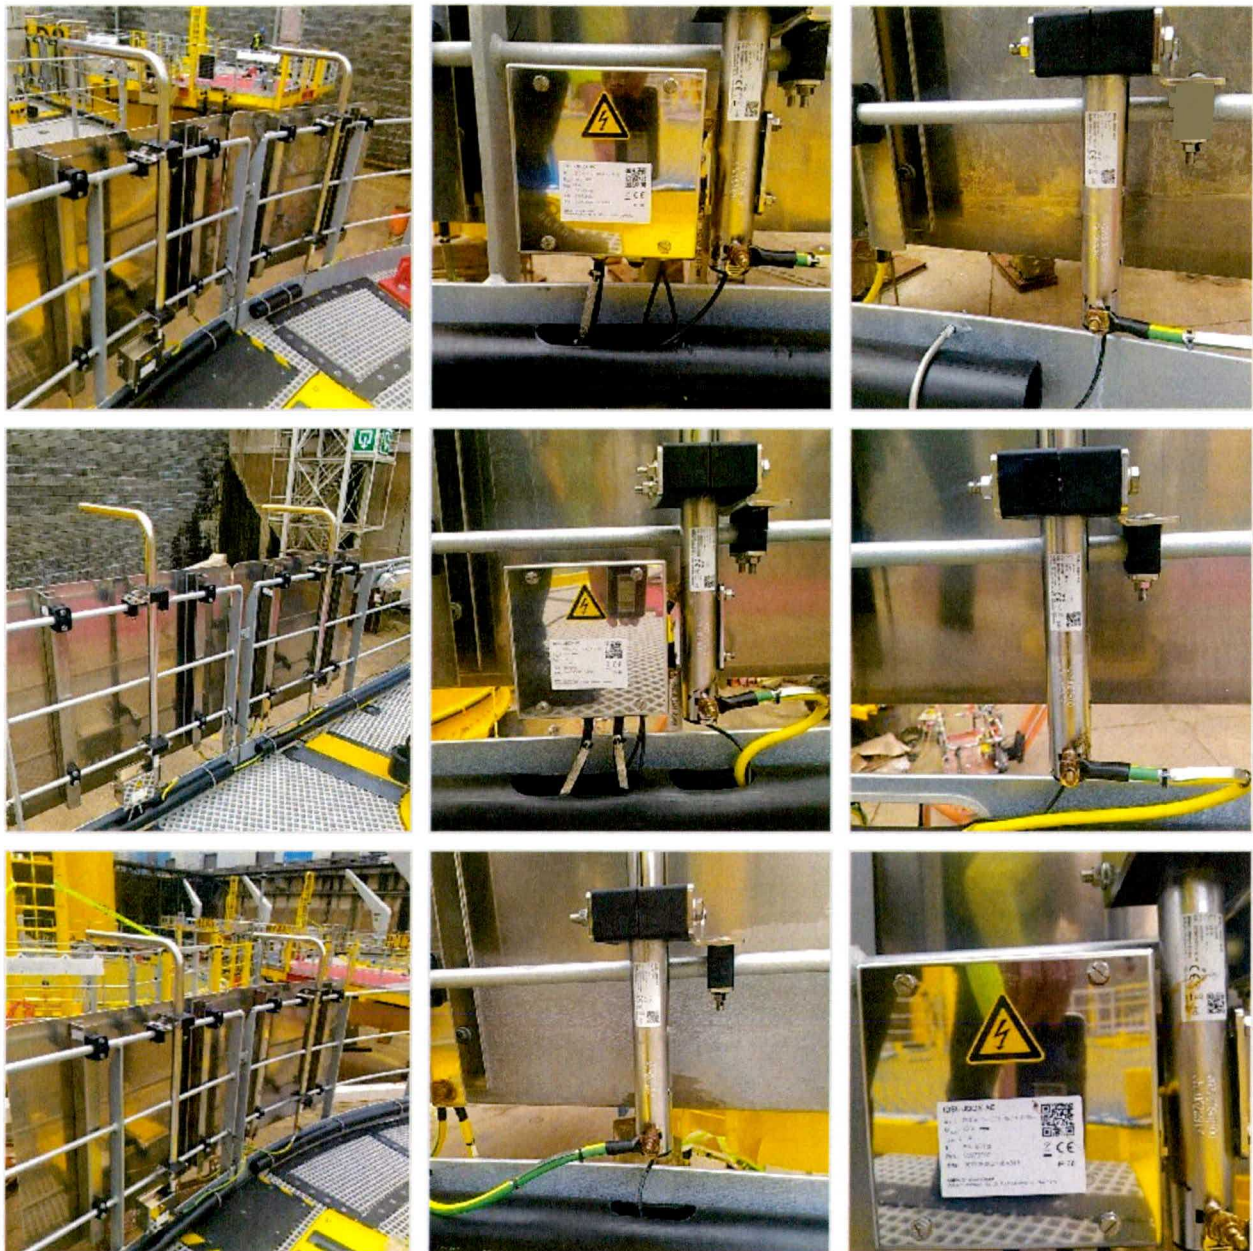
## .2 ID Lights incl. Junction box

Correctly installed & adequately supported, free of damages, connected, glands are tightened and RDS-PP labels are in place for equipment and cables.

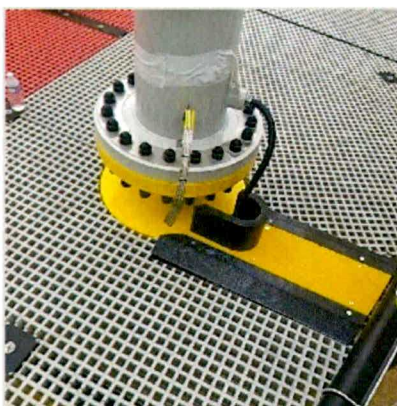
Remarks: RDS-PP label Davit Crane =XMM13
