| <b>SMULDERS</b> | <b>EWP G1</b><br>External work platform – FAT documentation | 25220<br>Hollandse Kust Zuid |

1. FAT mechanical
  - Final release note
  - Punch list
2. FAT electrical
  - Final release note
  - Punch list
3. FAT coating
  - Final release note
  - Punch list
4. Overview NCR's and TQ's

## Mechanical Release Note EWP Rev 2 #19

25220-GEN-RE05-XXX\_04 - EWP - Electrical Release Note Rev 4 #12

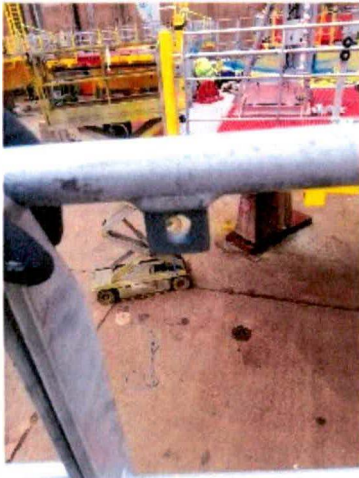
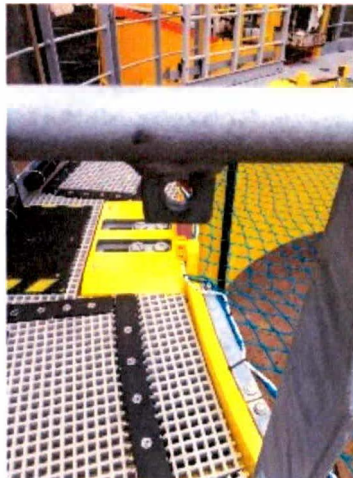
## ● #1403 - Coating missing

| Ben Herygers | Coating missing @TouchUp @ilchan_chanko #client | 26 Jun 08:26 |

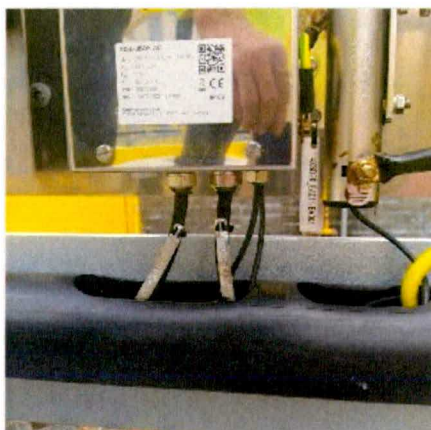
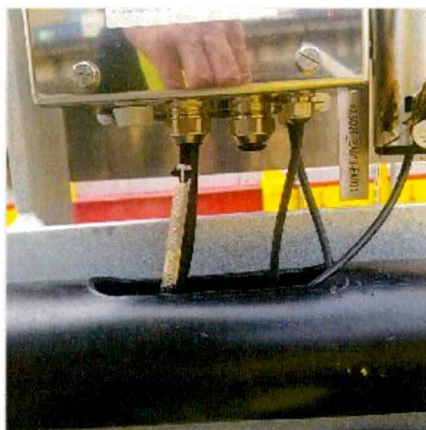
Check that no stress is applied to the equipment terminals or glands due to inadequate support of cables, and that cables enter glands straight.

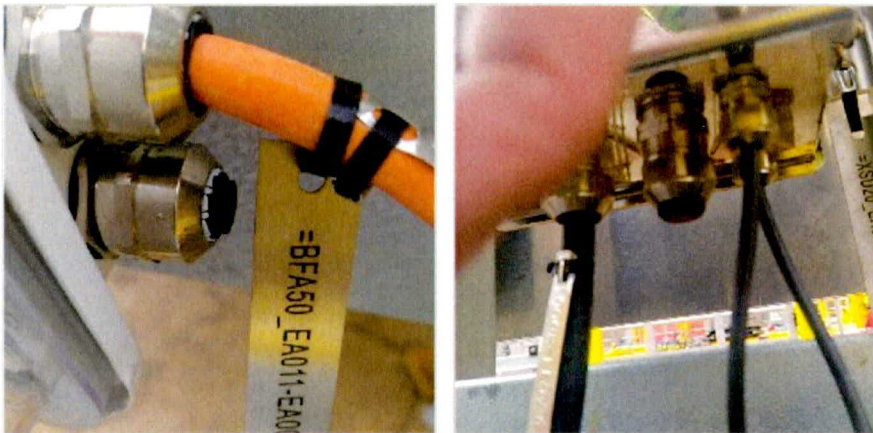
## 2.21 Blind plugs are used when glands are not in use.

Status OK

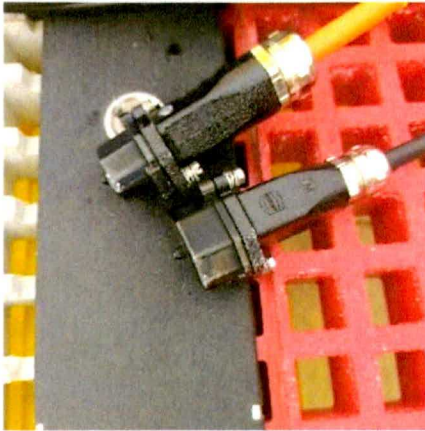
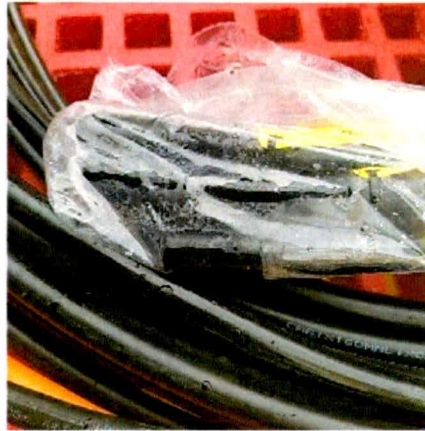
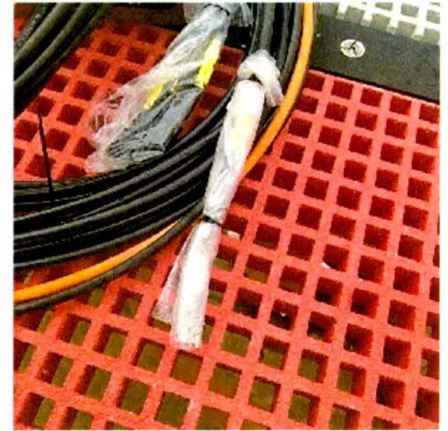
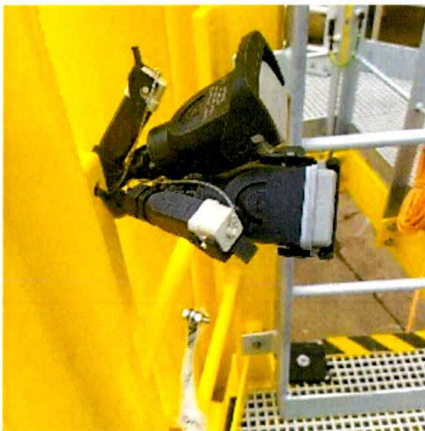
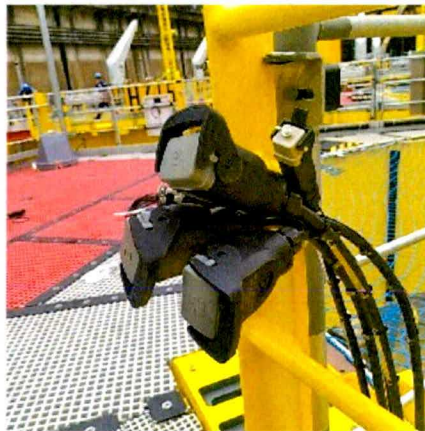
=XMM13\_MZ001-WD001: To be cut on length at MV II - to be checked in hoboken if cable is long enough ( Roxtec: 2,5m -2,7m / WTG: min 3,8m)

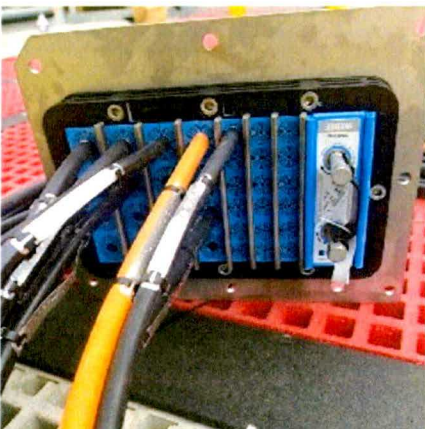
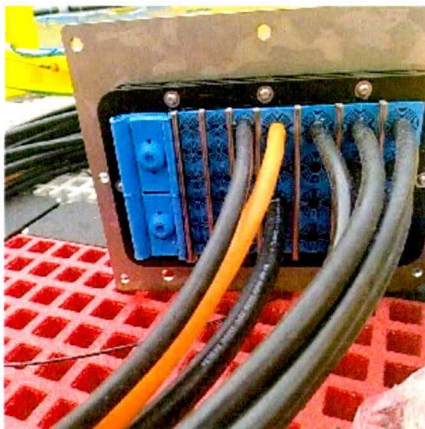
## 24 All interface cables pulled through roxtec and roxtec is correctly sealed

Status OK

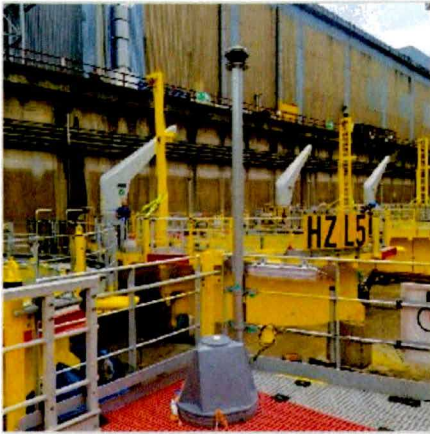
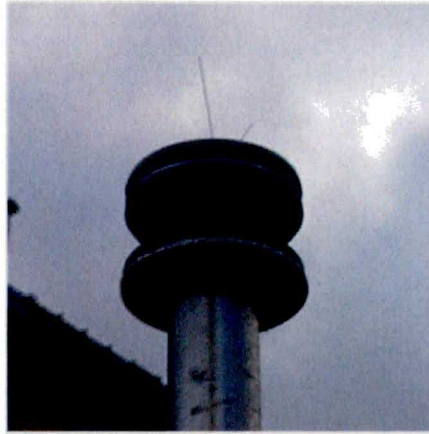
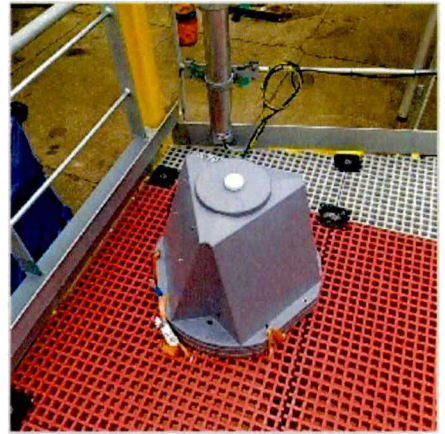
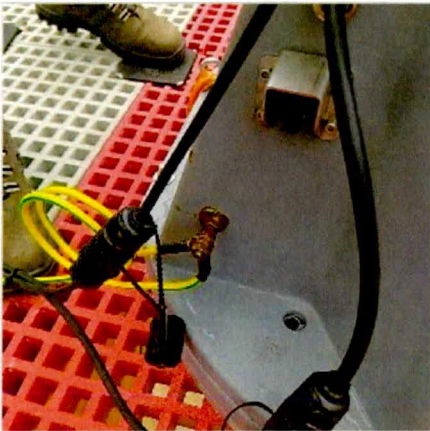
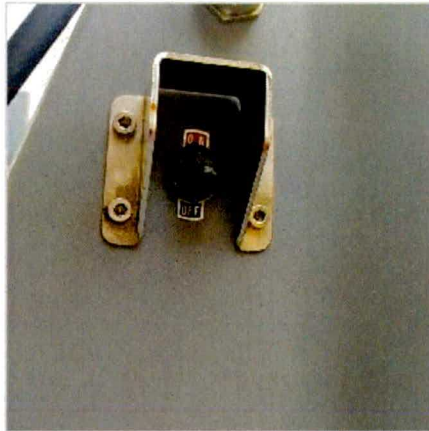
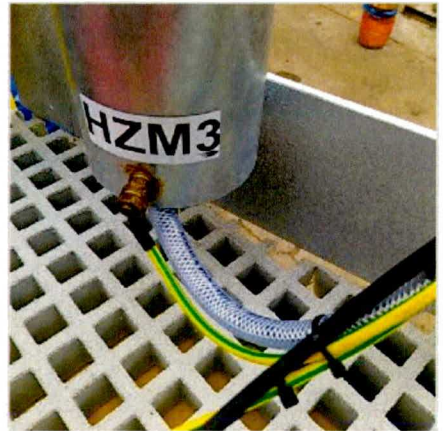
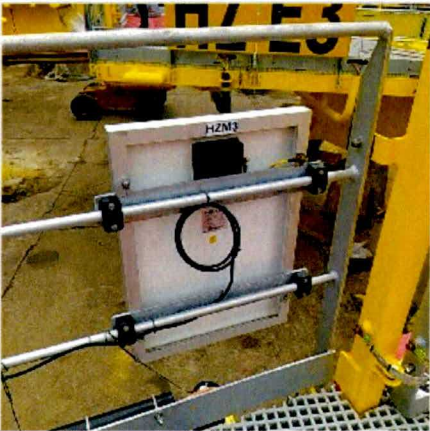
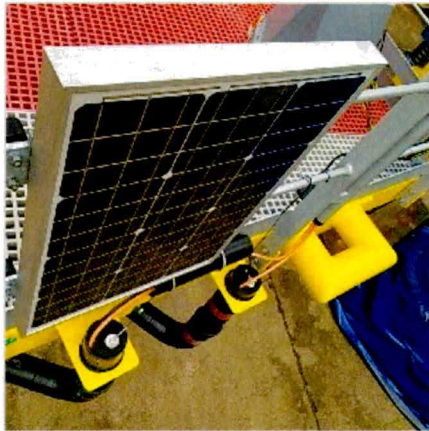
## 2.25 Temporary Navigation Aids present, seafastened & earthed

Status OK

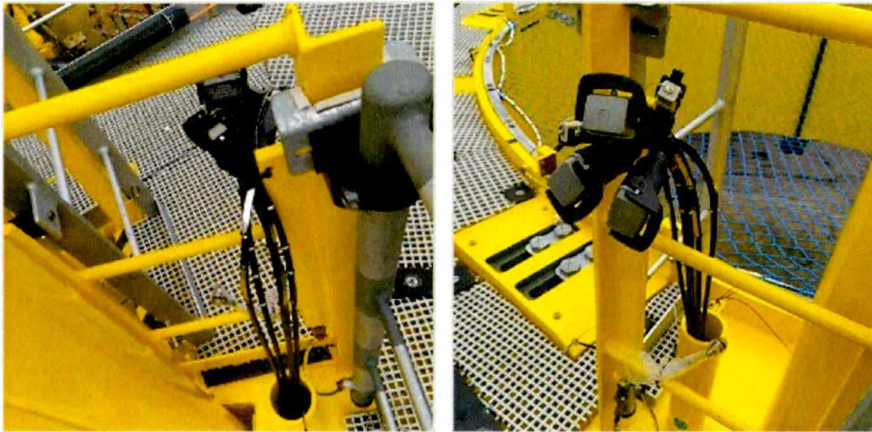
## 2.26 Storage of ICCP cables nearby BL

All cables are correctly stored with S-hook and over-length applied on ICCP cables on ICCP protection box side, cable ends sealed with plastic bag or Harting cover.

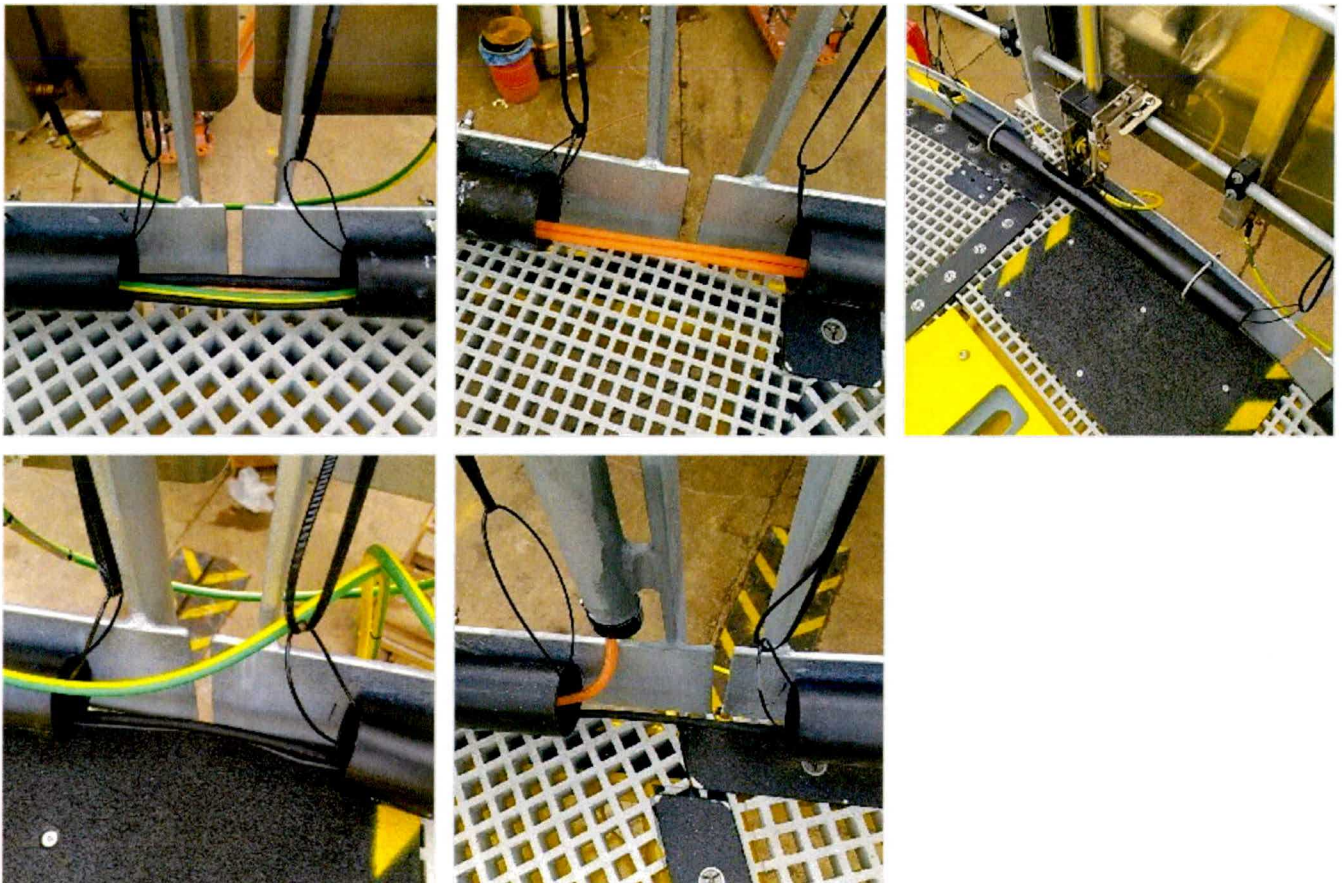
## 27 Messenger wire

On all cable tubes longer than 0,5m is a messenger wire installed according to the drawing 25220-1921-01-E\_02=55-EWP-AssemblyOverview-Cable Containment.
