| | <b>EWP M3</b><br>External work platform – FAT documentation | 25220<br>Hollandse Kust Zuid |

**Mechanical Release Note EWP Rev 2 #15**

**Final Checklist Mechanical**

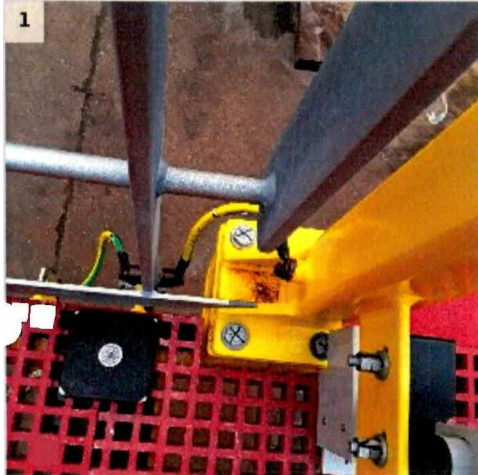
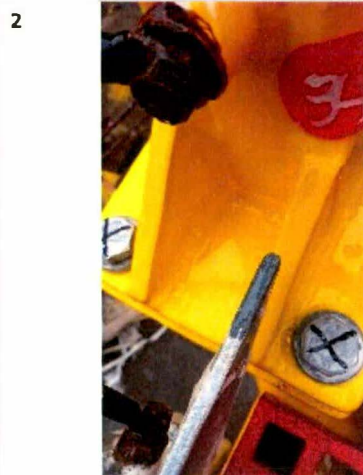
● **#1231 - Fly rust on the post**

Fly rust on the post @ilchan\_chanko #client @TouchUp

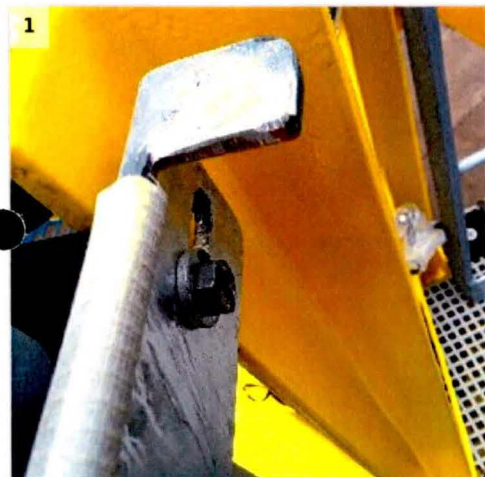
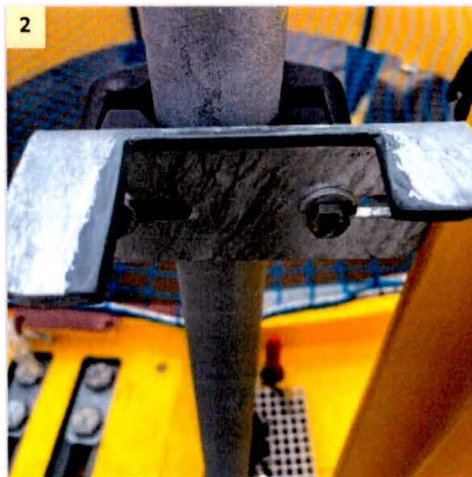
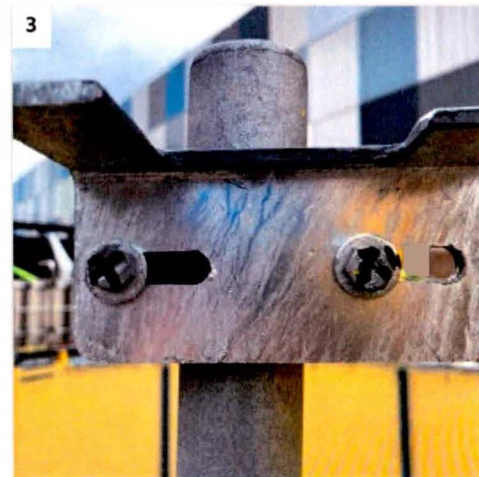
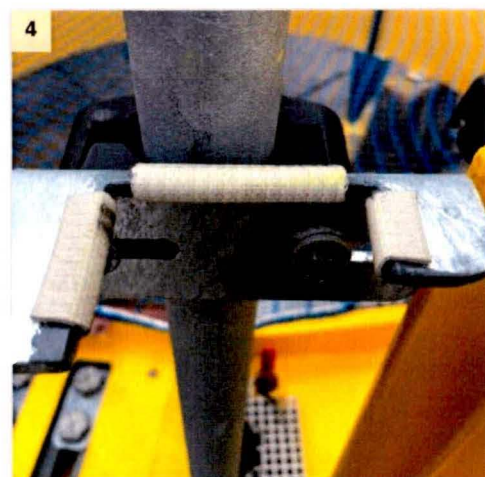
## ● #1370 - Paint missing and put some glue on the rubber

| Ben Herygers | Paint missing and put some glue on the rubber @Mechanical @kevin_kemps @ilchan_chanko #client | 24 jun 13:32 |

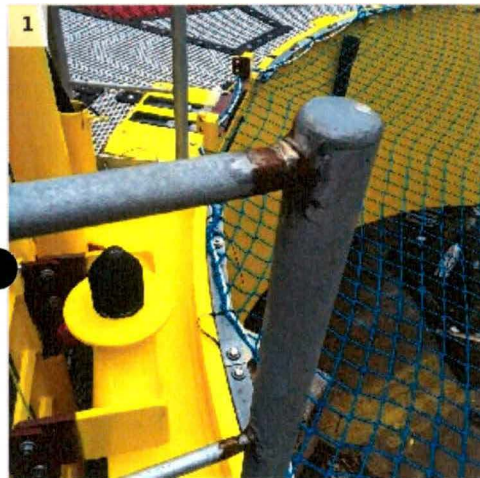
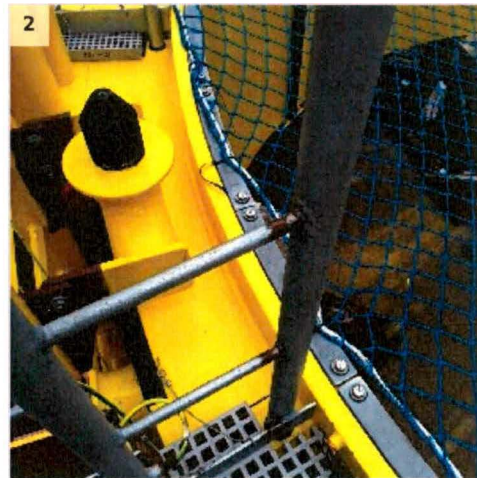
### #1226 - Wrong weld used. Stainless steel??

| Ben Herygers | Wrong weld used. Stainless steel?? @Mechanical @kevin_kems #client | 19 jun 09:46 |
| Marcin Witkowski | Info Kevin NCR while being made | 23 jun 09:55 |

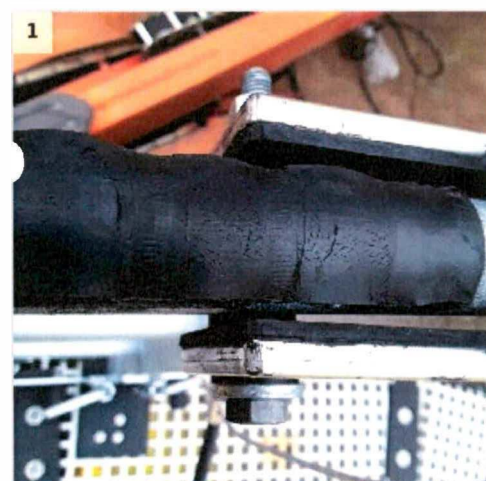
### #1229 - Needs to be adjusted

| Kevin Kempes | 3 mm installad according drawing | 21 jun 13:52 |

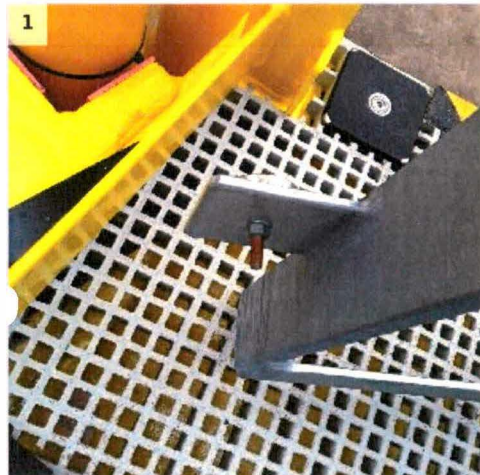
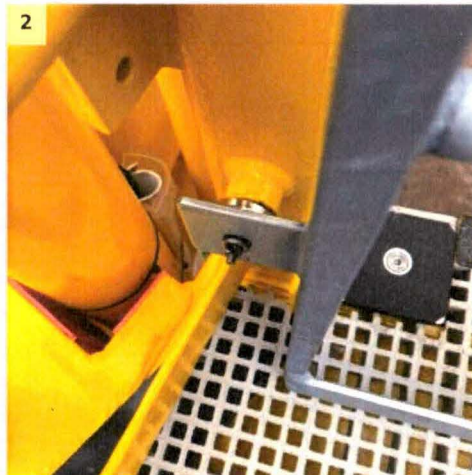
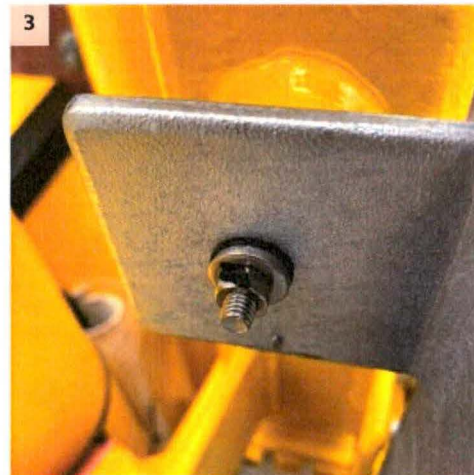
### #1220 - Put new bolt. Start already rusty

| Ben Herygers | Put new bolt. Start already rusty @Mechanical @kevin_kemps #client | 19 jun 09:37 |

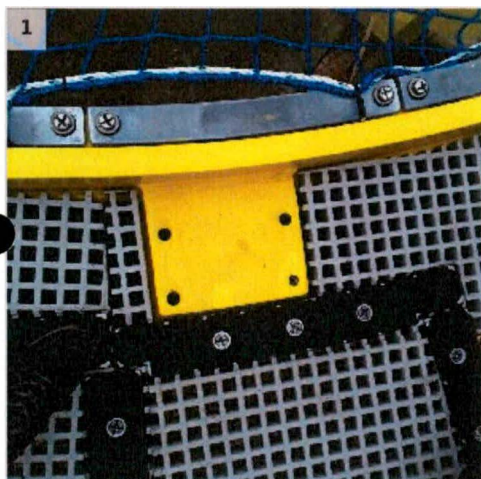
● #1222 - Missing plastic cap

Ben Herygers Photo 1  
Ben Herygers Missing plastic cap @Mechanical @kevin\_kemps #client

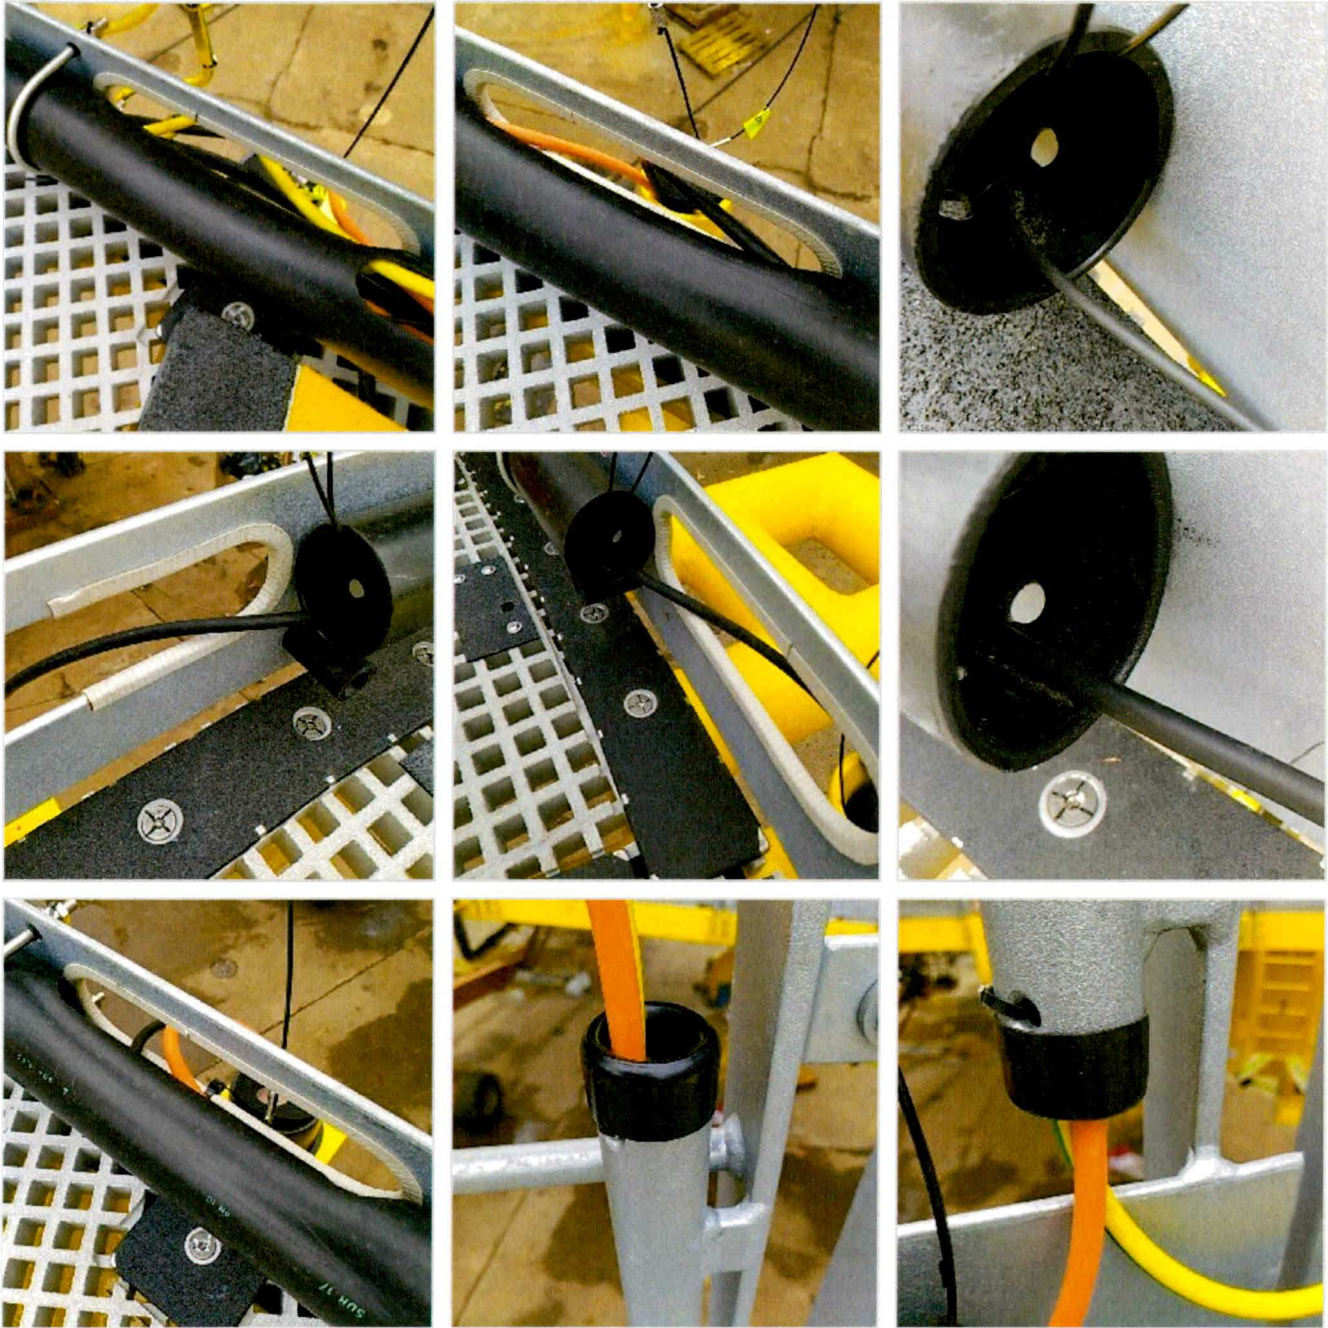
2.2 The path of cables are free of sharp edges

Status OK

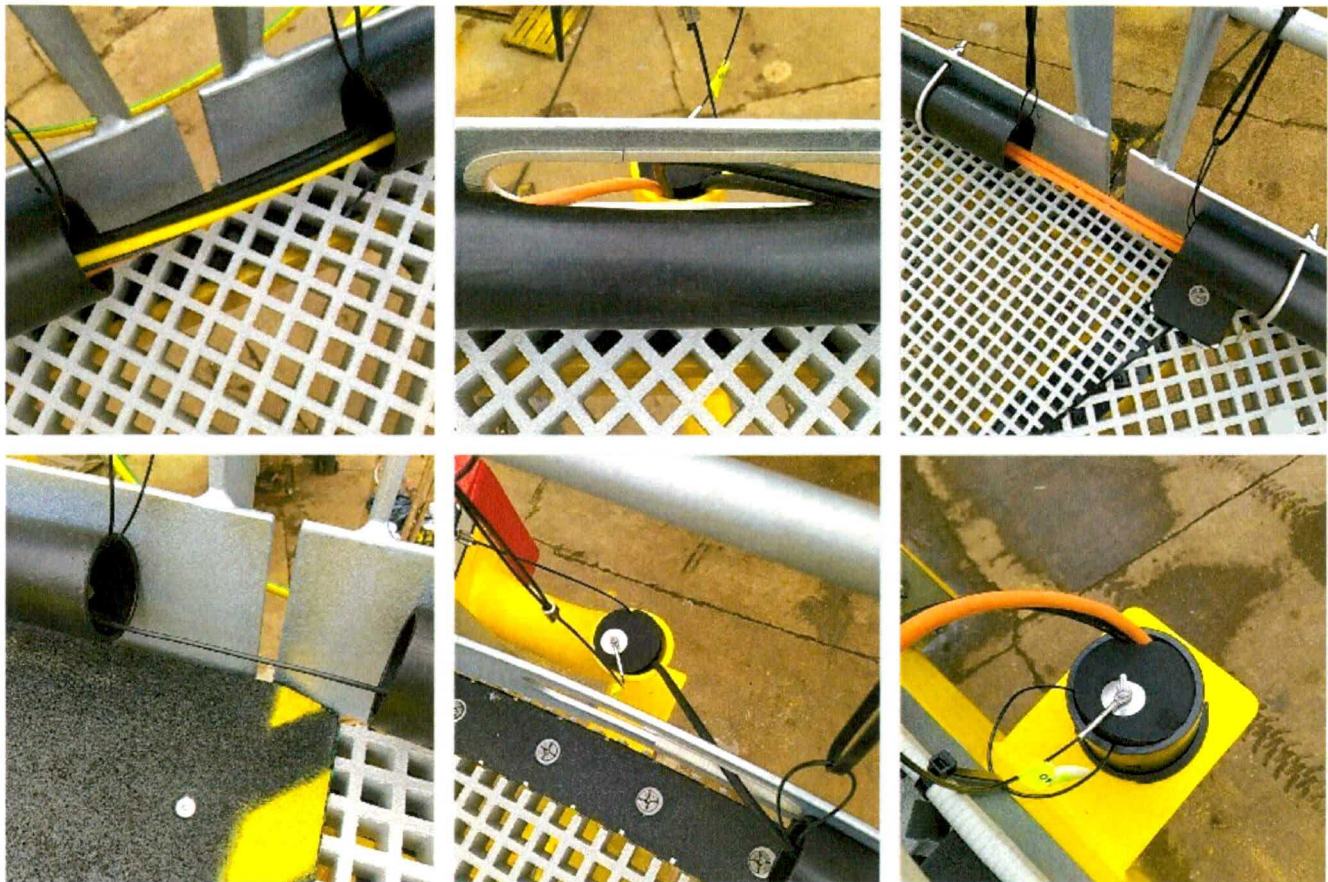
2.3 Power and signal cables

Doc. Nr. 25220-CBL-PR00\_01\_LvCables-ITP  
Correct selection of cable glands and routing / dressing of cables correct and free of damages. Cables are provided with ID labels  
All cable tests and visual inspection of the cable are recorded in the following protocols:  
25220-CBL-RE05-(xxx)\_01\_LvCablesInsulationTest-SatReport-EWP  
25220-CBL-RE08-(xxx)\_01\_LvCablesContinuityTest-SatReport-EWP

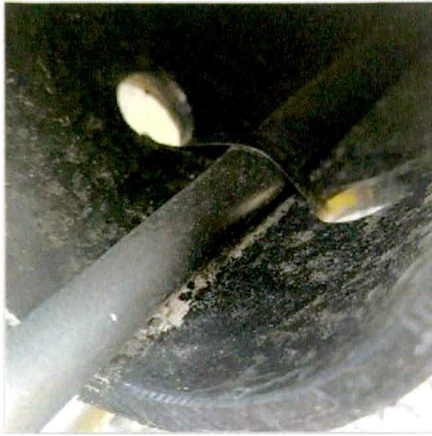
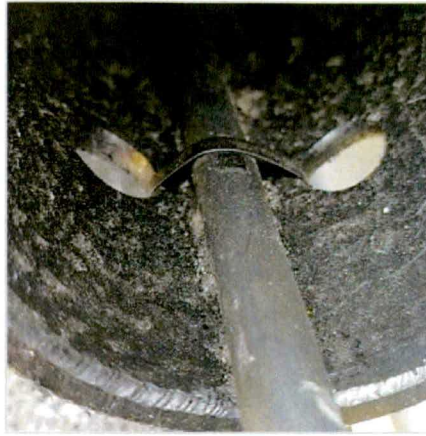
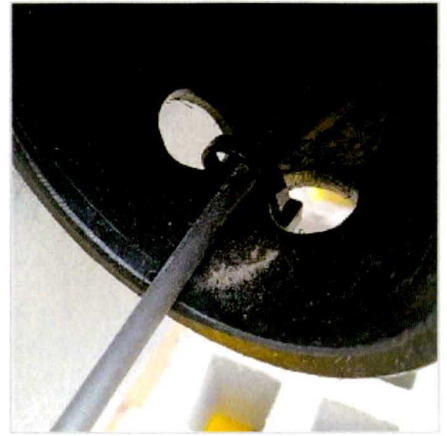
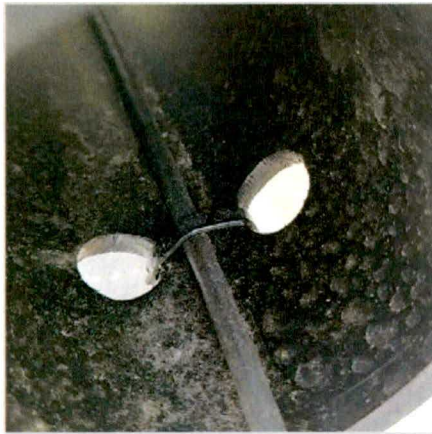
2.4 SS-Coated tie wraps are used

At the ends of cable pipes and every 300mm in cable trays (if applicable), maximum free span is respected.

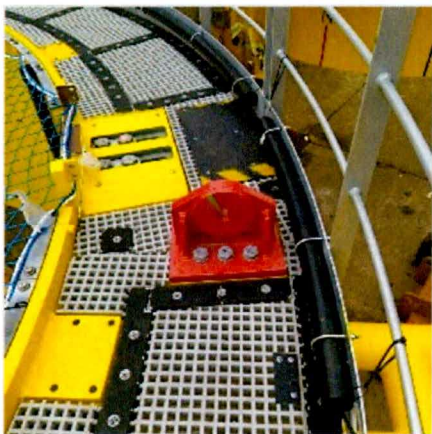
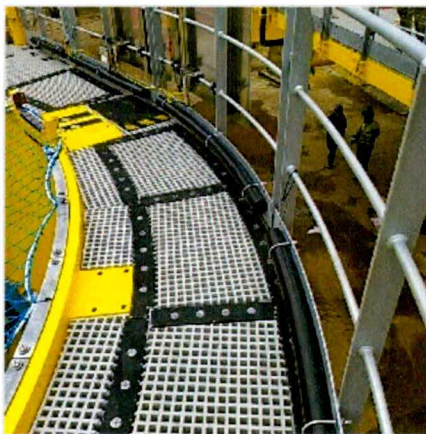
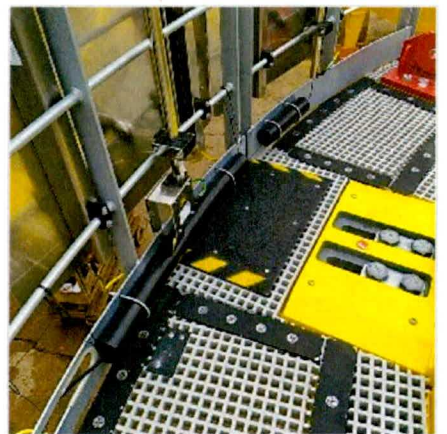
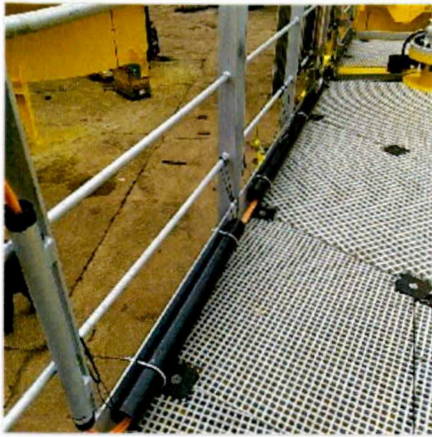
## 2.5 Cable trays & pipe's correctly installed & adequately supported

Edge protection applied if required

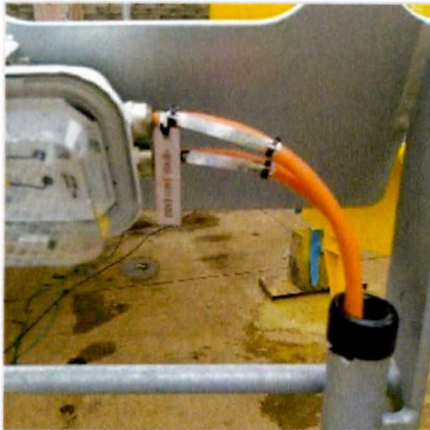
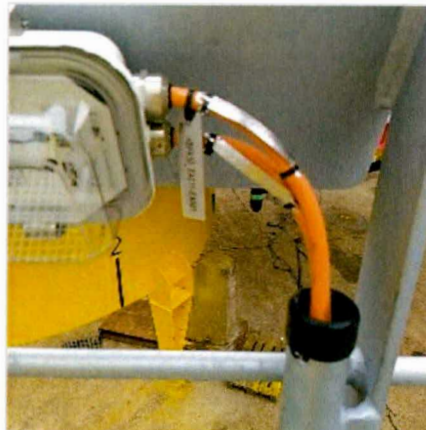
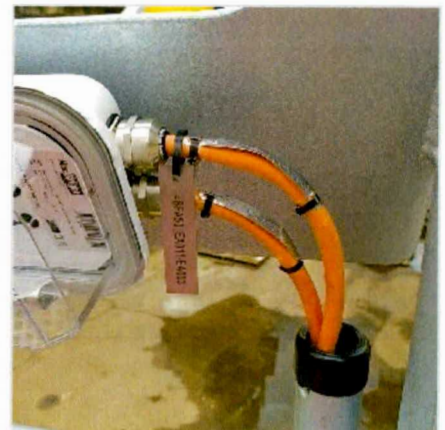
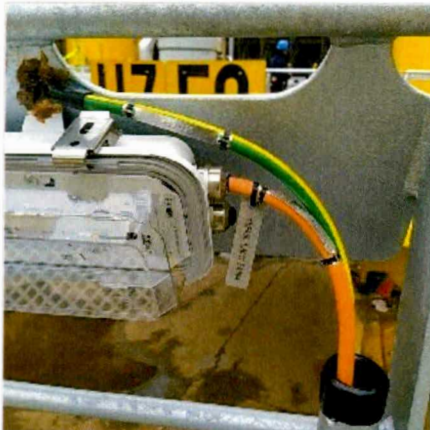
## 2.6 Bending radius on cables accepted & drip loops are present.

Status OK

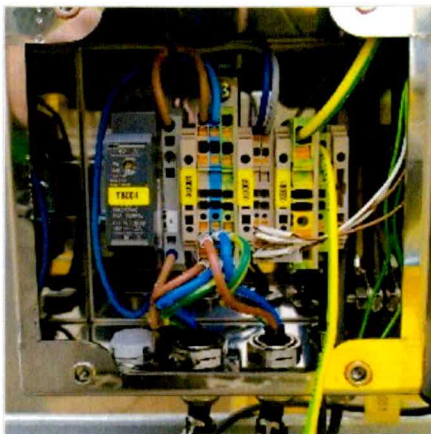
## 2.7 Cable terminations

Cable connections carry out correctly, conductor markers present (Conductors ID by markers or color code) & earthing lug is available and connected (PE) (if required).

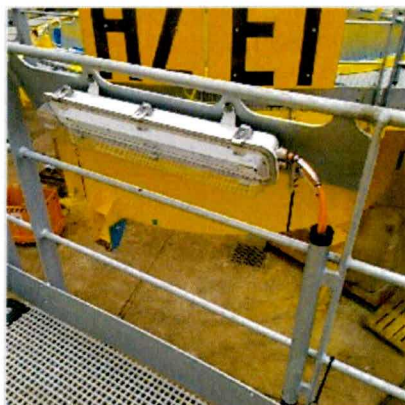
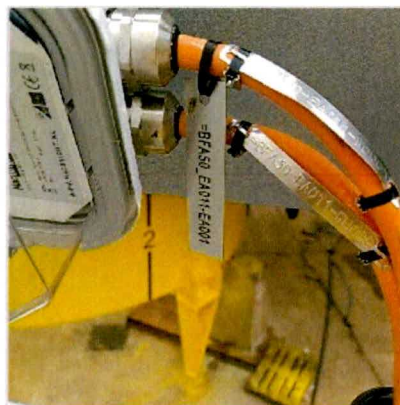
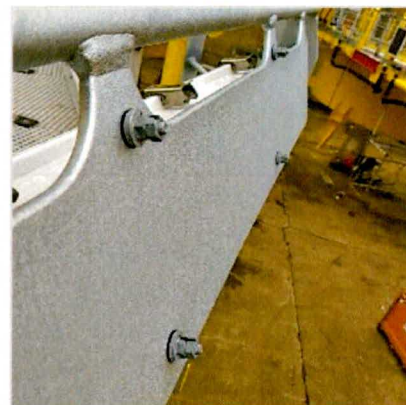
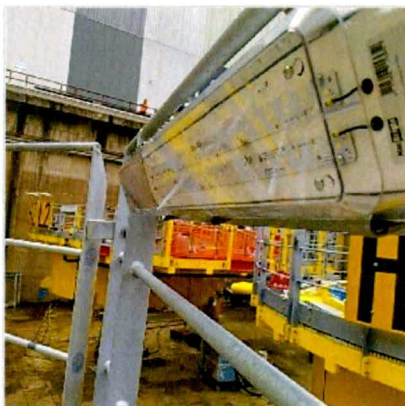
## 2.8 Normal Light Fixture 1 =BFA50\_EA011-EA001

Correctly installed & adequately supported, free of damages, connected and glands are tightened.  
RDS-PP labels are in place for equipment and cables, correct configuration off fixation bolt & washers are used and free of condensed water inside.

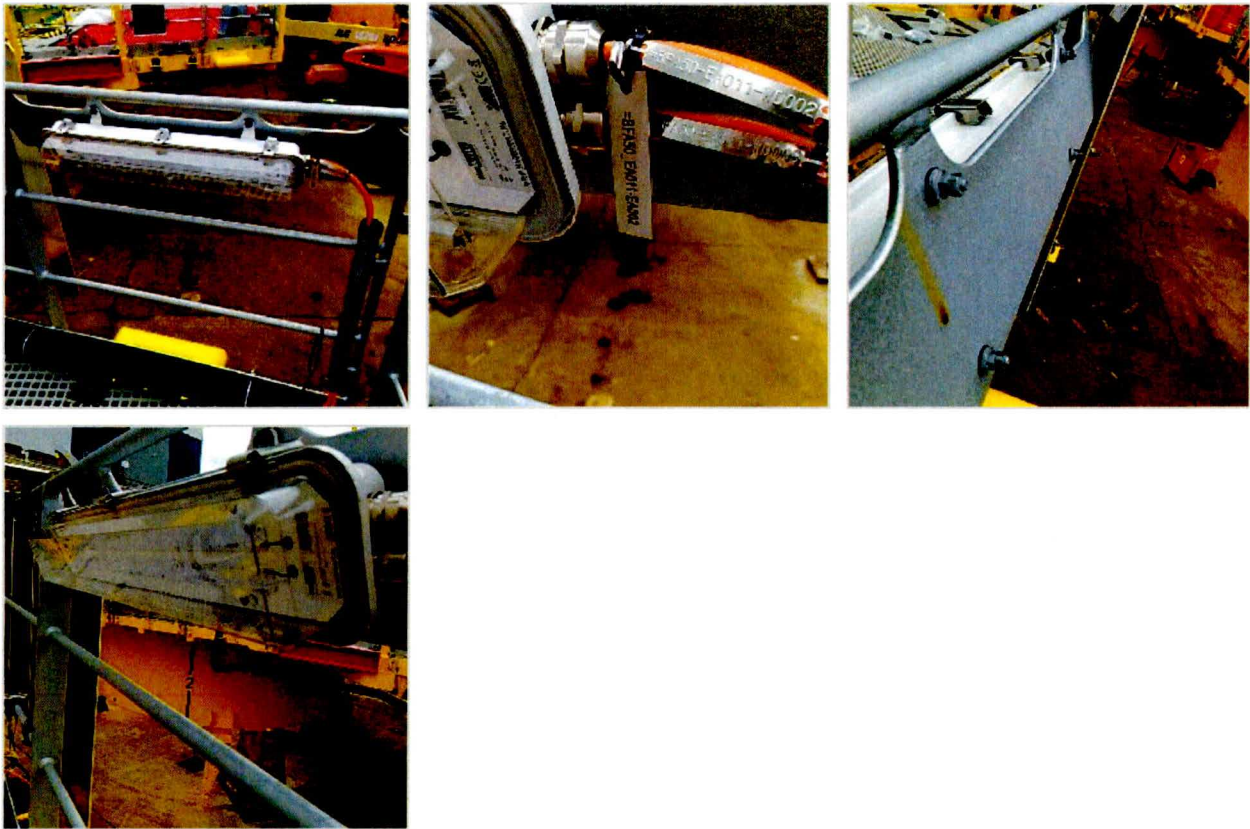
2.9 Normal Light Fixture 2 =BFA50\_EA011-EA002

Correctly installed & adequately supported, free of damages, connected and glands are tightened.  
RDS-PP labels are in place for equipment and cables, correct configuration off fixation bolt & washers are used and free of condensed water inside.

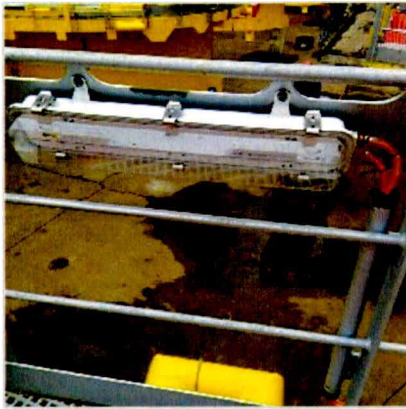
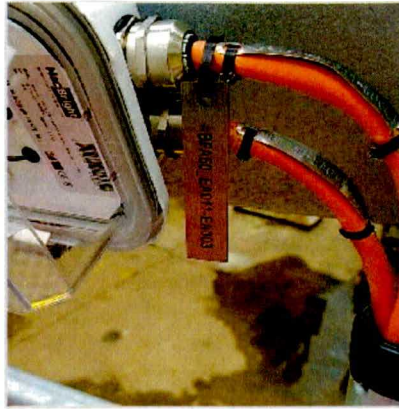
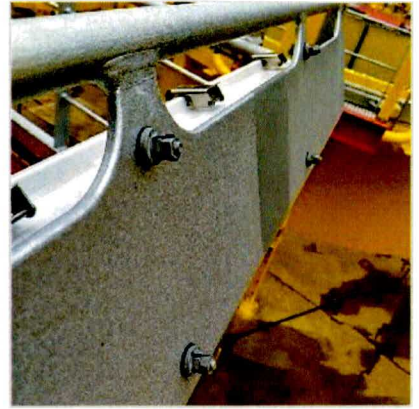
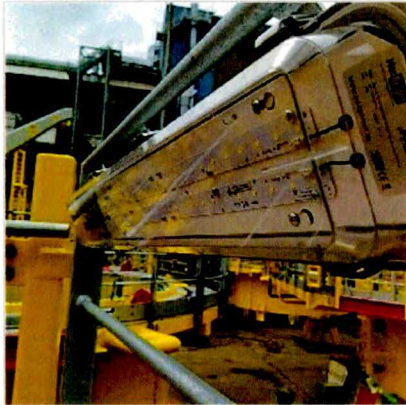
2.10 Normal Light Fixture 3 =BFA50\_EA011-EA003

Correctly installed & adequately supported, free of damages, connected and glands are tightened.  
RDS-PP labels are in place for equipment and cables, correct configuration off fixation bolt & washers are used and free of condensed water inside.

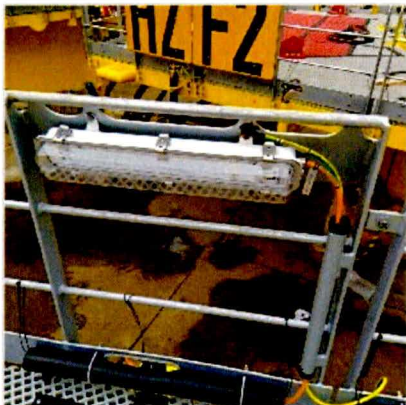
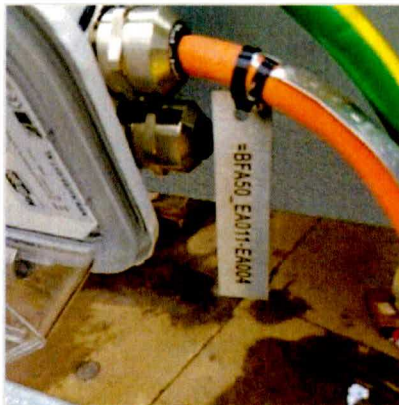
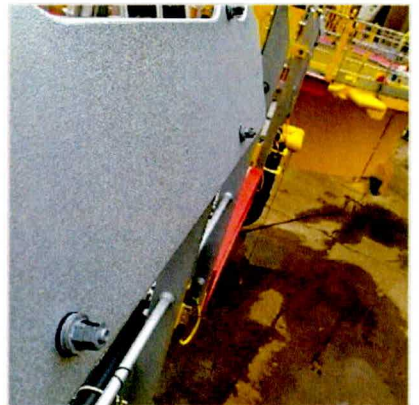
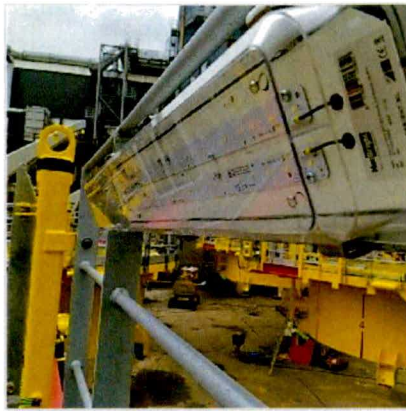
## 2.11 Normal Light Fixture 4 =BFA50\_EA011-EA004

Correctly installed & adequately supported, free of damages, connected and glands are tightened.  
RDS-PP labels are in place for equipment and cables, correct configuration off fixation bolt & washers are used and free of condensed water inside.

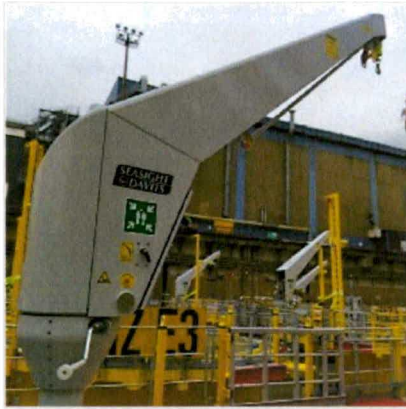
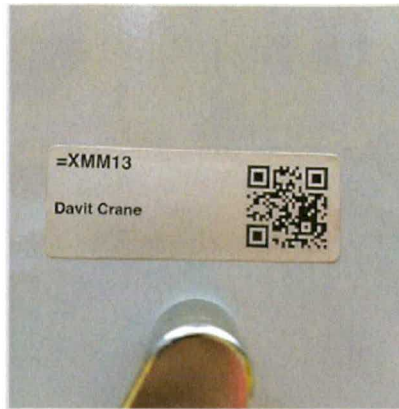
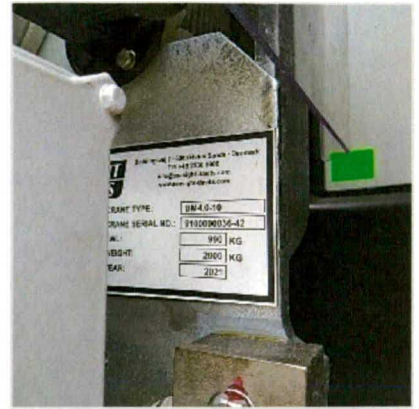
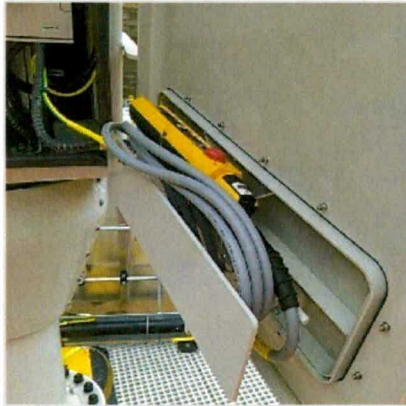
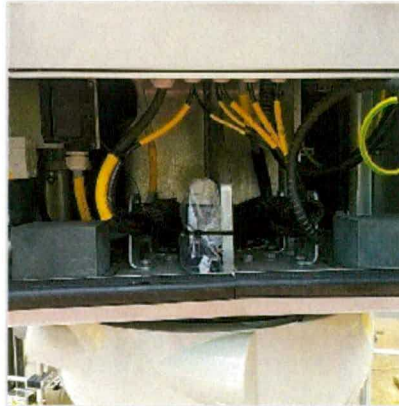
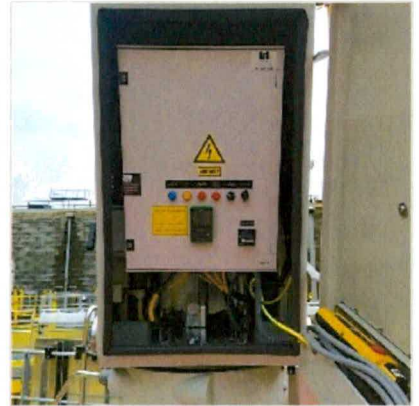
Remarks: RDS-PP label Davit Crane =XMM13

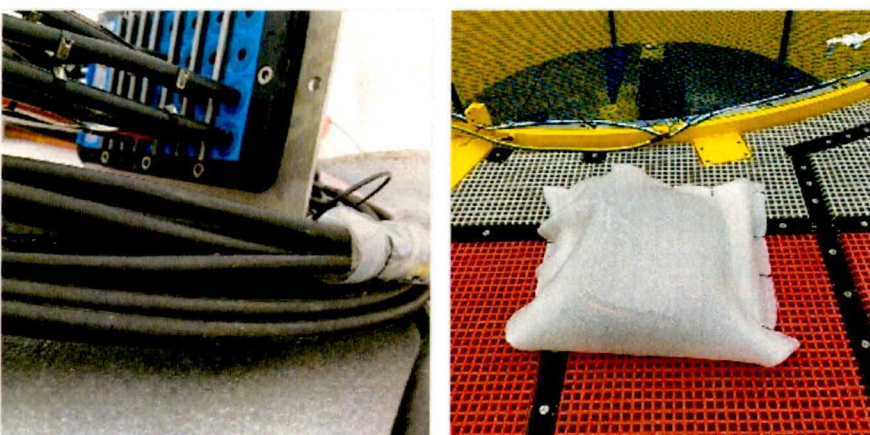
## 2.22 Over-length applied on cables where applicable and stored correctly

=XMM13\_MZ001-WD001: To be cut on length at MV II - to be checked in hoboken if cable is long enough ( Roxtec: 2,5m -2,7m / WTG: min 3,8m)

Remarks: TQ 4126 regarding storage is pending.

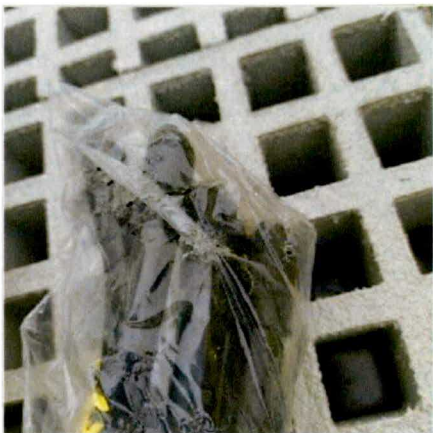
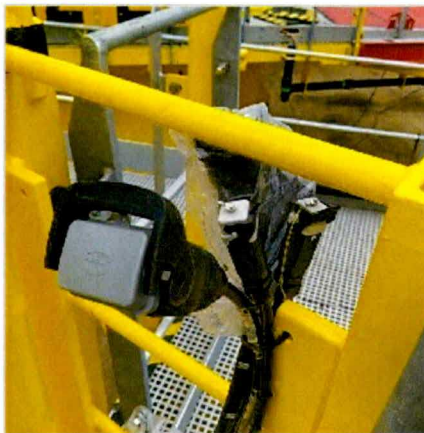
## 2.23 All interface cables are sealed with end caps or sealed with Harting cover

=XMM13\_MZ001-WD001: Harting plug will be installed at MV II by Crane Supplier, end cap to be installed in Hoboken

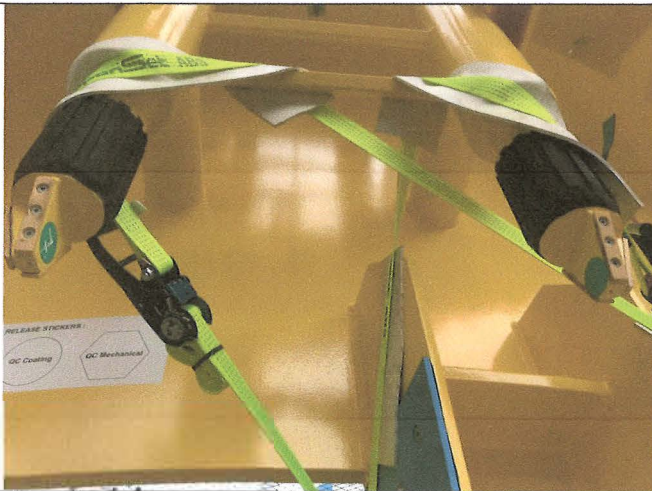
No. 7 – B. L. upper ladder, bolt holes must be sealed and top coated.

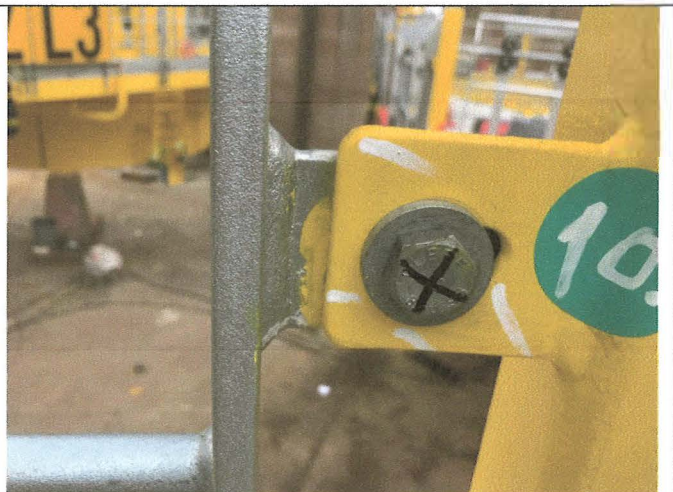
No. 10 – Pour workmanship, topcoat shall be removed from HDG handrail, additional layer of topcoat required on bracket.
