| <b>SMULDERS</b> | <b>EWP M3</b><br>External work platform – FAT documentation | 25220<br>Hollandse Kust Zuid |

**Mechanical Release Note EWP Rev 2 #15**

## Punchlist mechanical

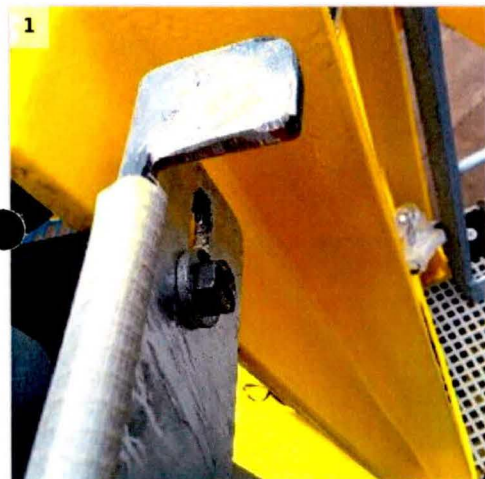
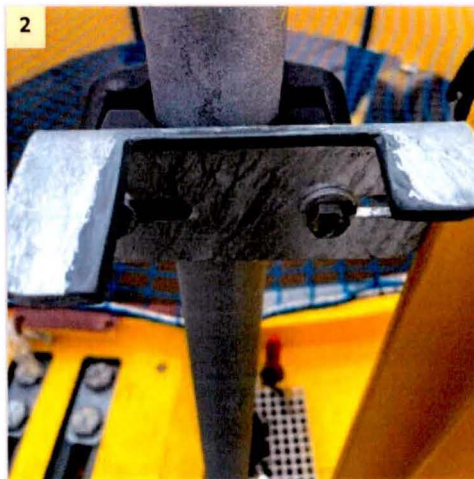
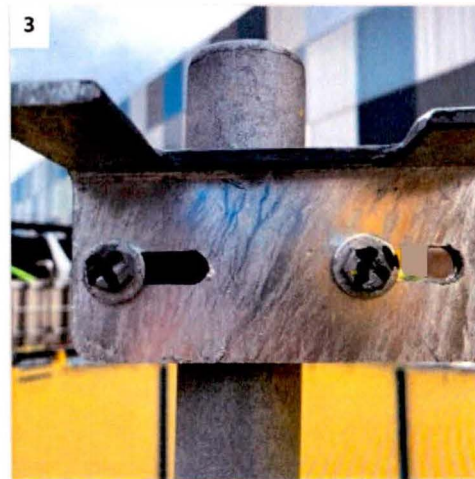
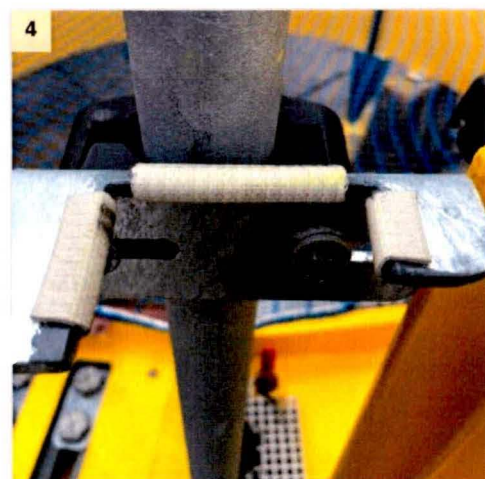
## ● #1370 - Paint missing and put some glue on the rubber

| Ben Herygers | Paint missing and put some glue on the rubber @Mechanical @kevin_kemps @ilchan_chanko #client | 24 jun 13:32 |

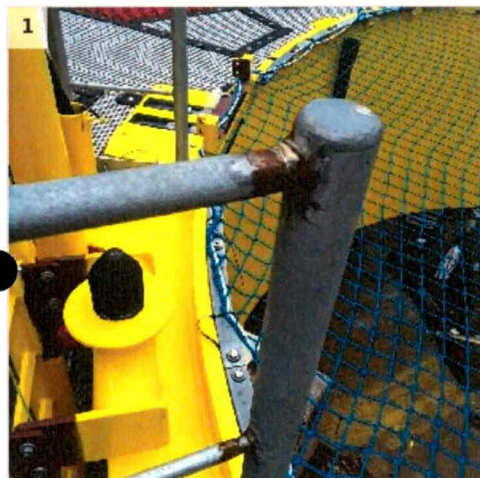
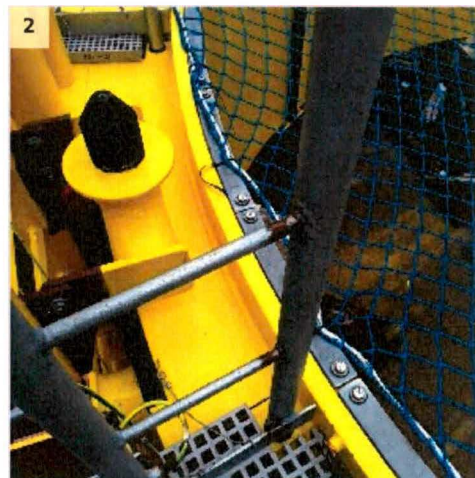
### #1226 - Wrong weld used. Stainless steel??

| Ben Herygers | Wrong weld used. Stainless steel?? @Mechanical @kevin_kamps #client | 19 jun 09:46 |
| Marcin Witkowski | Info Kevin NCR while being made | 23 jun 09:55 |

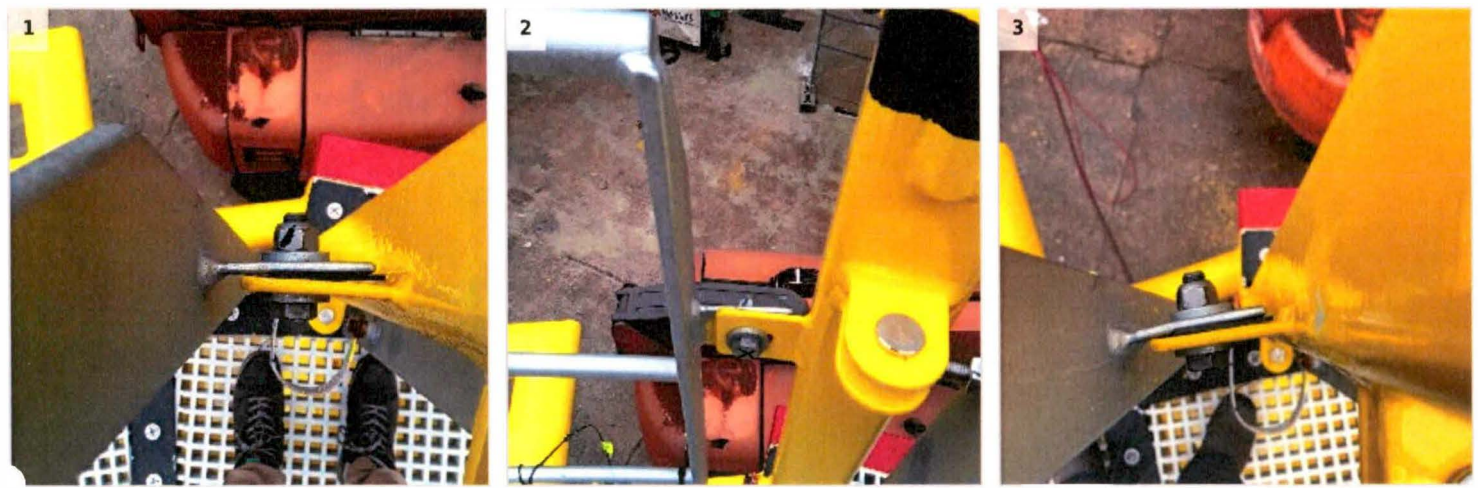
### #1229 - Needs to be adjusted

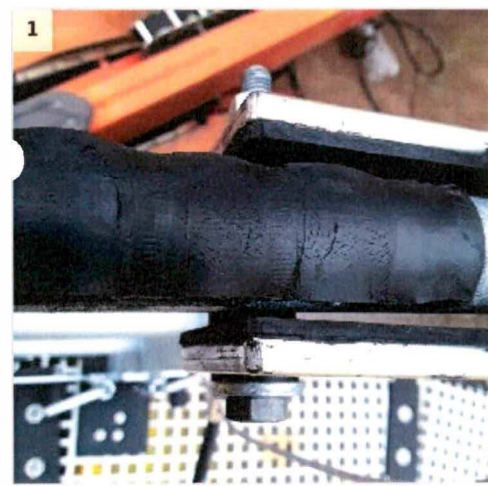
#1228 - Rubber already burst

| Kevin Kempes | 3 mm installad according drawing | 21 jun 13:52 |

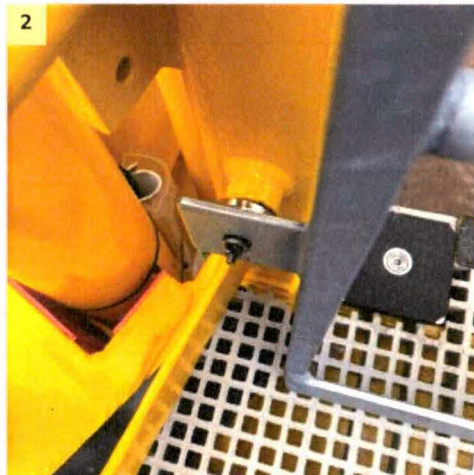
### #1220 - Put new bolt. Start already rusty

| Ben Herygers | Put new bolt. Start already rusty @Mechanical @kevin_kemps #client | 19 jun 09:37 |

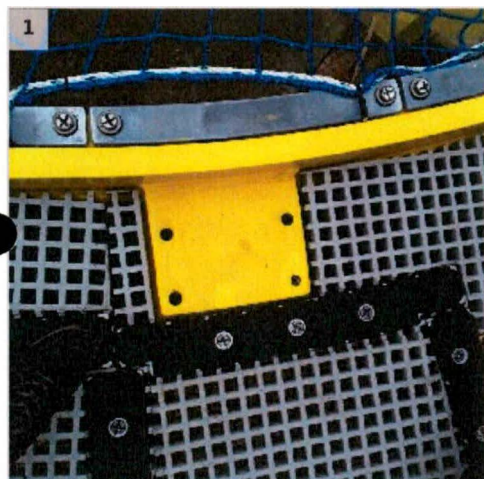
● #1222 - Missing plastic cap

Ben Herygers Photo 1  
Ben Herygers Missing plastic cap @Mechanical @kevin\_kemps #client

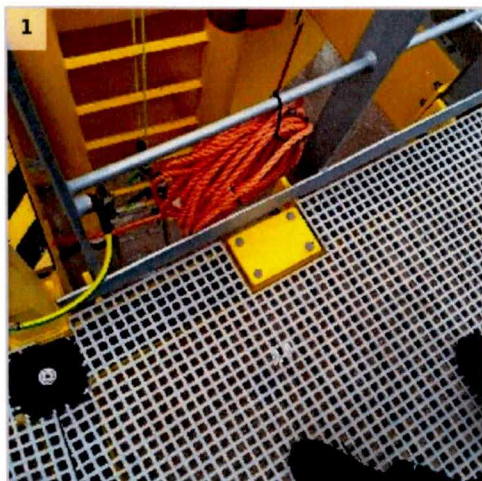
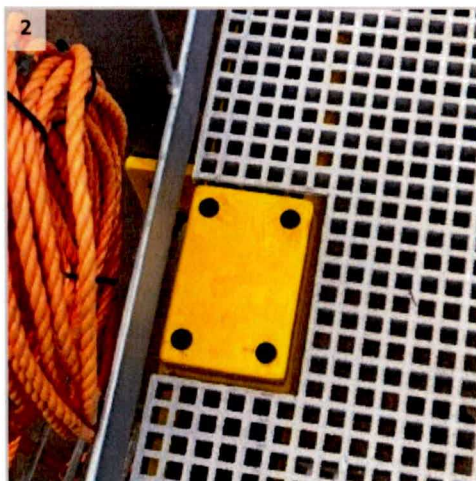
● #1223 - Needs black ones for UV protection

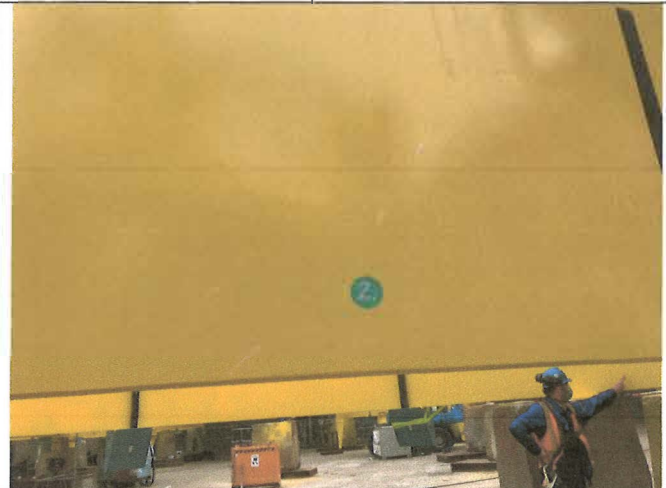
| H3M3 | Rev. 2 | Date: 24.06.2021 |
|---|---|---|
| No. 1 – Top coat repair, smoothing of the edge required. | No. 2 – Burn marks, fly rust, cleaning and topcoat repair required. | |

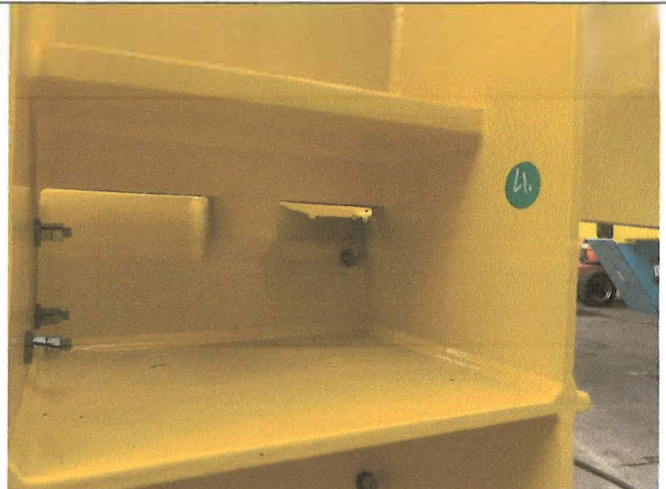
| H3M3 | Rev. 2 | Date: 24.06.2021 |
|---|---|---|
| No. 3 – Pour touch up, inclusions, topcoat repair required. | No. 4 – General comment, cleaning required. | |

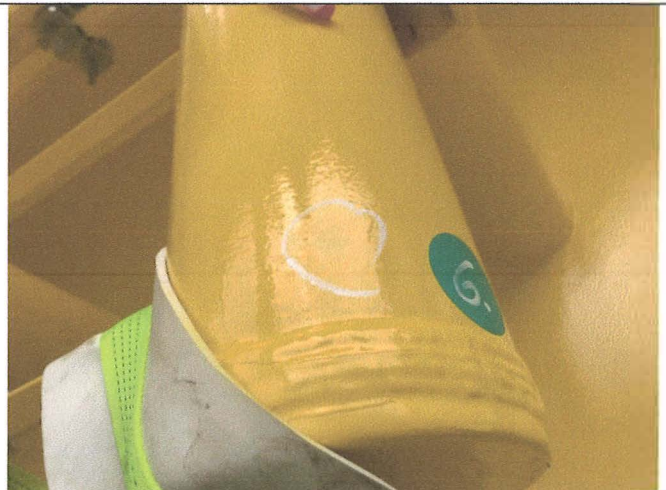
| H3M3 | Rev. 2 | Date: 24.06.2021 |
|---|---|---|
| No. 5 – Fly rust and burn marks, cleaning and topcoat repair required. | No. 6 – Another layer of topcoat required. | |

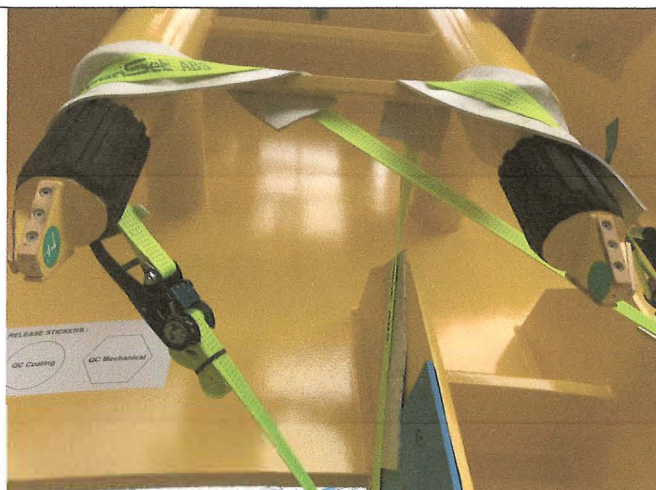
No. 7 – B. L. upper ladder, bolt holes must be sealed and top coated.

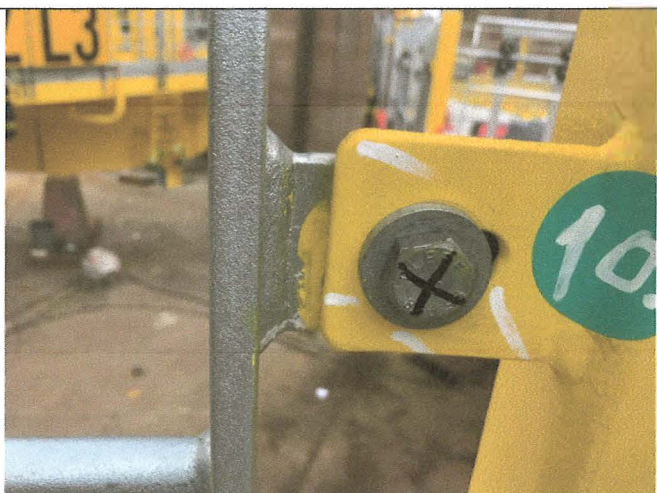
No. 10 – Pour workmanship, topcoat shall be removed from HDG handrail, additional layer of topcoat required on bracket.

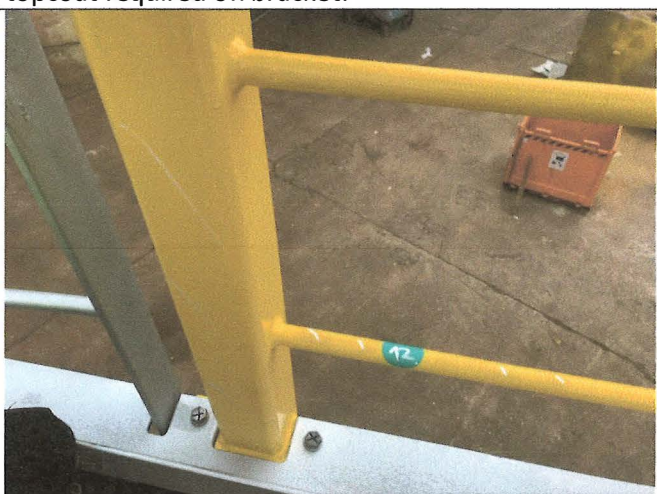
No. 12 – Topcoat repair required.
