| | <b>EWP M3</b><br>External work platform – FAT documentation | 25220<br>Hollandse Kust Zuid |

**Mechanical Release Note EWP Rev 2 #15**

## Punchlist mechanical

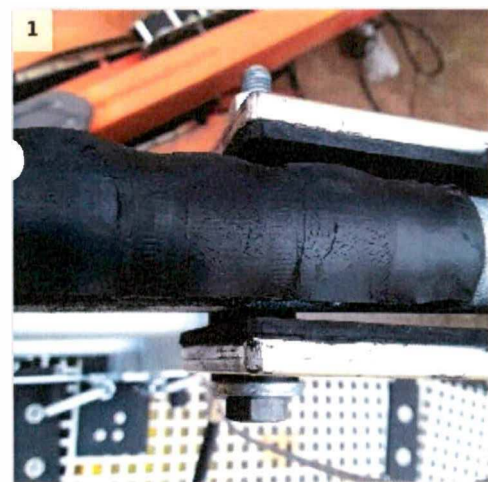
### #1229 - Needs to be adjusted

| Kevin Kempes | 3 mm installad according drawing | 21 jun 13:52 |

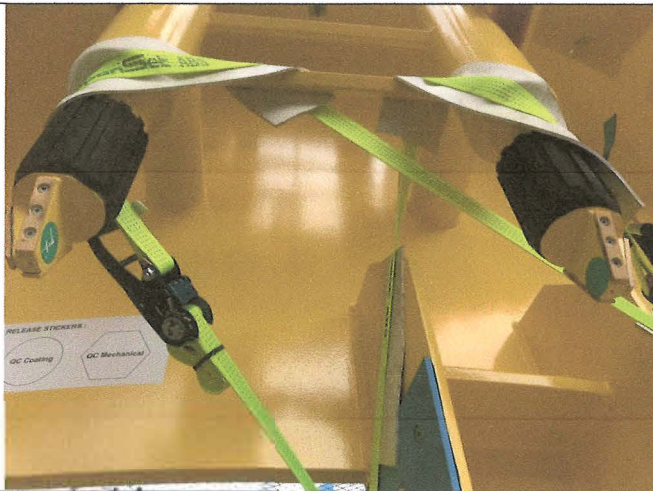
No. 7 – B. L. upper ladder, bolt holes must be sealed and top coated.

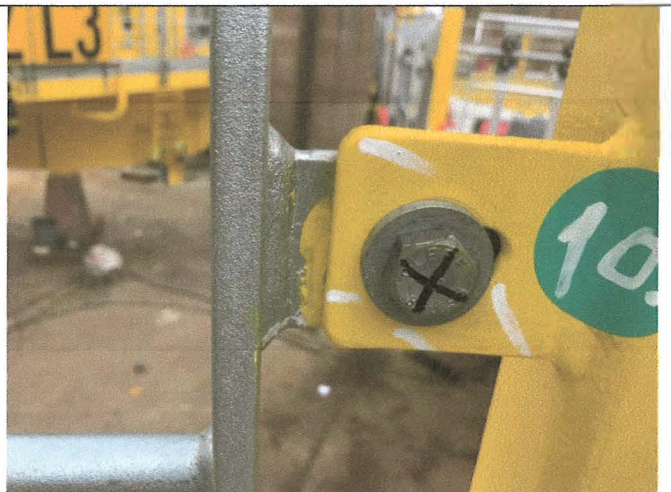
No. 10 – Pour workmanship, topcoat shall be removed from HDG handrail, additional layer of topcoat required on bracket.
